Please read before repairing and submitting a 2718F Curtain Air Bag Claim

2018 Mazda CX-5 Curtain Air Bag Module Recall 2718F

B. REPAIR PROCEDURE

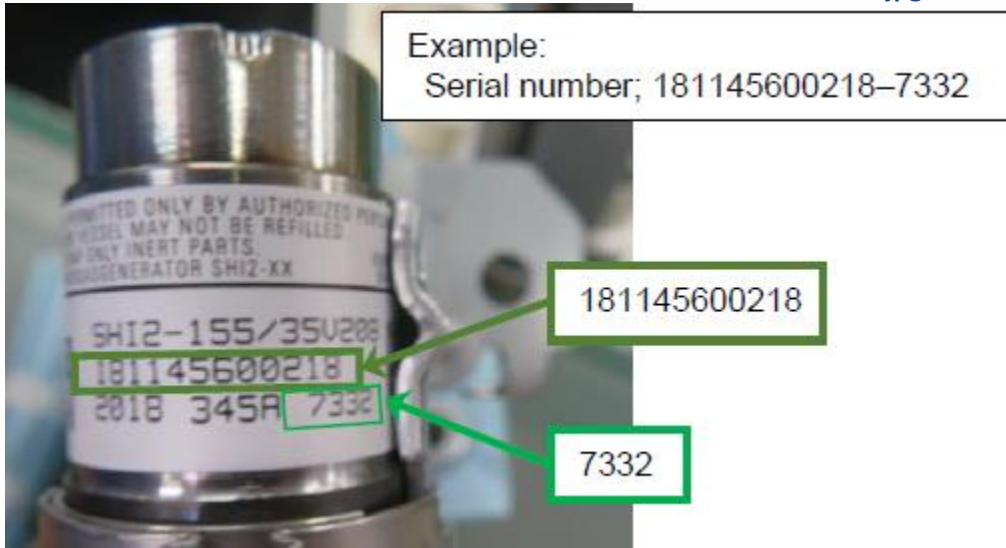
1. A clear photo of the **ORIGINAL** inflator(s) (right, left, or both) where the complete serial number is viewable. Save the photo as Claim_XXXX – Original Inflator Left and/or Claim_XXXX – Original Inflator Right. Attach one or both photos to the claim using Attachment ID D40. **IF THE PHOTO IS BLURRY OR THE ENTIRE SERIAL NUMBER CANNOT BE READ, RETAKE THE PHOTO AND ATTACH TO THE CLAIM. DO NOT USE LONG FILE NAMES USE RO45221L.jpg AS EXAMPLE**

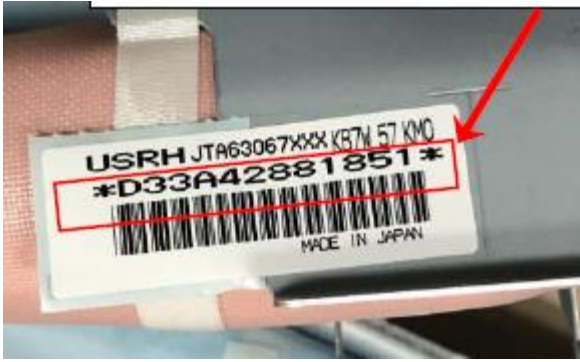
2. Clear photos of the new inflator (right, left, or both) showing the complete serial number. Save the photo as Claim_XXXX – New Inflator Left and/or Claim_XXXX – New Inflator Right. Attach one or both photos to the claim using Attachment ID D40. **IF THE PHOTO IS BLURRY OR THE ENTIRE SERIAL NUMBER CANNOT BE READ, RETAKE THE PHOTO AND ATTACH TO THE CLAIM. TECHNICIAN – CHECK YOUR PHOTO BEFORE REINSTALLING THE HEADLINER. MAKE SURE THE SERIAL NUMBER IS FULLY VISIBLE AND EASY TO READ**

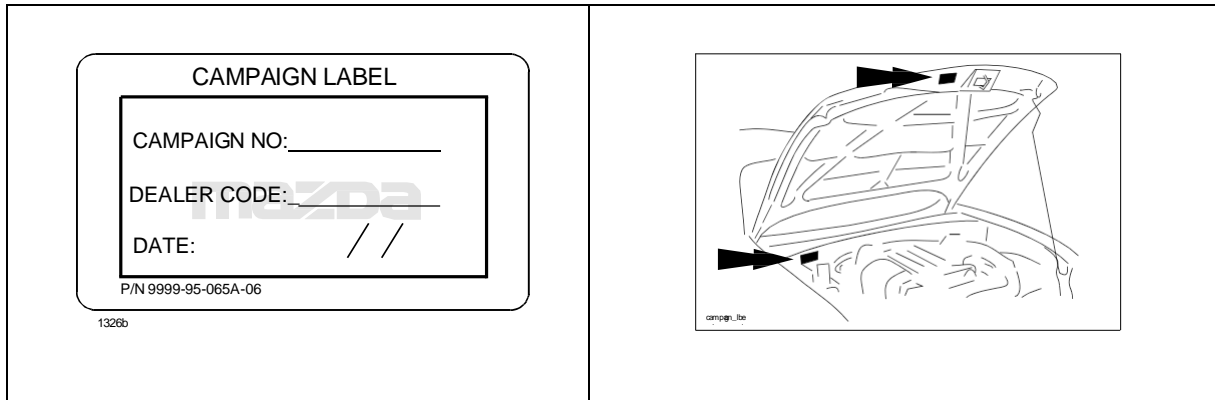
- If the vehicle is within the above ranges, proceed to Step 2.
 - If the vehicle is not within the above ranges, return vehicle to the customer or inventory.
2. Perform a Warranty Vehicle Inquiry using your eMDCS System and inspect vehicle for Campaign Labels **Recalls 2718F** attached to the vehicle’s hood or bulkhead. Refer to eMDCS System - Warranty Vehicle Inquiry Results table below.

NOTE: Be sure to verify Recall number as the vehicle may have multiple Recall labels.

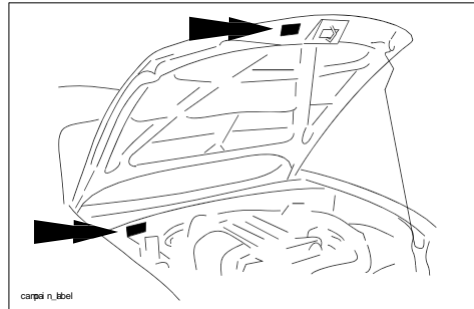
- Affix it to the hood or bulkhead as shown:

1. Fill out a blue "Campaign Label" (9999-95-065A-06) with Campaign No: "2718F", your dealer code, today's date.

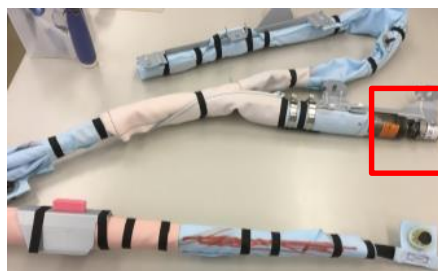
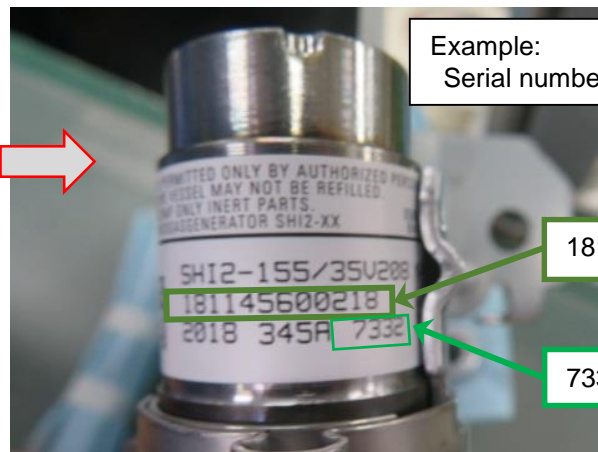
Refer to the picture below for the location where the serial number is printed. **These photos must be readable or the claim will be denied.**

Example:
Serial number; 181145600218-7332

Check the serial number of old (removed) curtain air bag inflator.

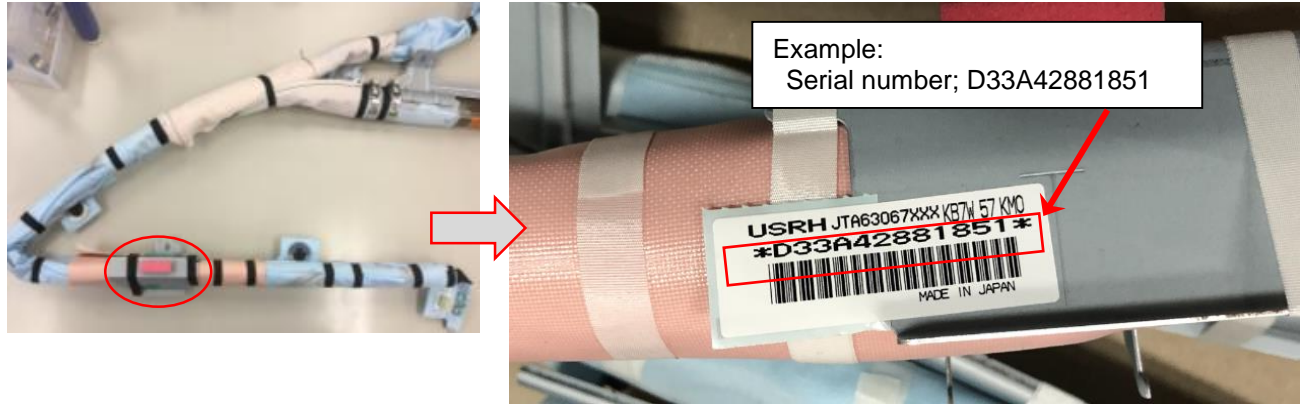
Check the serial number of new (to be installed) curtain air bag module.
Refer to the picture below for the location where the serial number label is attached.

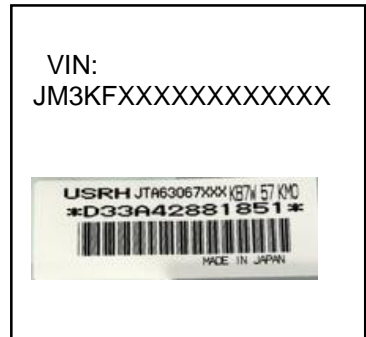
Sample:

2. Record the Serial Numbers of old curtain air bag module(s) and new curtain air bag module(s) in the TECHNICIAN REPAIR TEXT ON THE REPAIR ORDER.
3. Peel off the serial number label from the new curtain air bag module AND SCAN OR ATTACH THE SERIAL NUMBER OF THE NEW CURTAIN TO THE RO.
