Safety Recall Code: 69R7

Passenger Frontal Airbag (Takata)

June 29, 2018

U.S.A. & Canada: Certain 2005-2011 MY Audi vehicles

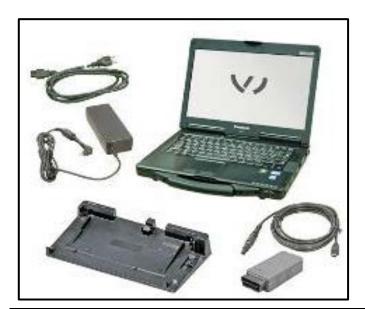
- Ensure ODIS is updated to the latest version.
- Connect vehicle diagnostic tester to the vehicle using USB cable.
- Select Start Diagnosis function and identify vehicle.
- After identification of control units, Guided Fault Finding is started automatically.
- Follow the instructions on screen.

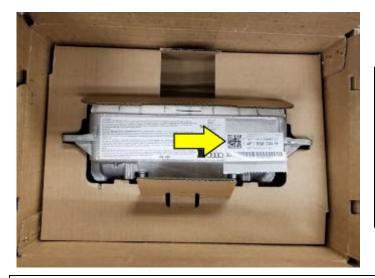
Scan the data matrix code <arrow> of the new airbag at a distance of about 15 cm, then follow the instructions on screen.
