Safety Recall

Code: 69R7

Subject	Passenger Frontal Airbag (Takata)	
Document History	Date	Summary
	April 30, 2024	Updated part return/disposal information
Affected Vehicles	<p>U.S.A. & Canada: Certain 2005-2011 MY Audi vehicles</p> <p>Check Campaigns/Actions screen in Elsa on the day of repair to verify that a VIN qualifies for repair under this action. Elsa is the <u>only</u> valid campaign inquiry & verification source.</p> <ul style="list-style-type: none"> ✓ Campaign status must show "open." ✓ If Elsa shows other open action(s), inform your customer so that the work can also be completed at the same time the vehicle is in the workshop for this campaign. 	
Problem Description	The passenger frontal airbag may explode in a crash with airbag deployment. Sharp metal fragments can hit people and cause serious injury or death.	
Corrective Action	Replace the passenger frontal airbag with a newly manufactured version. This is considered to be the final repair for these vehicles.

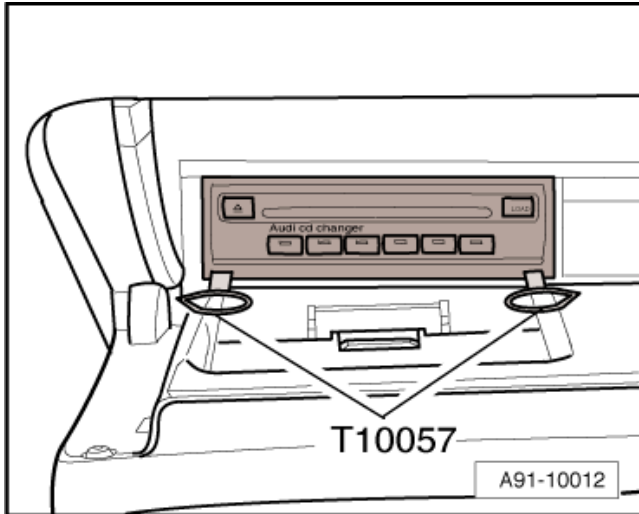
Section B – Passenger Airbag Inspection

- If applicable, remove CD Changer -R41- as follows:
 - Insert 2 clamps on Radio Removal Tool -T10057- in front side of CD Changer -R41-.
 - Top L = upper left.
 - Top R = upper right.
 - Remove CD Changer -R41- from installation frame.
 - Disconnect electrical connector.
 - Disconnect fiber optic connector <2>.
 - Seal the open wiring set connector <2> for fiber-optic cable using Protective Cap for Cable Connector -VAS 6223/9- <item 1>.
 - Remove release tools by pressing locking tabs on CD Changer -R41-.

The protective cap prevents soiling and damage to fiber optic face, which would impair light transfer.

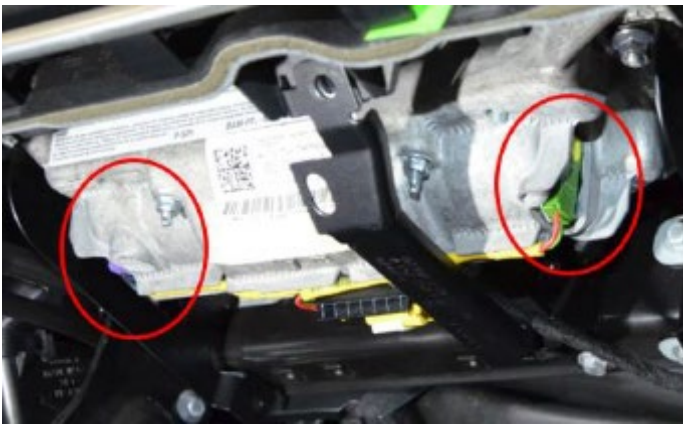
- If the passenger airbag inflator connectors are configured on the ends <as shown>, the airbag was manufactured by Takata and will require replacement.

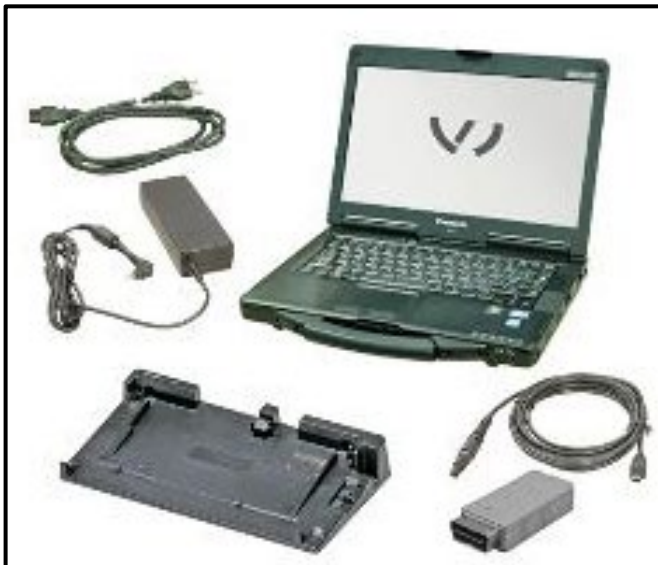
- Ensure ODIS is updated to the latest version.
- Connect vehicle diagnostic tester to the vehicle using USB cable.
- Select Start Diagnosis function and identify vehicle.
- After identification of control units, Guided Fault Finding is started automatically.
- Follow the instructions on screen.

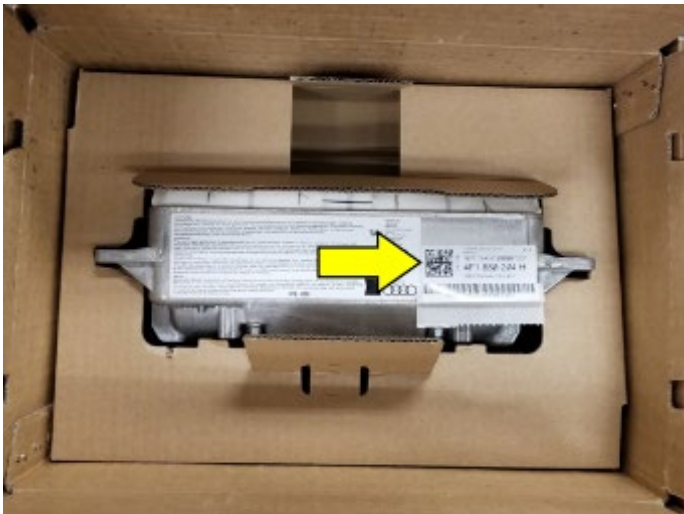
- Scan the data matrix code <arrow> of the new airbag at a distance of about 15 cm, then follow the instructions on screen.
