Safety Recall Code: 69R7

Subject	Passenger Frontal Airbag (Takata)
Revision Summary	Updated instructions for the mandatory Takata parts return process in Appendix B.
Release Date	July 21, 2018
Affected Vehicles	U.S.A. & Canada: Certain 2005-2011 MY Audi vehicles
	Check Campaigns/Actions screen in Elsa on the day of repair to verify that a VIN qualifies for repair under this action. Elsa is the <u>only</u> valid campaign inquiry & verification source.
	 ✓ Campaign status must show "open." ✓ If Elsa shows other open action(s), inform your customer so that the work can also be completed at the same time the vehicle is in the workshop for this campaign.
Problem Description	The passenger frontal airbag may explode in a crash with airbag deployment. Sharp metal fragments can hit people and cause serious injury or death.
Corrective Action	Replace the passenger frontal airbag with a newly manufactured version. This is considered to be the final repair for these vehicles.

Section B – Passenger Airbag Inspection

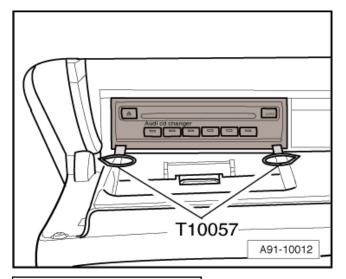
- If applicable, remove CD Changer -R41- as follows:
 - Insert 2 clamps on Radio Removal Tool -T10057- in front side of CD Changer -R41-.
 - \circ Top L = upper left.
 - \circ Top R = upper right.
 - Remove CD Changer -R41- from installation frame.
 - o Disconnect electrical connector.
 - Disconnect fiber optic connector <2>.
 - Seal the open wiring set connector <2> for fiber-optic cable using Protective Cap for Cable Connector -VAS 6223/9- <item 1>.
 - Remove release tools by pressing locking tabs on CD Changer -R41-.

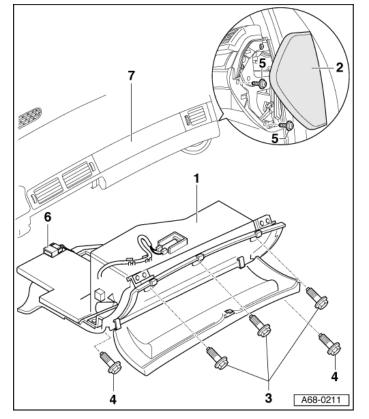
- Disconnect instrument panel cover <2>.
- Open glove compartment cover.
- Remove three bolts <3> at top in depressions of glove compartment <1>.
- Remove outside bolts <5>.
- Remove bolts <4>.
- Remove glove compartment downward.
- Remove connector <6> from glove compartment light.

- Install connector <6> to glove compartment light.
- Install glove compartment.
- Install bolts <3, 4 and 5> and torque to 5 Nm.
- Install instrument panel cover <2>.

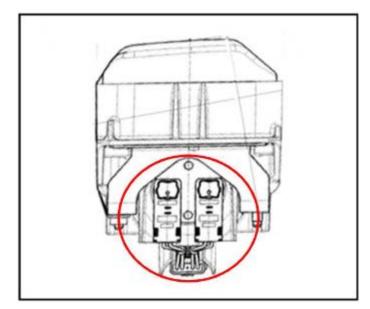
- If the passenger airbag inflator connectors are configured side by side <as shown>, the airbag was not manufactured by Takata and NO further work is required:
 - Reassemble glove box and **Continue to Section E.**

If the passenger airbag inflator connectors are configured on the ends <as shown>, the airbag was manufactured by Takata and will require replacement.

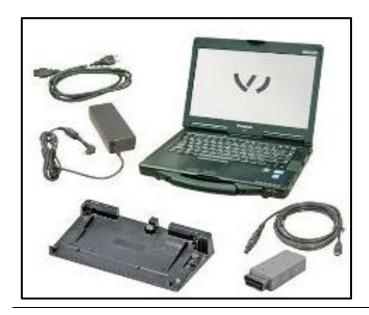
- Ensure ODIS is updated to the latest version.
- Connect vehicle diagnostic tester to the vehicle using USB cable.
- Select Start Diagnosis function and identify vehicle.
- After identification of control units, Guided Fault Finding is started automatically.
- Follow the instructions on screen.

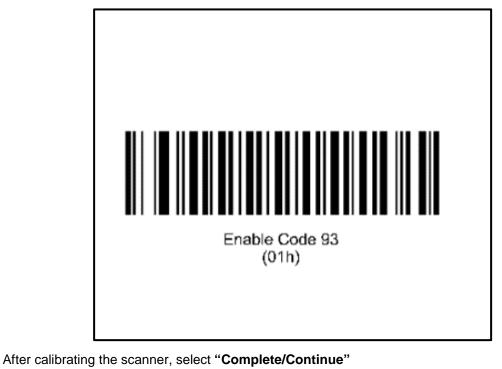
- Scanning the bar code during this test plan step calibrates the scanner to avoid error messages.
- Scanning the calibrating bar code may not have to be done every time. Only when the scanner requires calibration. You will know if the scanner needs calibrating if the scanner does not scan the airbag's bar code.
- If the airbag bar code cannot be scanned, then print out the barcode shown below and scan the printout.

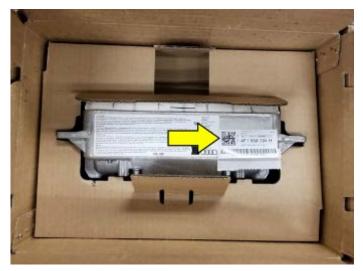
• Scan the data matrix code <arrow> of the new airbag at a distance of about 15 cm, then follow the instructions on screen.

Ensure the correct airbag data matrix code is scanned at this time.

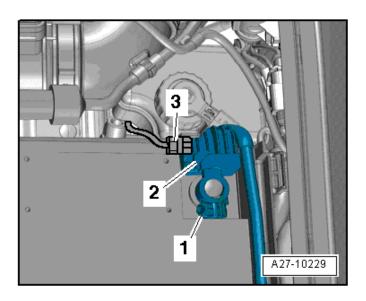
- Access the battery.
- Make sure the ignition is turned **ON**.
- Loosen the nut <1>.
- Remove and isolate the battery ground cable terminal <2> from the battery terminal.

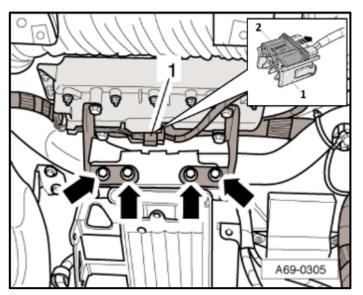
- Remove and discard instrument panel bolts <arrows> on central tube.
- Press securing catch <2> in <direction of arrow> until connection disengages.
- Remove electrical connector <1>.

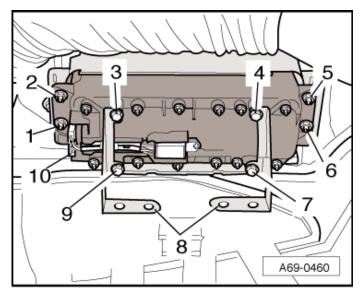
- Remove and discard bolts <3, 4, 7 and 9> and remove airbag unit bracket <8>.
- Remove and discard nuts <1, 2, 5 and 6>.
- Remove passenger airbag.

- Install new passenger airbag, with new nuts <1,
 2, 5 and 6> and torque to 9 Nm.
- Install bracket <8>, with new bolts <3, 4, 7 and 9> and torque to 6 Nm.

Part Number	Part Description
4F1880204F	Passenger Airbag
N 02300213	M6 Self Locking Nut <1, 2, 5 and 6>
N 10305302	M6 x 20 Bolt (airbag bracket to airbag) <3, 4, 7 and 9>

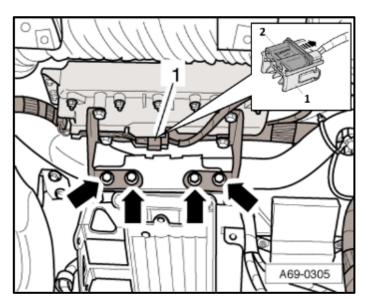
Install new bolts <arrows> on central tube and torque to 9 Nm.

• Install electrical connector <1>.

Part Number	Part Description
N 90654602	M6 x 18.25 Bolt (airbag bracket to central tube) <arrows></arrows>

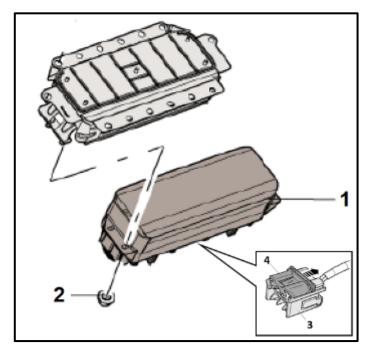
- Press securing catch <4> in <direction of arrow>.
- Remove electrical connector <3>.
- Remove and discard passenger airbag nuts <2> from passenger airbag <1>.
- Remove passenger airbag

Install new passenger airbag <1>, with new nuts
 <2> and torque to 9 Nm.

• Install electrical connector <3>.

Part Number	Part Description
8E1880204F	Passenger Airbag
N 90887703	M6 Self Locking Nut

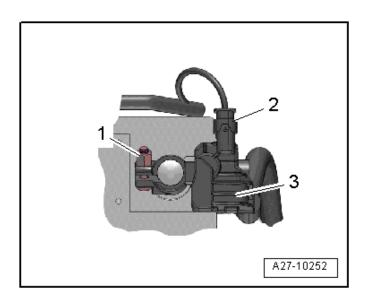
Ignition must be **ON** when connecting battery. If pyrotechnic components (e.g. airbag, belt tensioner) are not repaired correctly, they may deploy unintentionally after connecting battery. There must not be anyone inside the vehicle when connecting the battery.

- If equipped, disconnect the connector <2> from the Battery Monitoring Control Module -J367-.
- Connect the battery ground cable terminal by hand to the battery negative terminal.
- Torque the nut <1>:
 - A6 Models = 6 Nm.
 - A4/A4 Cabriolet Models = 7.5 Nm.
- If equipped, reconnect the connector to the Battery Monitoring Control Module -J367-.
- Install battery covers.
- If equipped, install battery strap.
- If necessary, install luggage compartment storage area floor and if equipped, cover for spare tire.
- Cycle the ignition off and back on.
- Bring passenger seat to an upright position.
- Store previously recorded radio presets (if necessary).
- Set clock to local time.
- Activate the power window regulator one-touch up/down function.
- Check the DTC memories of all the control units and erase under-voltage faults if necessary.
