# Safety Recall

## Code: 69R7

Audi

<b>Subject</b>	<b>Passenger Frontal Airbag (Takata)</b>
<b>Release Date</b>	February 18, 2022
<b>Revision Summary</b>	<b><u>USA ONLY</u></b> <b>Updated Rental Car/Loaner claiming labor number</b>
<b>Affected Vehicles</b>	<b>U.S.A. &amp; Canada: Certain 2005-2011 MY Audi vehicles</b> <i>Check Campaigns/Actions screen in Elsa on the day of repair to verify that a VIN qualifies for repair under this action. Elsa is the <u>only</u> valid campaign inquiry &amp; verification source.</i> <ul style="list-style-type: none"><li>✓ Campaign status must show "open."</li><li>✓ If Elsa shows other open action(s), inform your customer so that the work can also be completed at the same time the vehicle is in the workshop for this campaign.</li></ul>
<b>Problem Description</b>	The passenger frontal airbag may explode in a crash with airbag deployment. Sharp metal fragments can hit people and cause serious injury or death.

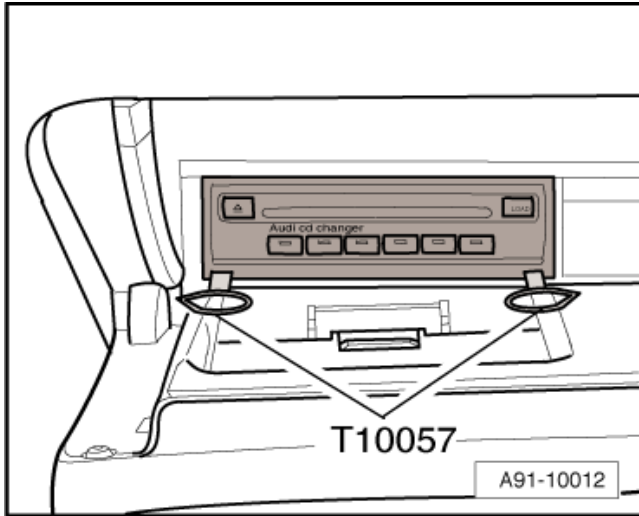
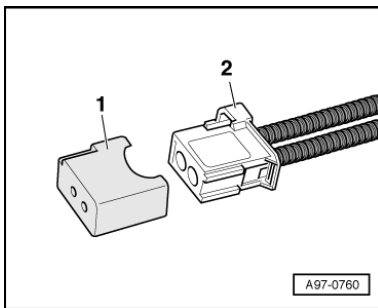
- If applicable, remove CD Changer -R41- as follows:
  - Insert 2 clamps on Radio Removal Tool -T10057- in front side of CD Changer -R41-.
  - Top L = upper left.
  - Top R = upper right.
  - Remove CD Changer -R41- from installation frame.
  - Disconnect electrical connector.
  - Disconnect fiber optic connector <2>.
  - Seal the open wiring set connector <2> for fiber-optic cable using Protective Cap for Cable Connector -VAS 6223/9- <item 1>.
  - Remove release tools by pressing locking tabs on CD Changer -R41-.

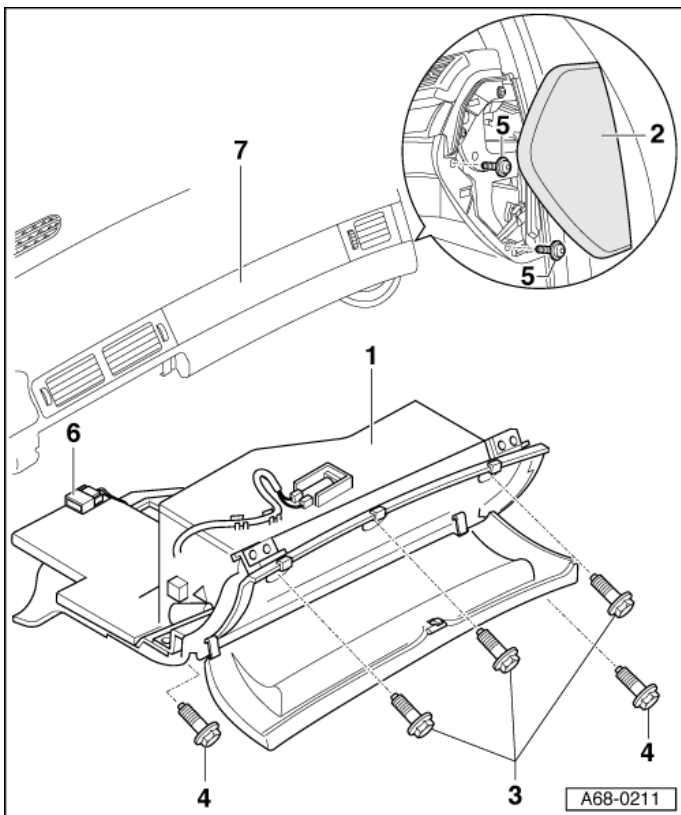
- Disconnect instrument panel cover <2>.
- Open glove compartment cover.
- Remove three bolts <3> at top in depressions of glove compartment <1>.
- Remove outside bolts <5>.
- Remove bolts <4>.
- Remove glove compartment downward.
- Remove connector <6> from glove compartment light.

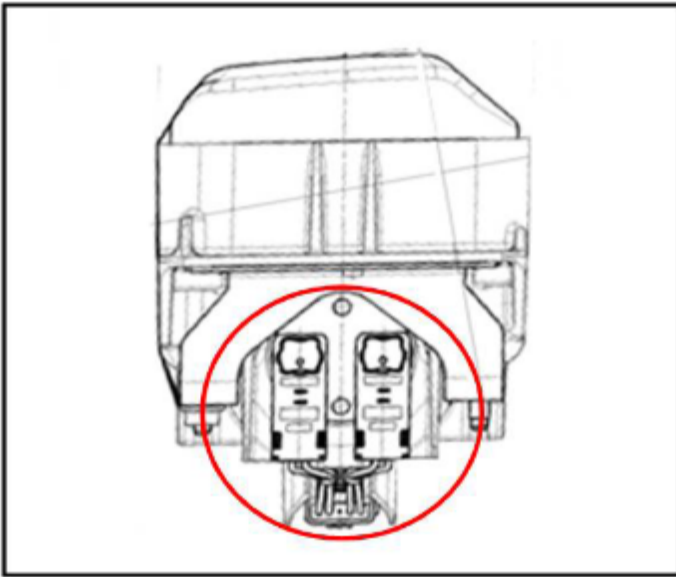
- If the passenger airbag inflator connectors are configured side by side <as shown>, the airbag was not manufactured by Takata and NO further work is required:
  - Reassemble glove box and **Continue to Section E.**

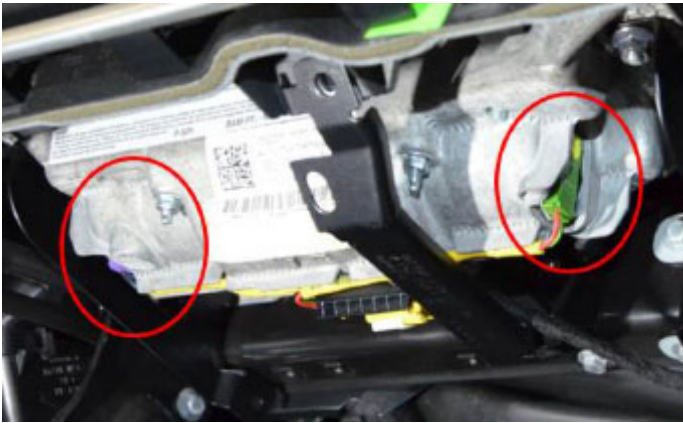
- If the passenger airbag inflator connectors are configured on the ends <as shown>, the airbag was manufactured by Takata and will require replacement.

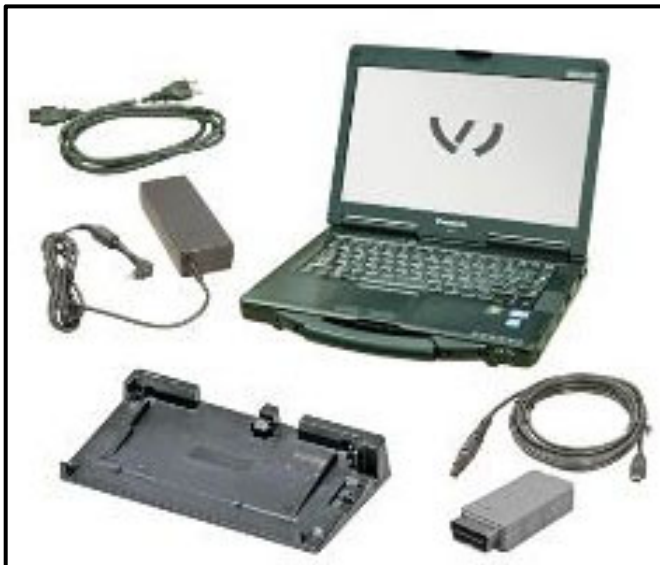
- Ensure ODIS is updated to the latest version.
- Connect vehicle diagnostic tester to the vehicle using USB cable.
- Select Start Diagnosis function and identify vehicle.
- After identification of control units, Guided Fault Finding is started automatically.
- Follow the instructions on screen.

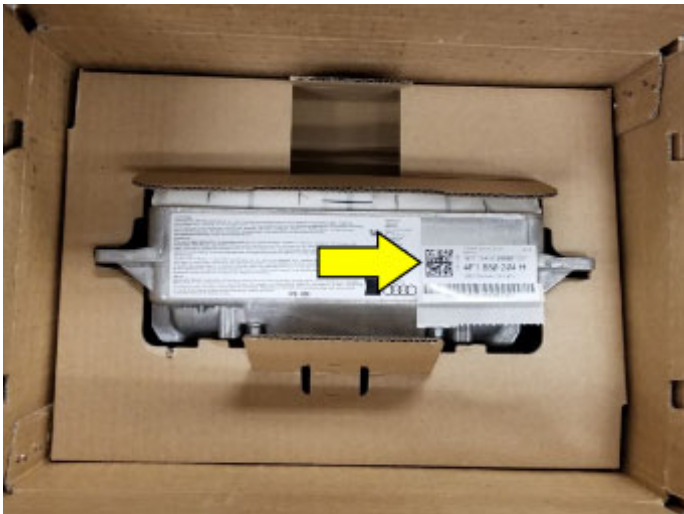
- Scan the data matrix code <arrow> of the new airbag at a distance of about 15 cm, then follow the instructions on screen.

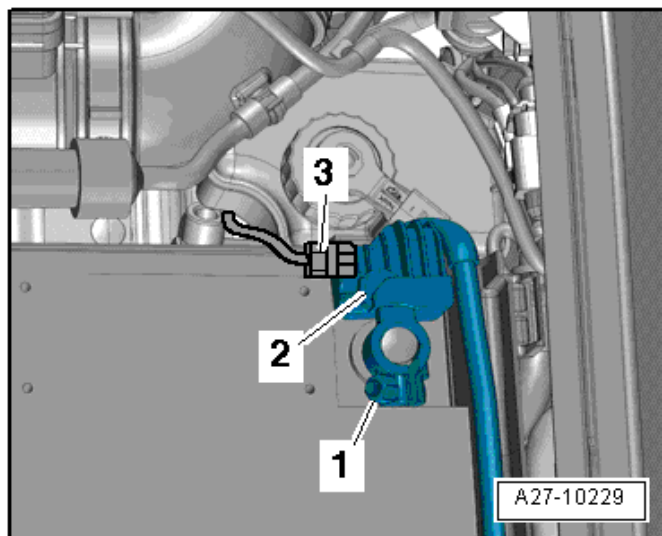
- Access the battery.
- Make sure the ignition is turned **ON**.
- Loosen the nut <1>.
- Remove and isolate the battery ground cable terminal <2> from the battery terminal.

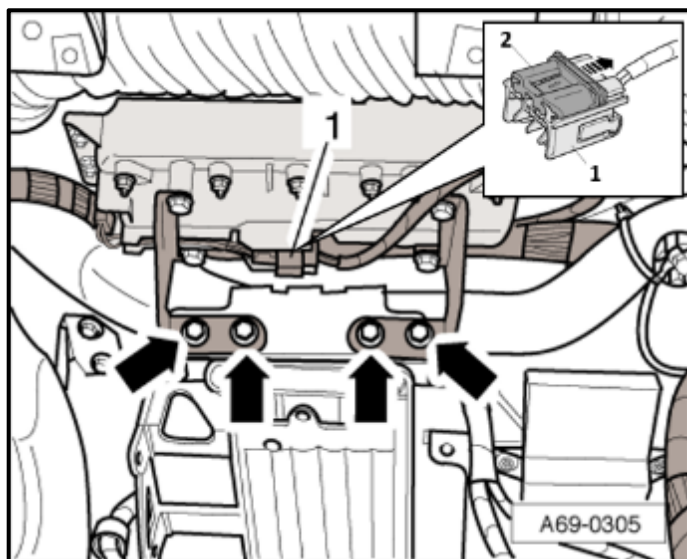
- Remove and discard instrument panel bolts <arrows> on central tube.
- Press securing catch <2> in <direction of arrow> until connection disengages.
- Remove electrical connector <1>.

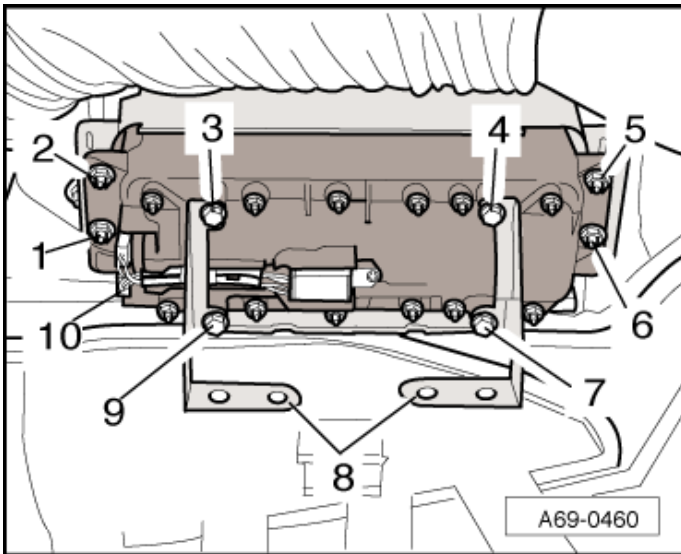
- Remove and discard bolts <3, 4, 7 and 9> and remove airbag unit bracket <8>.
- Remove and discard nuts <1, 2, 5 and 6>.
- Remove passenger airbag.

- Install new passenger airbag, with new nuts <1, 2, 5 and 6> and torque to 9 Nm.
- Install bracket <8>, with new bolts <3, 4, 7 and 9> and torque to 6 Nm.

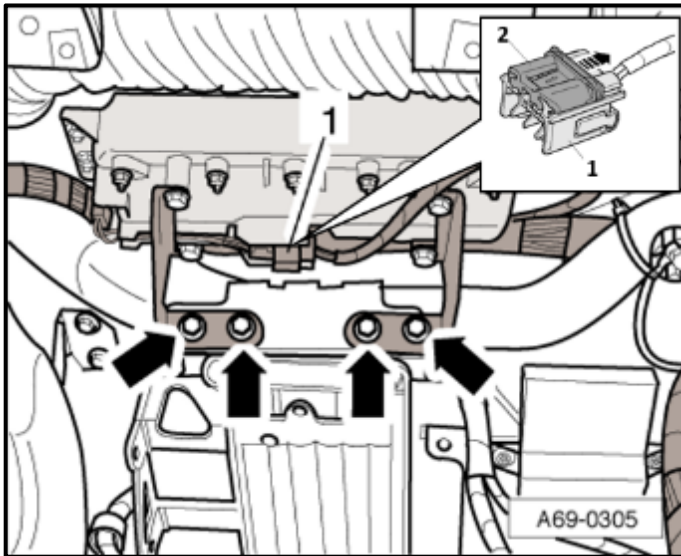
- Install new bolts <arrows> on central tube and torque to 9 Nm.

- Install electrical connector <1>.

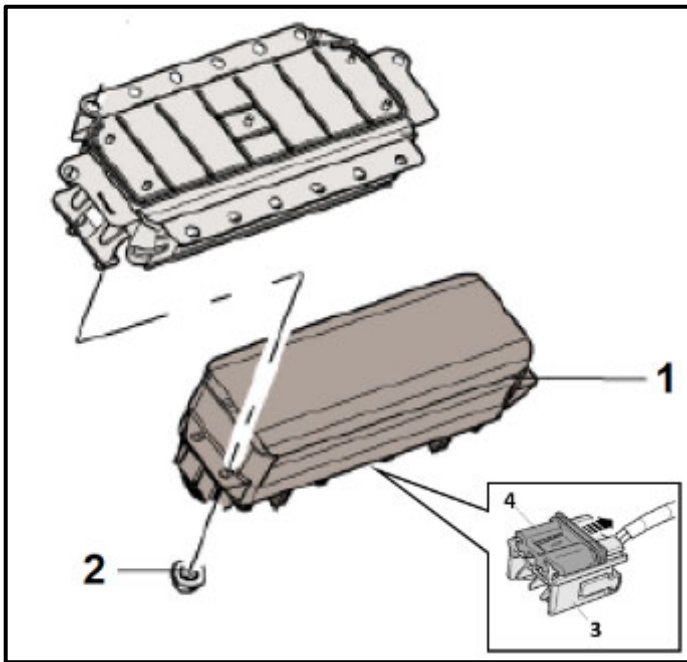
- Press securing catch <4> in <direction of arrow>.
- Remove electrical connector <3>.
- Remove and discard passenger airbag nuts <2> from passenger airbag <1>.
- Remove passenger airbag

- Install new passenger airbag <1>, with new nuts <2> and torque to 9 Nm.

- Install electrical connector <3>.

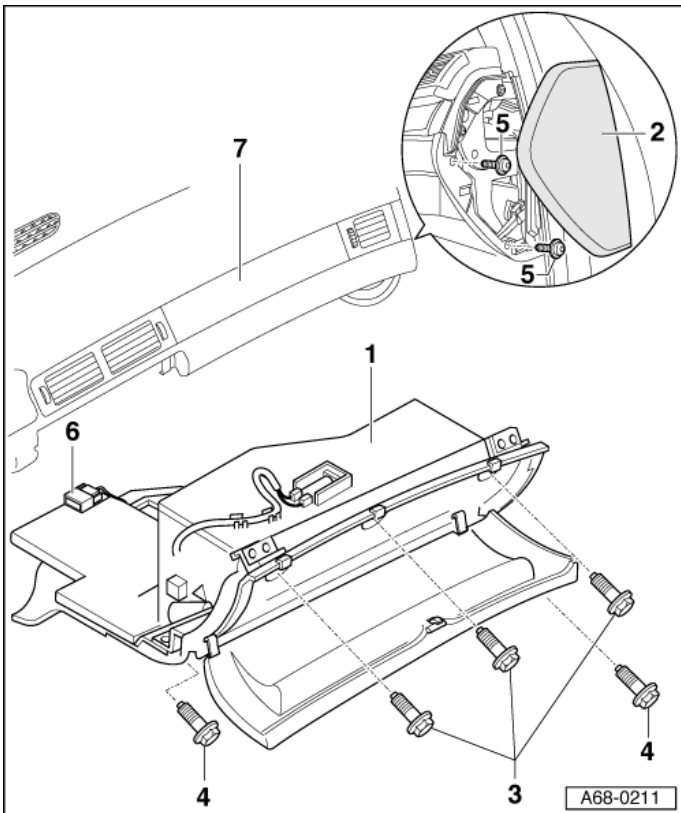
- Install connector <6> to glove compartment light.
- Install glove compartment.
- Install bolts <3, 4 and 5> and torque to 5 Nm.
- Install instrument panel cover <2>.

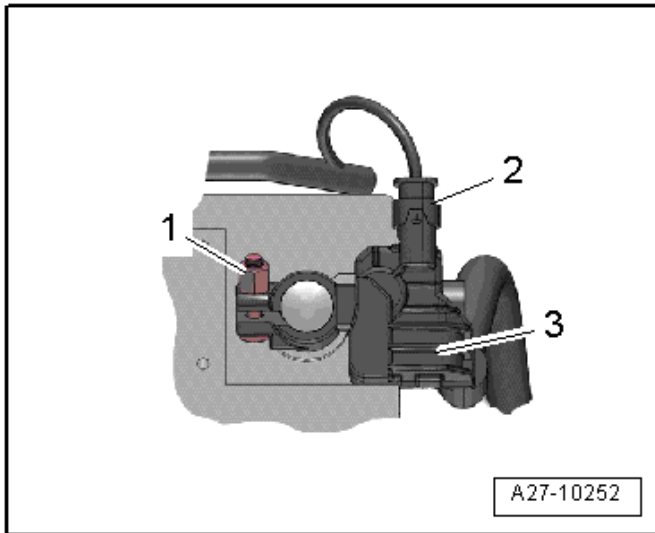
- If equipped, disconnect the connector <2> from the Battery Monitoring Control Module -J367-.
- Connect the battery ground cable terminal by hand to the battery negative terminal.
- Torque the nut <1>:
  - A6 Models = 6 Nm.
  - A4/A4 Cabriolet Models = 7.5 Nm.
- If equipped, reconnect the connector to the Battery Monitoring Control Module -J367-.
- Install battery covers.
- If equipped, install battery strap.
- If necessary, install luggage compartment storage area floor and if equipped, cover for spare tire.
- Cycle the ignition off and back on.
- Bring passenger seat to an upright position.
- Store previously recorded radio presets (if necessary).
- Set clock to local time.
- Activate the power window regulator one-touch up/down function.
- Check the DTC memories of all the control units and erase under-voltage faults if necessary.
