Safety Recall

Code: 20AV

Subject	Fuel Line
Release Date	July 20, 2018
Affected Vehicles	U.S.A. & CANADA: Certain 2013-2015 Model Year Audi A8 and S8 Vehicles <i>Check Campaigns/Actions screen in Elsa on the day of repair to verify that a VIN qualifies for repair under this action. Elsa is the <u>only</u> valid campaign inquiry & verification source.</i> <ul style="list-style-type: none">✓ Campaign status must show "open."✓ If Elsa shows other open action(s), inform your customer so that the work can also be completed at the same time the vehicle is in the workshop for this campaign.
Problem Description	Over time, the fuel supply line for the high pressure fuel pump may become porous, resulting in a fuel smell or a fuel leak. Leaking fuel, in the presence of an ignition source, may result in a fire.
Corrective Action	Replace the fuel line.
Precautions	Customers are advised to contact their authorized Audi dealer without delay if they notice a fuel smell in the vehicle.

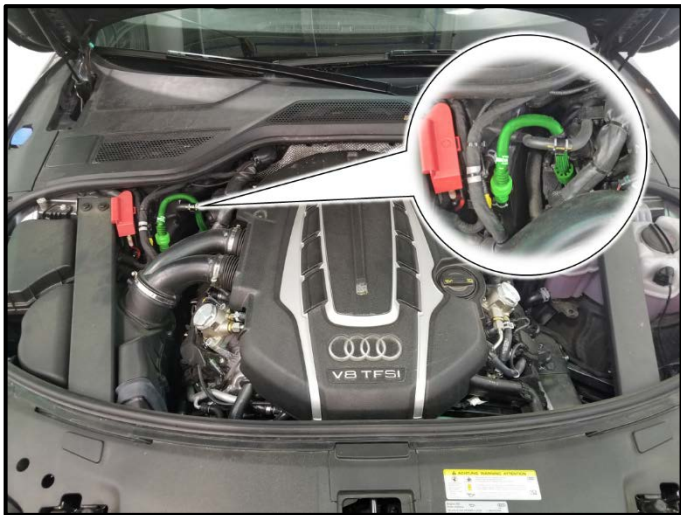
Repair Overview

- Replace underhood fuel supply hose.

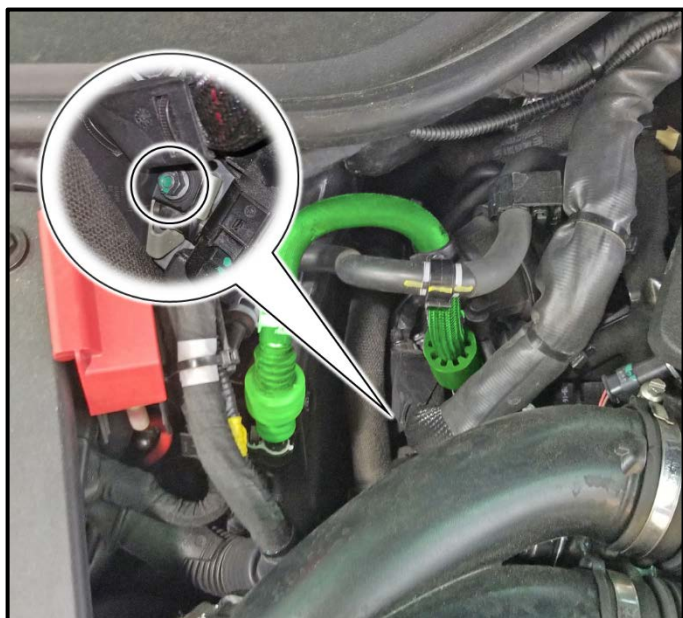
- Remove nut <circle> from wiring harness bracket.

Removal of this nut allows for easier access to the fuel hose clamp.

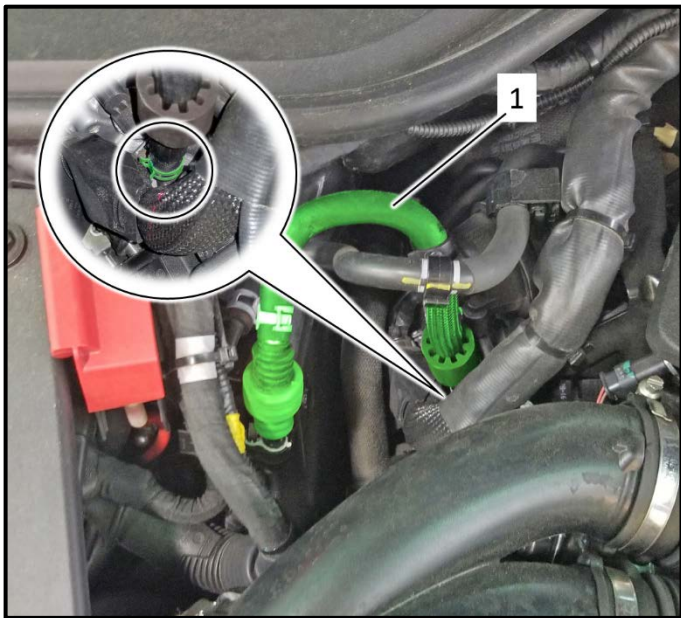
- Place clean cloths around the fuel hose connections to catch any leaking fuel.
- Compress clamp <circle> and remove fuel hose <1> from metal fuel line.

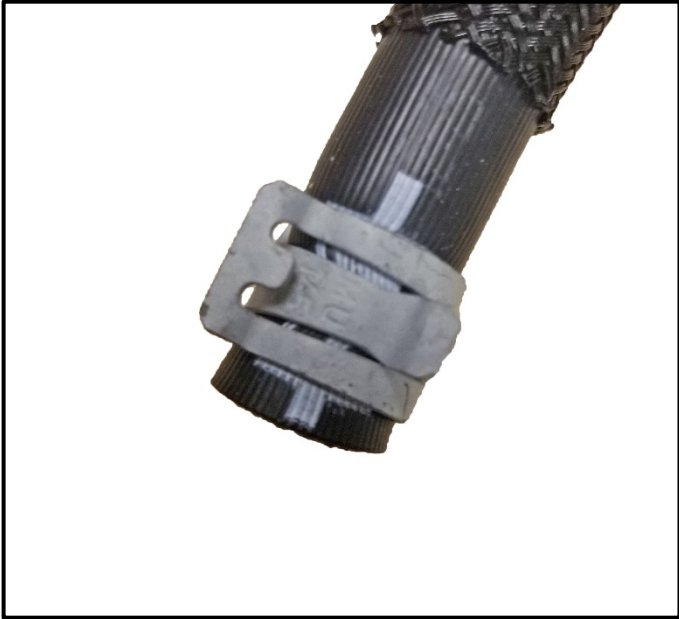
- Install new fuel hose onto fuel line.
- Ensure the fuel hose is not twisted.
- Position clamp (included on new fuel hose) in the correct installed position (as shown between paint markings).

Hose shown removed for clarity.

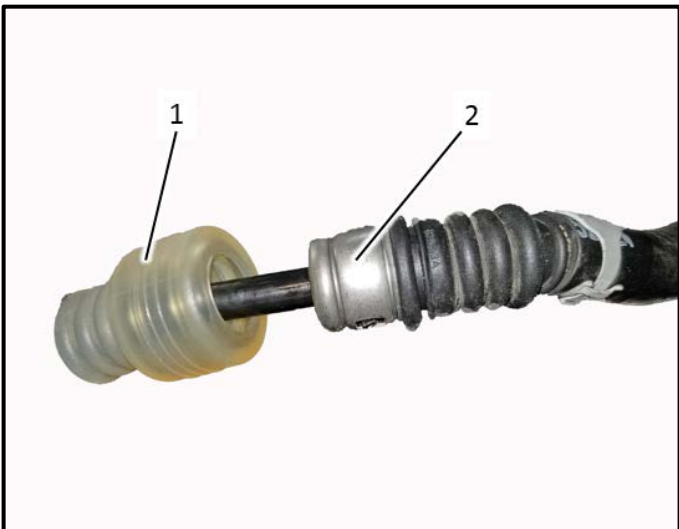
- Remove the protective cap from the new fuel hose and slide it onto the fuel line.
- Connect fuel line coupling <2> until it audibly engages.
- Slide fuel line coupling cover <1> over fuel line coupling.

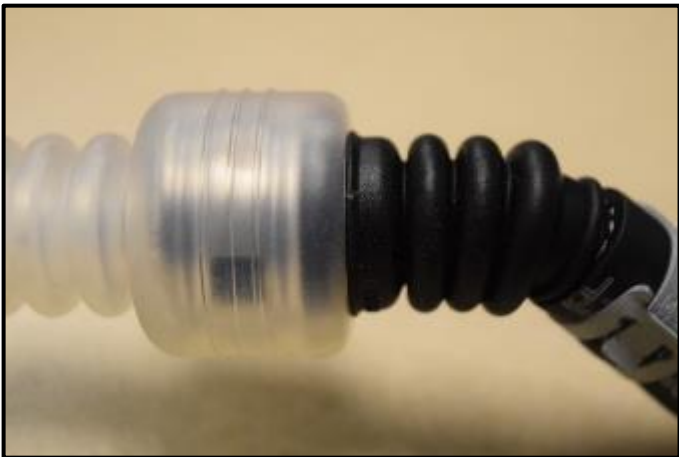
- When correctly seated, the fuel line coupling cover should appear as shown.

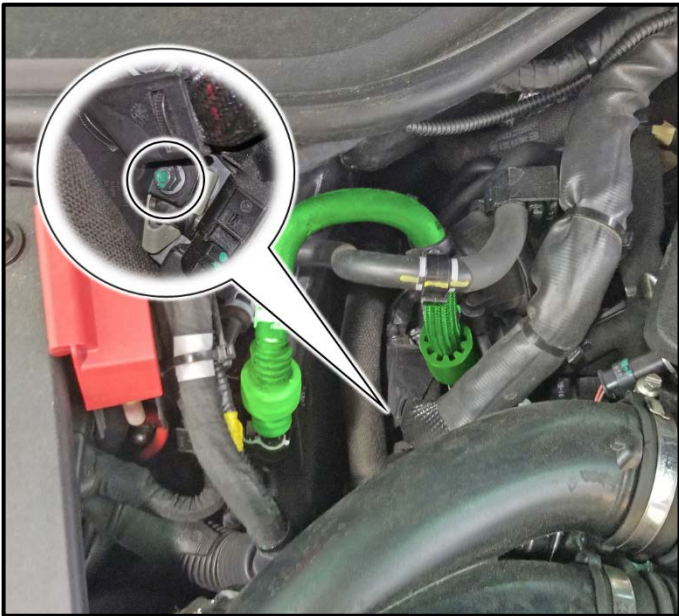
- Install nut <circle> and torque to 9 Nm.
- Start the engine and verify no fuel leaks are present.
