Safety Recall Notice

Service Bulletin

507478 Rev. A

NHTSA Recall: 18V489

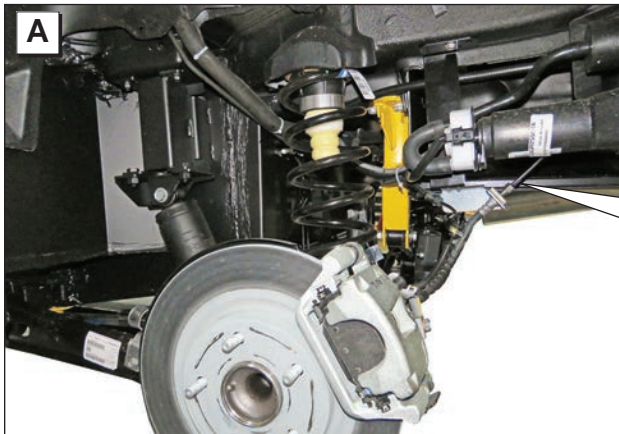
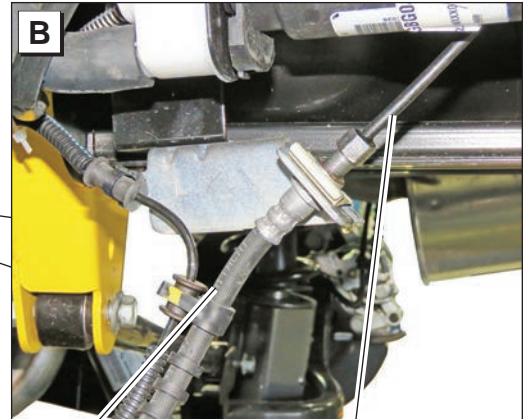
Flex Brake Line

Driver Side Hard Brake Line
(Will Be Rerouted to Passenger Side)

1. Disconnect vehicle battery.
2. Lift rear of vehicle and remove both rear wheels.
3. Locate driver side hard brake line. See Photos A and B.
4. Remove wire ties securing harness to hard brake line. See Photo C.
5. Disconnect hard brake line from flex brake line. Refer to Photo B.

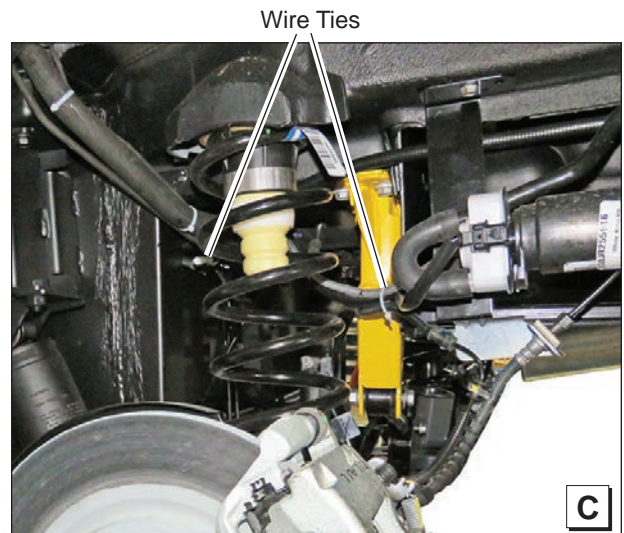
Wire Ties

14. Secure harnesses to brake lines. Refer to Photos C and E.

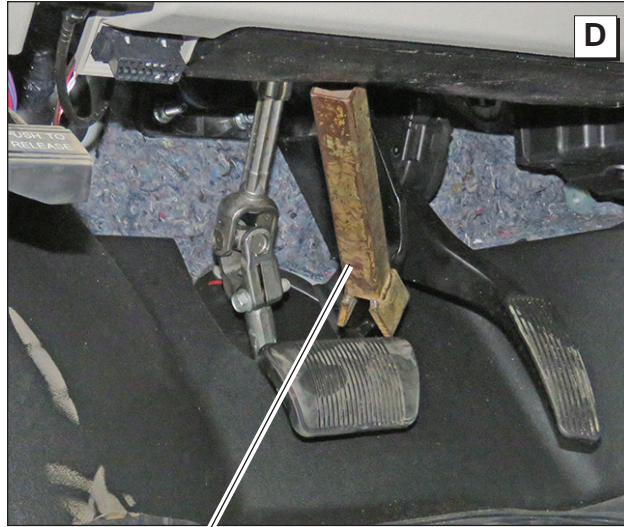
Brake Pedal Blocked

7. Press brake pedal to floor and place block to keep pedal depressed to prevent fluid flow while brake lines are separated. See Photo D.

15. Remove block installed in Step 7 and bleed brakes per manufacturer guidelines.

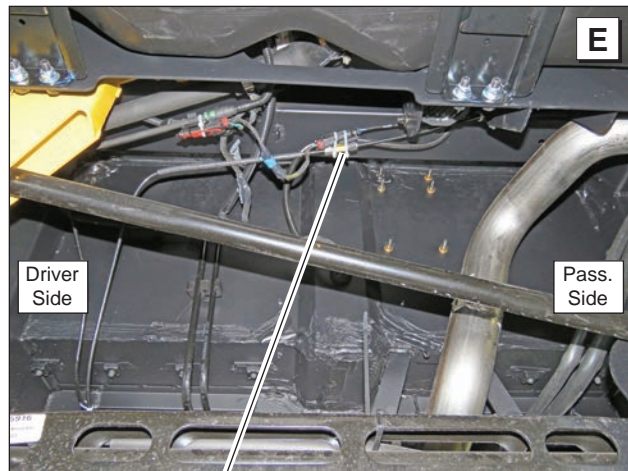
Wire Ties

8. Remove wire ties securing harness to passenger side hard brake line. See Photo E.

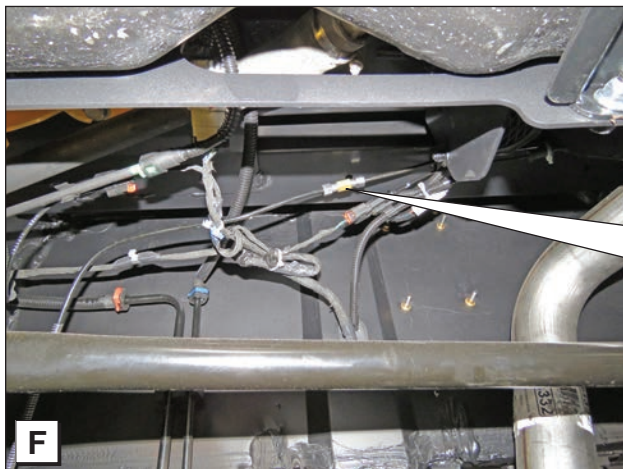
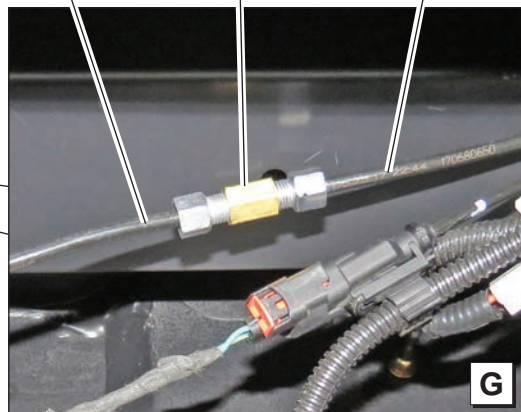
Disconnect Passenger Side Hard Brake Line to Master Cylinder From Coupling

Coupler Fitting

Do Not Disconnect Passenger Side Hard Brake Line to Brake Caliper From Coupling

9. Separate the two halves of the passenger side hard brake line. Disconnect master cylinder side of line from line coupler fitting, leaving the coupler fitting attached to the caliper side of the line. See Photos F through H.

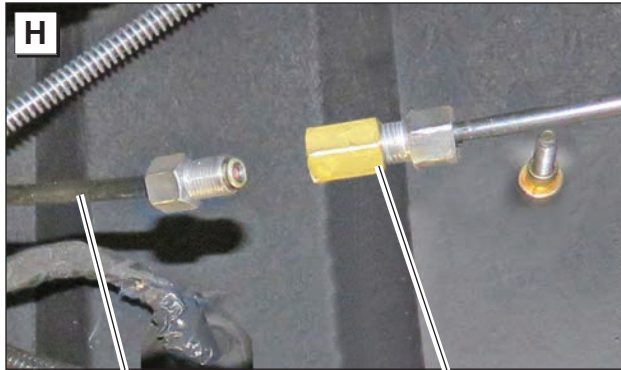
Passenger Side Hard Brake Line to Master Cylinder (Will Be Rerouted to Driver Side Caliper)

Passenger Side Hard Brake Line to Brake Caliper With Retained Coupler Fitting

11. Connect rerouted driver side hard brake line (male fitting) to passenger side coupler fitting (female fitting). Refer to Photos H and J.

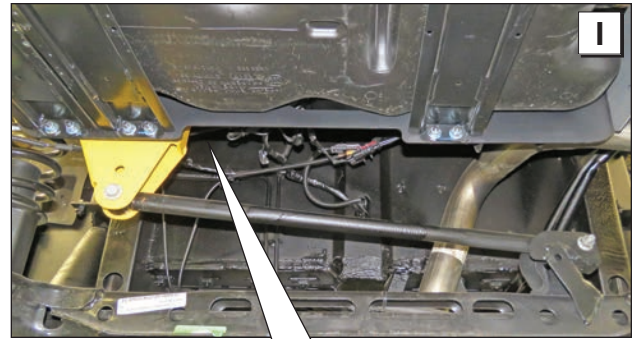
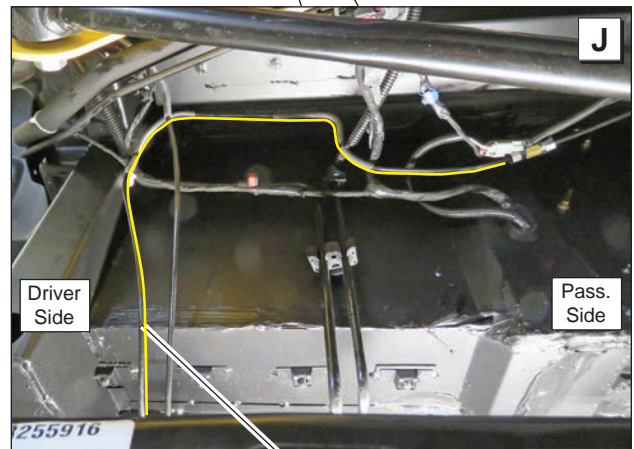
Rerouted Driver Side Hard Brake Line to Passenger Side

10. Reroute driver side hard brake line disconnected in Step 5 as shown. See Photos I and J.

Note: Use care when connecting brake line fittings to avoid cross threading.

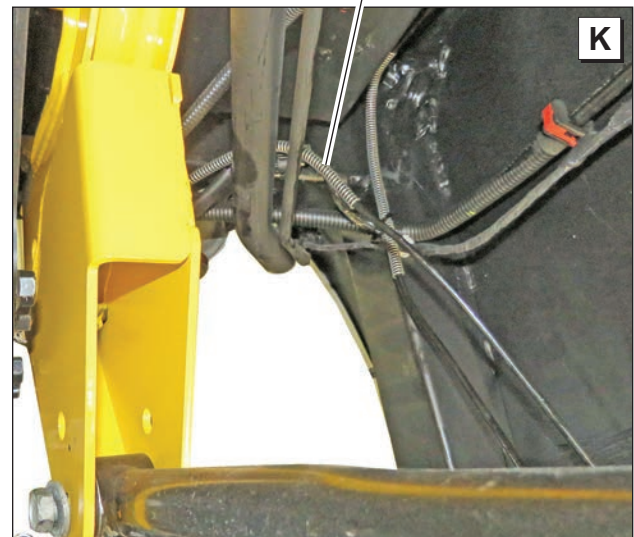
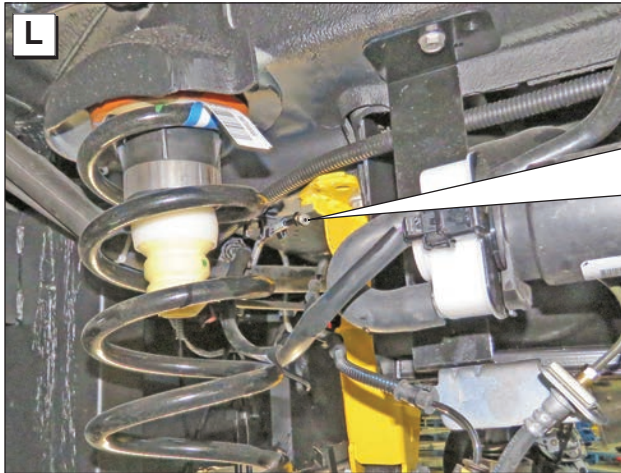
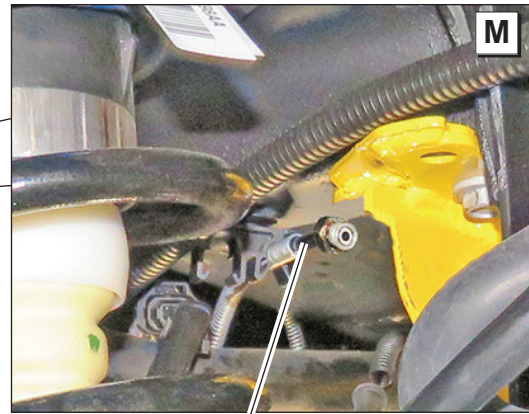
Reroute Passenger Side Hard Brake Line to Driver Side

Passenger Side Hard Brake Line

12. Reroute hard brake line disconnected in Step 9 to driver side as shown. See Photos K through M.

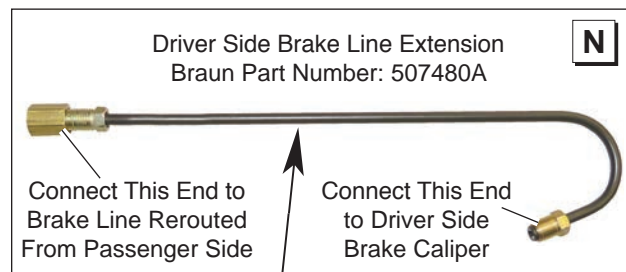
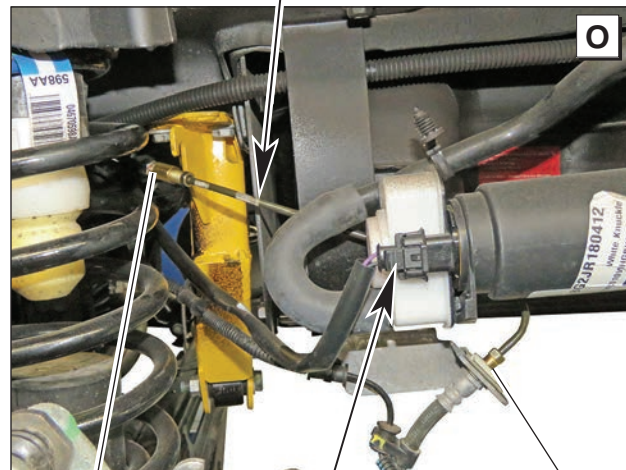
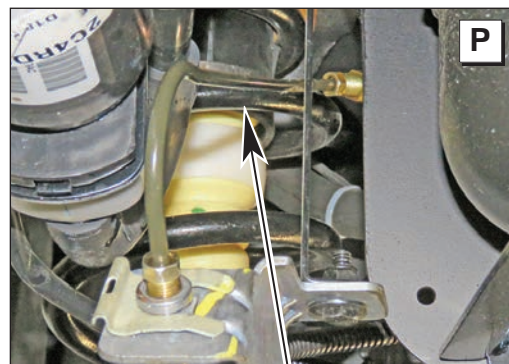
Connect to Hard Brake Line Route Behind EVAP Cannister Connect to Flex Line

Ensure Brake Line is Clear of Coil Spring

13. Install driver side brake line extension. See Photos N through P.
