Technical Service Bulletin

GROUP RECALL	NUMBER 18-01-002-G
DATE August, 2018	MODEL(S) G80 (DH)

SUBJECT: 2018 G80 (DH) OCCUPANT CLASSIFICATION SYSTEM
(RECALL CAMPAIGN 002G)

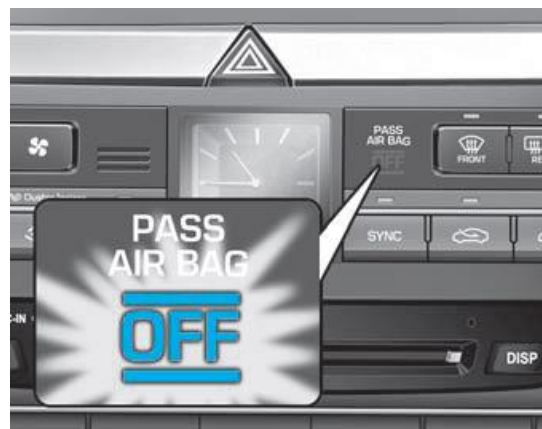
Description: Genesis G80 (DH) vehicles are equipped with an Occupant Classification System ("OCS") that classifies the occupant type as an adult, a child, or a child restraint seat. The OCS control module in certain 2018MY G80 (DH) may have been programmed incorrectly causing an erroneous detection of an adult in the passenger seat when the passenger seat is unoccupied or occupied by an infant or child. If an infant or child is seated in the front passenger seat and the OCS system does not deactivate the passenger front airbag during a crash, the child or infant could be injured by the airbag.

This bulletin describes the procedure to reprogram the Occupant Classification System ("OCS").

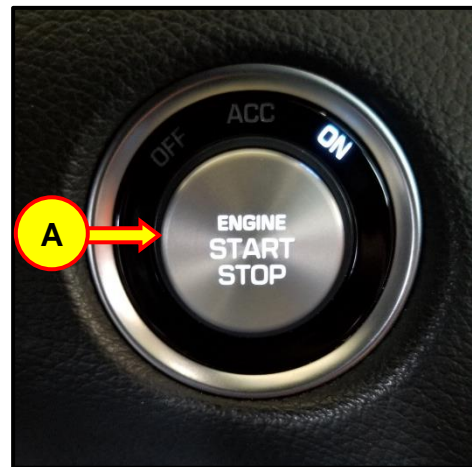
1. Turn the ignition to the “ON” position by pressing the **START STOP BUTTON (A)** twice without pressing the brake pedal.

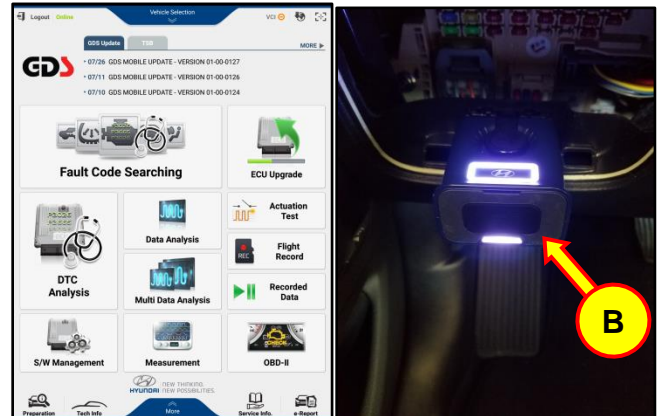
2. Launch the Hyundai/Genesis GDS app on the Hyundai/Genesis tablet and plug the VCI-II (B) into the vehicle’s DLC connector.

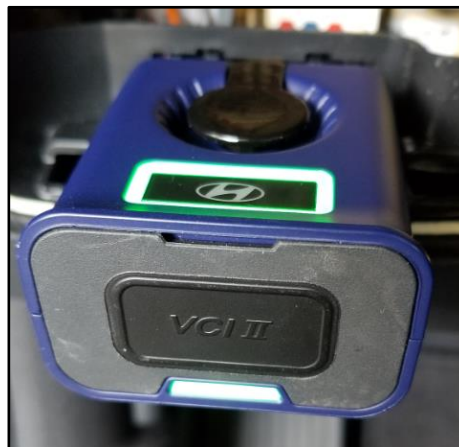
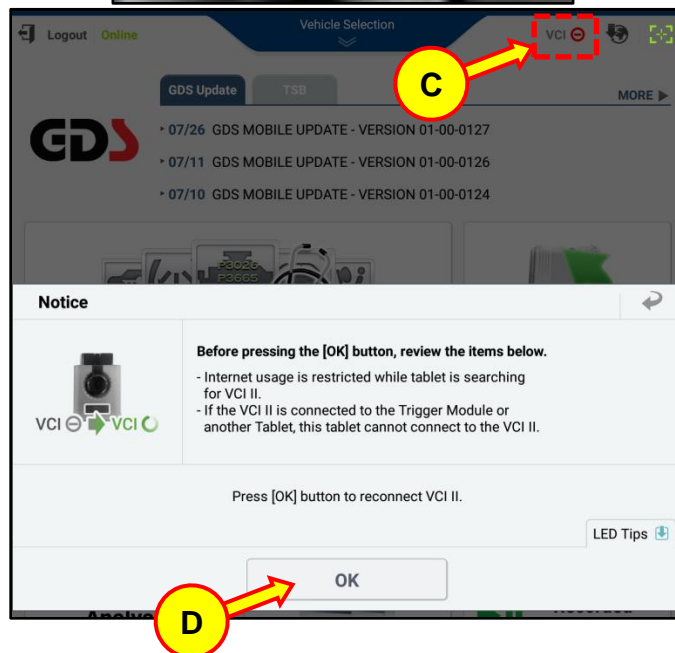
- 3. Wait for the VCI indicator light to turn green.

If the VCI indicator light doesn't turn green, press the VCI button (C) located on top right corner and press [OK] (D) to connect the VCI manually.

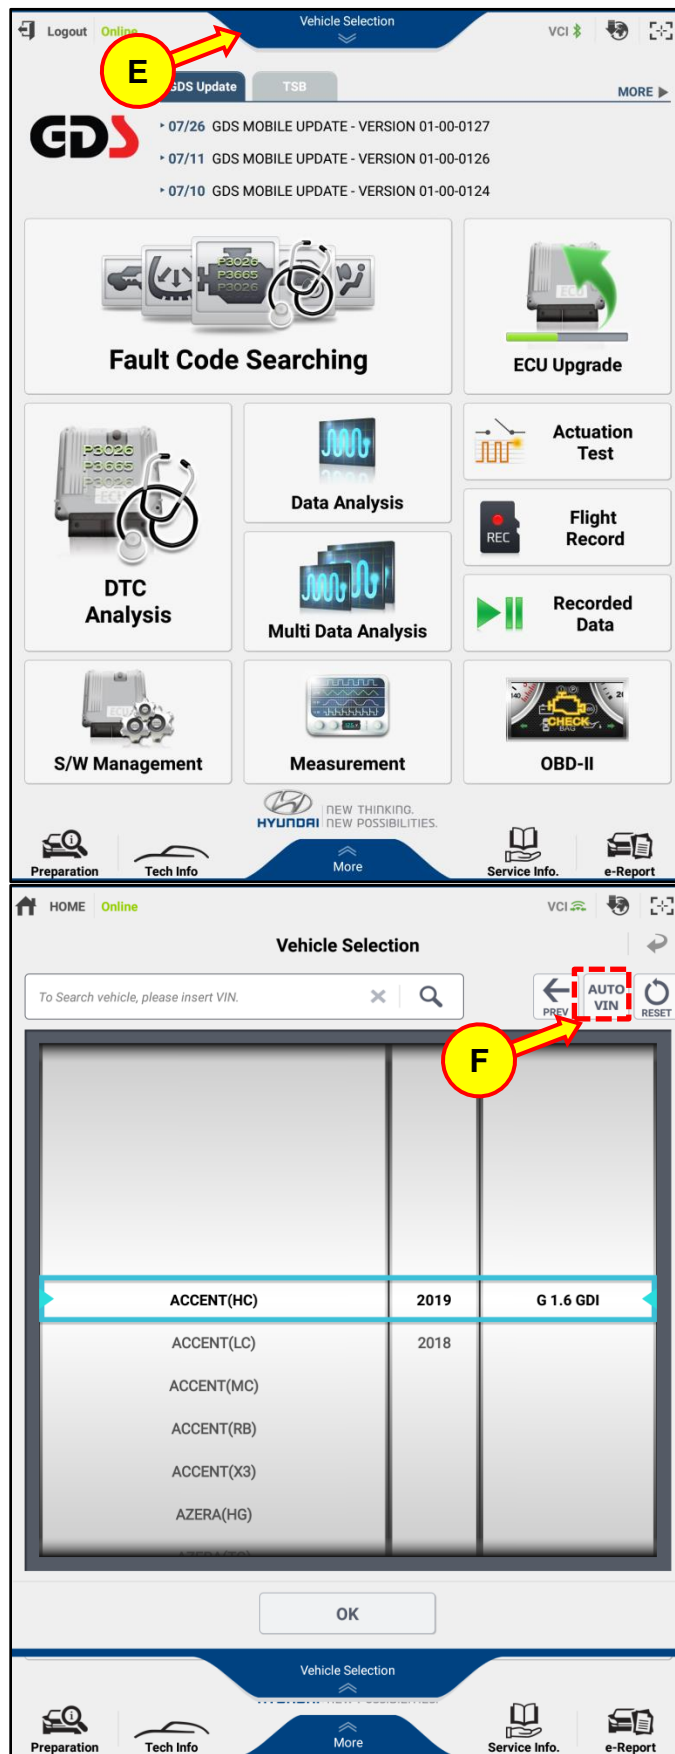
- Once the VCI has connected, slide down Vehicle Selection (E) to verify the VIN.

If the VIN was not recognized automatically, press AUTO VIN (F) or type in the VIN.

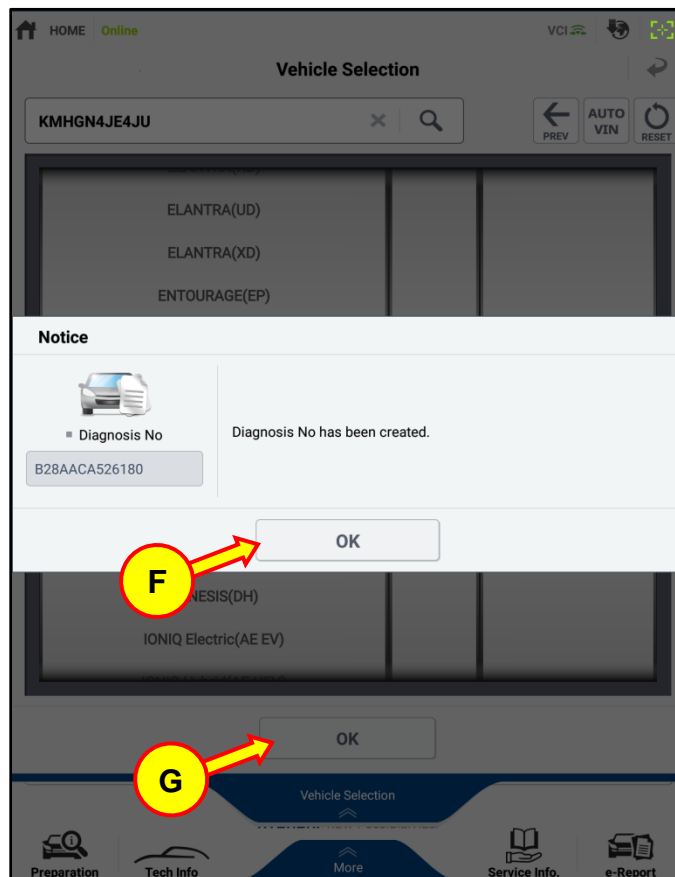
- 5. When the VIN is recognized, a notice for Diagnosis No. will appear. Press [OK] (F) for the Diagnosis No.

Then, press [OK] (G) after verifying the VIN is correct.

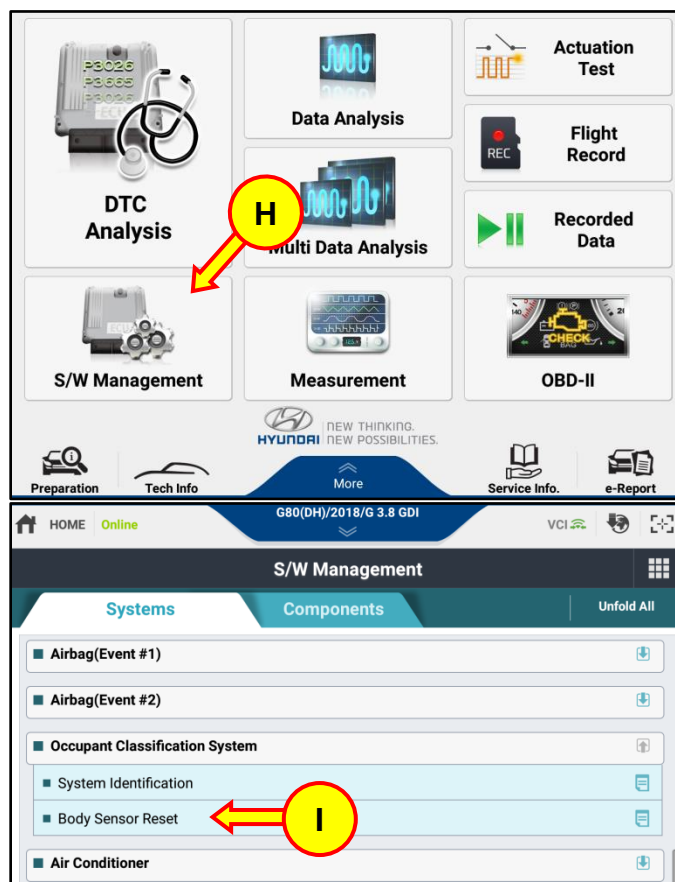
- 6. In S/W Management (H), scroll down to find Body Sensor Reset (I) under Occupant Classification System. And, press Body Sensor Reset.

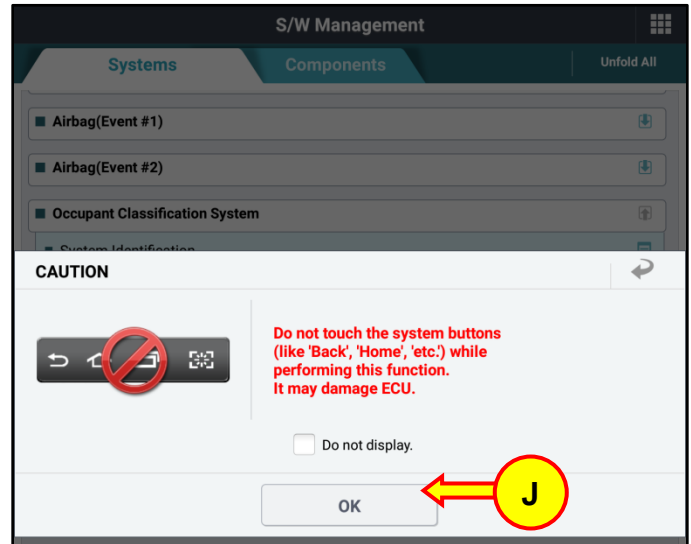
7. Press [OK] (J) when the Caution window appears.

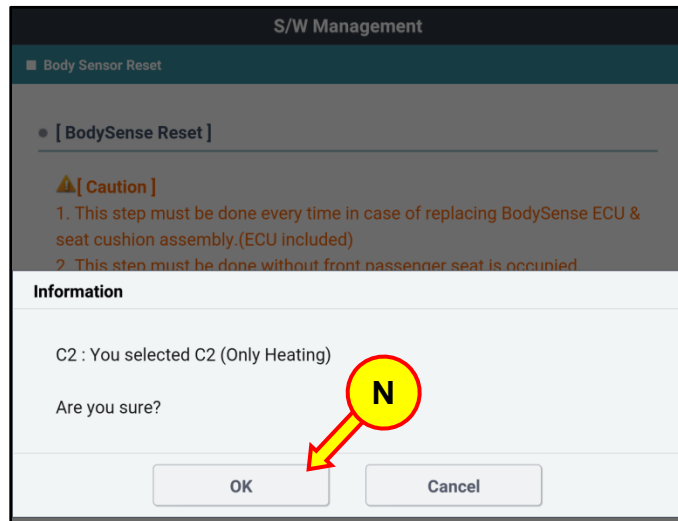
11. Verify that you have selected [C2] by clicking [OK] (N).

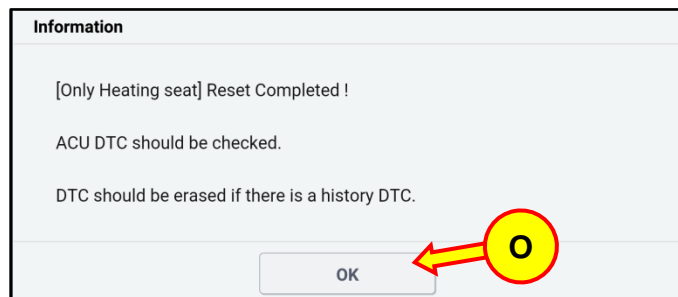
12. Click [OK] (O) to confirm that reset is completed.
