## SAFETY ADVISORY # 18-328

### Summerland Propane Bottle Bracket

Keystone is conducting a voluntary RECALL notification campaign in accordance with the National Highway Transportation and Safety Act. It has been decided that the vehicles in the recall population have a propane bottle bracket with 2 mounting legs that may break at the mounting point. Under certain conditions during travel, the bracket can break at the mounting point allowing the propane bottle to become detached from the frame of the unit leading to an increased risk of property damage and/or personal injury.

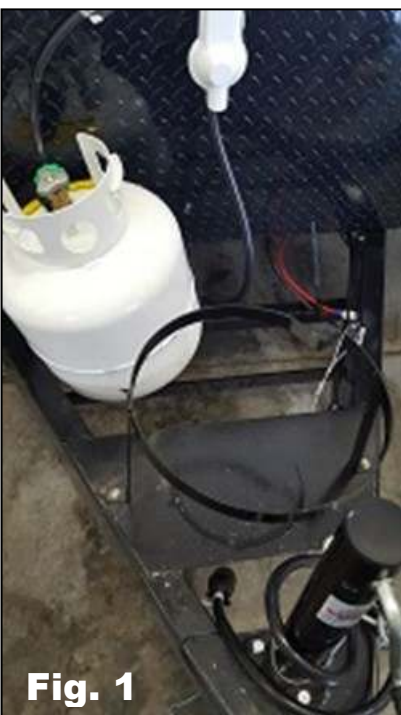
Locate the Propane bottle at the front of the unit and turn off the propane supply and remove the bottle, Figure 1.

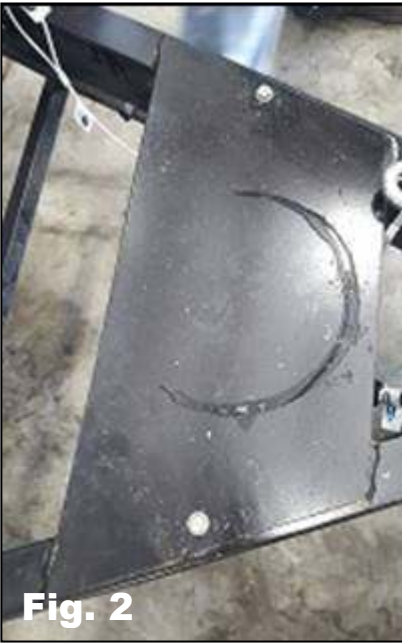
**Fig. 2**

Remove the screws holding the bracket down and remove the bracket. The old bracket must be field scrapped and not used for any other application. Reinstall the two screws in the old holes that they were removed from.

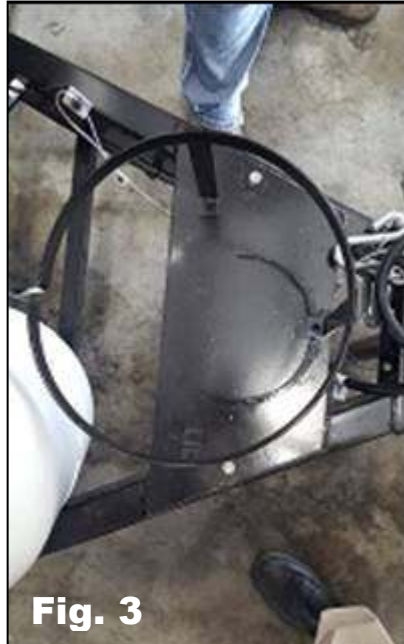
**Fig. 3****Step 4**

Place propane bottle bracket (KRV # 401368) on platform and center as pictured in Figure 3. Mark holes and set the bracket aside. Using a 9/32" drill bit, drill the holes that were marked for the bracket.

Set the bracket over the holes from step 5 and install the 5/16" screws to mount the bracket to the platform.
