# Safety Recall

## Code: 46H6

<b>Subject</b>	<b>Brake Caliper Carrier (Bracket) Bolts</b>
<b>Release Date</b>	08/28/2018
<b>Affected Vehicles</b>	<b>USA:</b> 2018 MY Atlas & 2017-2018 MY Passat <b>Canada:</b> 2018 MY Atlas & Passat <i>Check Campaigns/Actions screen in Elsa on the day of repair to verify that a VIN qualifies for repair under this action. Elsa is the <u>only</u> valid campaign inquiry &amp; verification source.</i> <ul style="list-style-type: none"><li>✓ Campaign status must show "open."</li><li>✓ If Elsa shows other open action(s), inform your customer so that the work can also be completed at the same time the vehicle is in the workshop for this campaign.</li></ul>
<b>Problem Description</b>	The brake caliper carrier (bracket) bolts may not be torqued to the correct specification. Because of this, the brake caliper carrier (bracket) may loosen, causing the brake caliper to move on its mount. If this happens, it may lead to increased vehicle stopping distance, may damage a wheel or even cause the vehicle to lose control, increasing the risk of a crash.

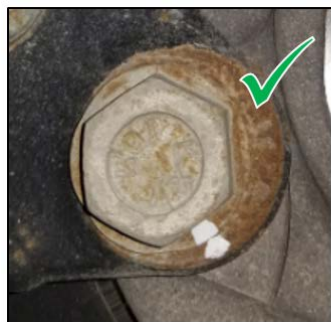
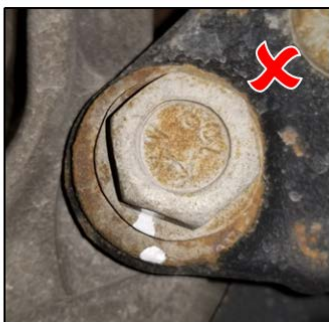
- Make marks <arrows> on the brake caliper carrier bolt and the wheel bearing housing.
- Set torque wrench to 160 Nm.
- Slowly turn the torque wrench until the 160 Nm test torque value is achieved.

- Inspect the previously made marks.
  - If the marks are aligned, the bolt does not require replacement.
  - If the marks are not aligned, the bolt must be replaced and torqued to 200 Nm.

Part Number	Part Description
N 909.488.02	Caliper Carrier Bolt

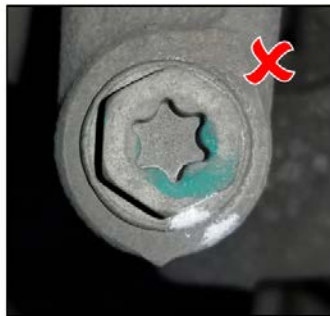
- Make marks on both brake caliper bolts <arrows> and the brake caliper.
- Set torque wrench to 28 Nm.
- Counterhold guide pins and slowly turn the torque wrench until the 28 Nm test torque value is achieved.

Lower bolt shown. Procedure for the upper bolt with attached weight is similar.

- Inspect the previously made marks.
  - If the marks are aligned, the bolt does not require replacement.
  - If the marks are not aligned, the bolt must be replaced and torqued to 35 Nm.

Part Number	Part Description
WHT.001.921	Caliper Bolt w/ Attached Weight
WHT.003.252	Caliper Bolt

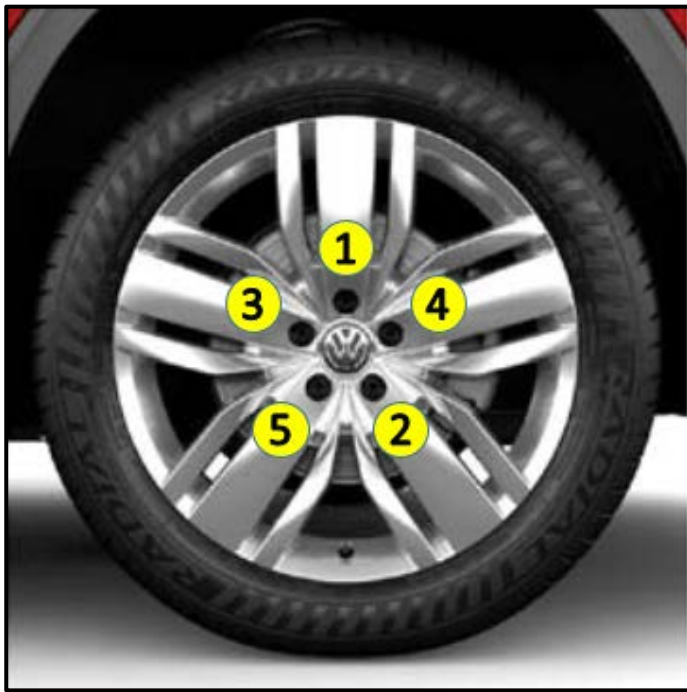
- Install wheels and torque diagonally to 120 Nm.

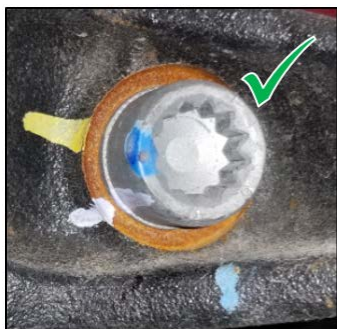
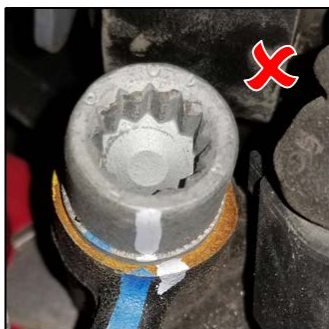
- If the internal splines of the caliper carrier bolt are found stripped <see inset>, the bolt must be replaced and torqued to 90 Nm + 90°.
- Make marks <arrows> on the brake caliper carrier bolt and the wheel bearing housing.
- Set torque wrench to 115 Nm.
- Slowly turn the torque wrench until the 115 Nm test torque value is achieved.

- Inspect the previously made marks.
  - If the marks are aligned, the bolt does not require replacement.
  - If the marks are not aligned, the bolt must be replaced and torqued to 90 Nm + 90°.

Part Number	Part Description
N 911.689.01	Caliper Carrier Bolt

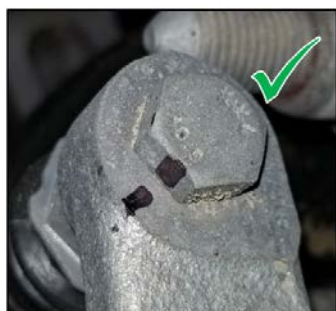
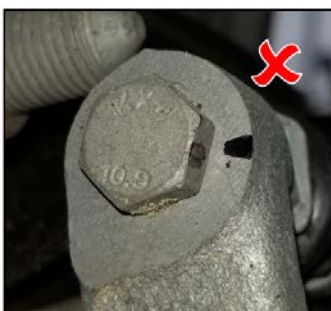
- Make marks on both brake caliper bolts <arrows> and the brake caliper.
- Set torque wrench to 28 Nm.
- Counterhold guide pins and slowly turn the torque wrench until the 28 Nm test torque value is achieved.

- Inspect the previously made marks.
  - If the marks are aligned, the bolt does not require replacement.
  - If the marks are not aligned, the bolt must be replaced and torqued to 35 Nm.

Part Number	Part Description
N 010.241.24	Caliper Bolt

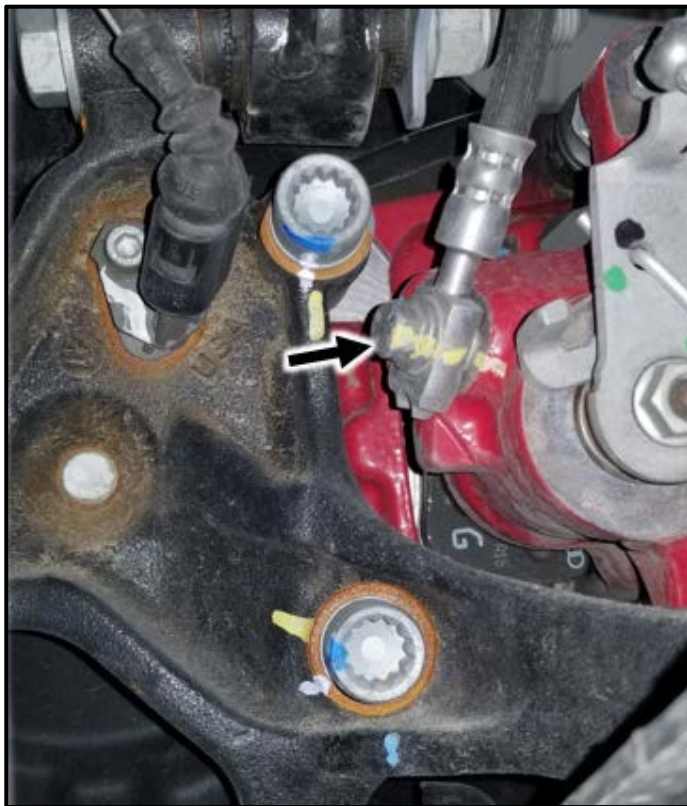
- Verify torque on brake hose banjo bolt:
  - Torque the brake hose bolt <arrow> to 35 Nm.
  - If the brake hose banjo bolt was found loose and there is an active brake fluid leak from the brake hose connection, the brake system must be bled (see Section D).

If the brake hose banjo bolt was found loose, the brake hose does not require replacement.

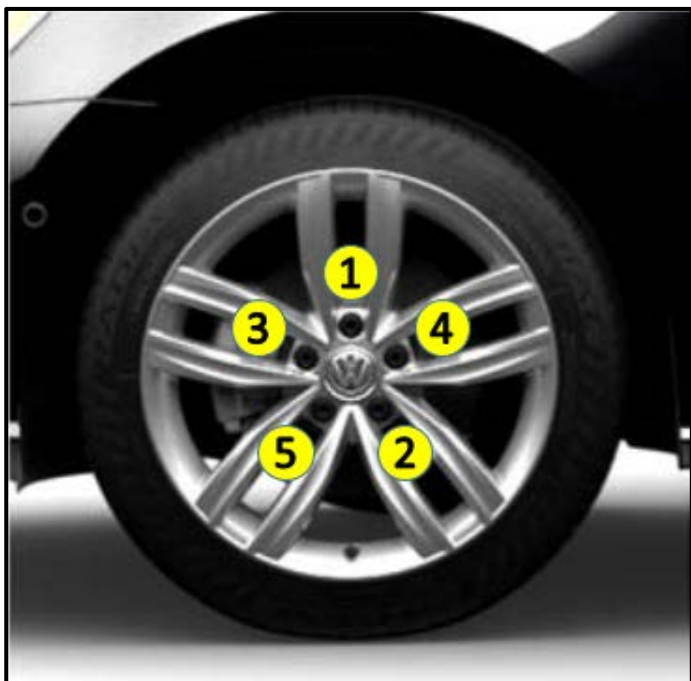
The wheel bolts must be loosened and properly torqued due to the possibility of the wheel bolts being over torqued or under torqued during the factory rework.
