Safety Recall

Code: 87F9

Subject	HVAC Drain Tube/Airbag Control Module
Release Date	09/25/2018
REVISION SUMMARY	Added step to inspect airbag control module and connector for corrosion on page 14.
Affected Vehicles	U.S.A. & CANADA: Certain 2018 MY Volkswagen Atlas <i>Check Campaigns/Actions screen in Elsa on the day of repair to verify that a VIN qualifies for repair under this action. Elsa is the <u>only</u> valid campaign inquiry & verification source.</i> <ul style="list-style-type: none">✓ Campaign status must show "open."✓ If Elsa shows other open action(s), inform your customer so that the work can also be completed at the same time the vehicle is in the workshop for this campaign.
Problem Description	In certain vehicles, an air conditioning evaporator (HVAC) drain tube may have been twisted during vehicle assembly. If this tube is twisted, it can lead to water draining inside the passenger compartment and also onto the airbag control module. If the airbag control module gets wet, it can malfunction and possibly lead to an unintended airbag deployment. An unintended airbag deployment can cause injuries to vehicle occupants and possibly lead to a crash.

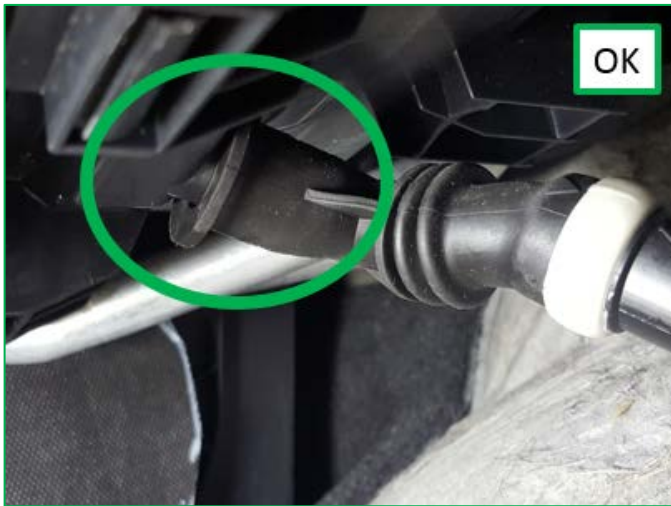
Repair Overview

- Inspect evaporator housing drain tube and/or replace airbag control module.
 - Criteria 01: Vehicles not included in the 40M3 or unrepaired 40M3 vehicles.
 - Criteria 01 and 02: Vehicles not included in the 40M3 or unrepaired 40M3 vehicles and an evaporator drain tube was replaced under warranty.
 - Criteria 02: Vehicles included in the 40M3 which had an evaporator drain tube replaced, but the airbag control module was not replaced.

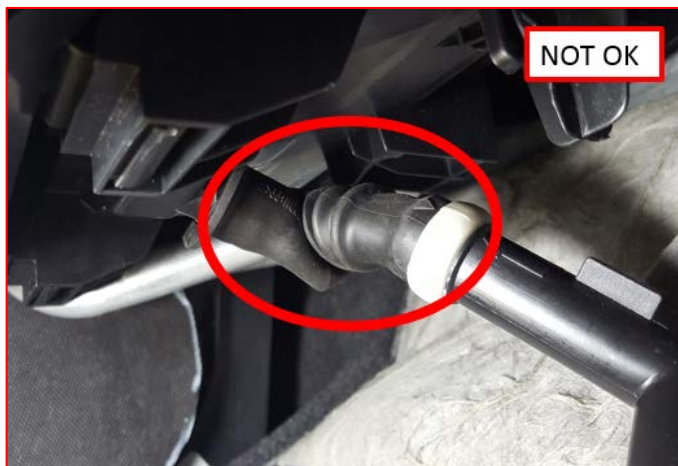
- Inspect the HVAC drain tube.
- If the drain tube is twisted:
 - Replace the drain tube.
 - Inspect the airbag control module and connector (**See Section C**).
 - Replace the airbag control module (**See Section C**).

If the drain tube was found twisted, the possibility of water intrusion in the airbag control module is high. The vehicle should not be driven until the module is replaced.

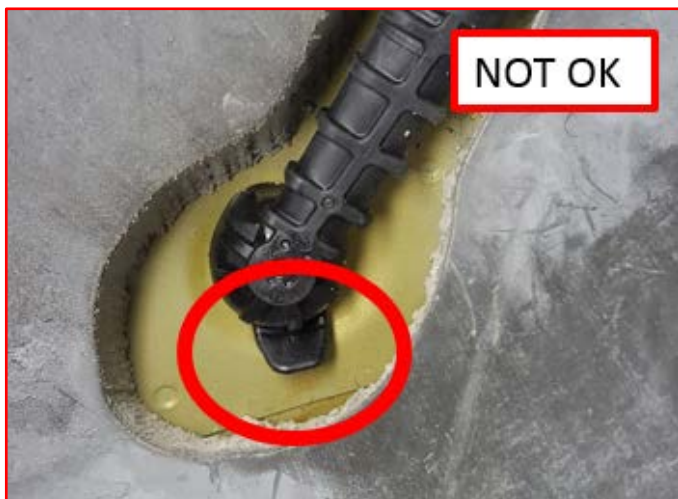
- Inspect the evaporator drain tube installation at the body.
- If the tab <circle> is not installed into the body and the drain tube is not twisted, the drain tube must be reinstalled correctly/fully.

If tube is to be reinstalled, spray water on the body or the drain tube to aid in installation.

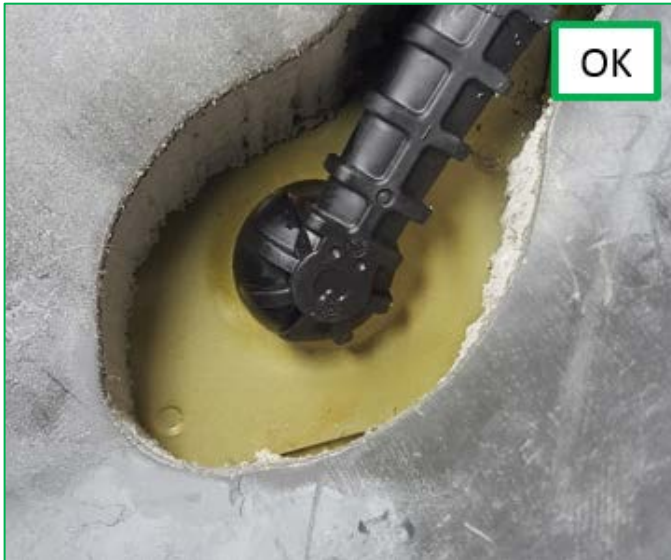
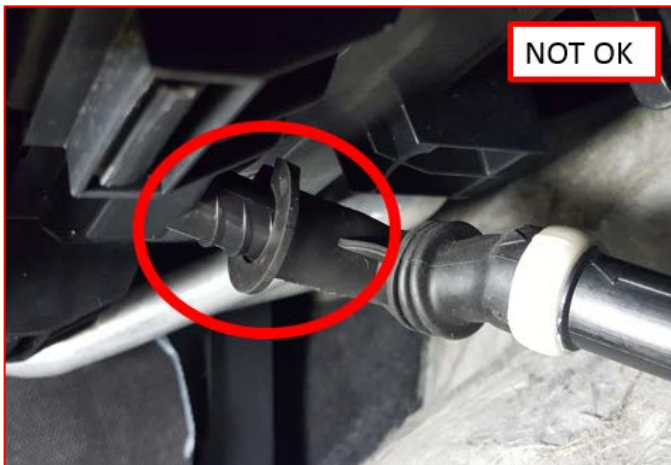
- Inspect the evaporator drain tube connection at the evaporator housing.
- If the drain tube is only partially installed on the evaporator housing and the drain tube is not twisted, it must be reinstalled correctly/fully.

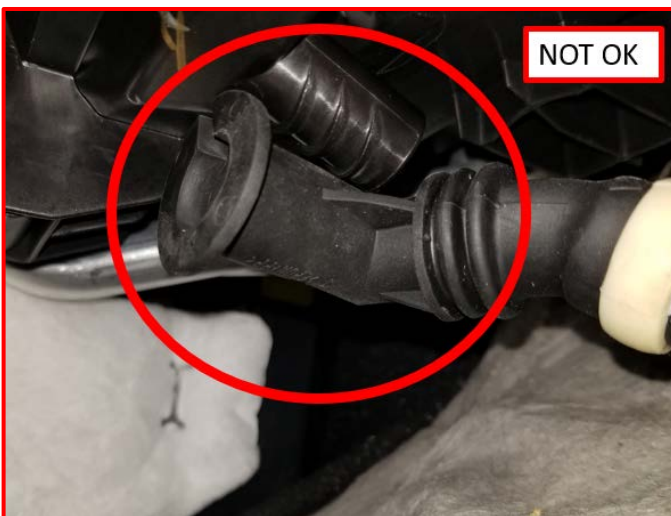
- If the drain tube is fully disconnected from the evaporator housing:
 - Reattach the drain tube.
 - Inspect the airbag control module and connector (**See Section C**).
 - Replace the airbag control module (**See Section C**).

If the drain tube was found disconnected, the possibility of water intrusion in the airbag control module is high. The vehicle should not be driven until the module is replaced.

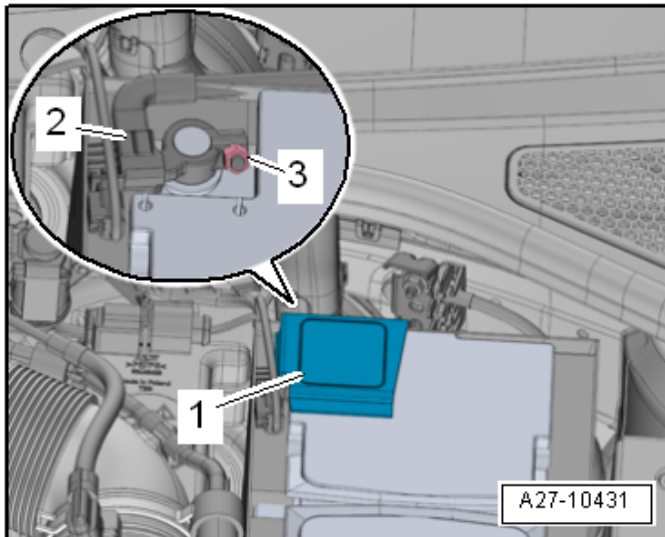
- Open the cover <1> over the battery ground terminal post.
- Loosen the nut <3>.
- Remove and isolate the battery ground cable <2> from the battery terminal.

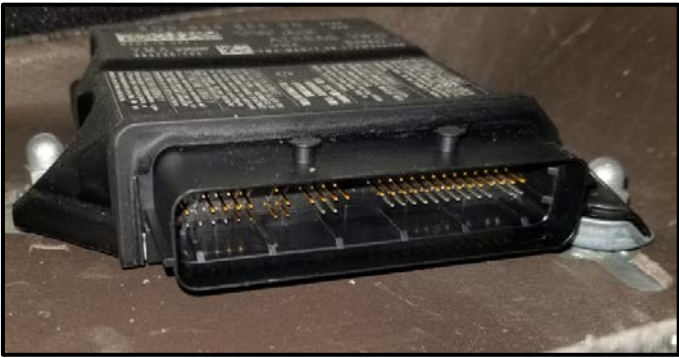
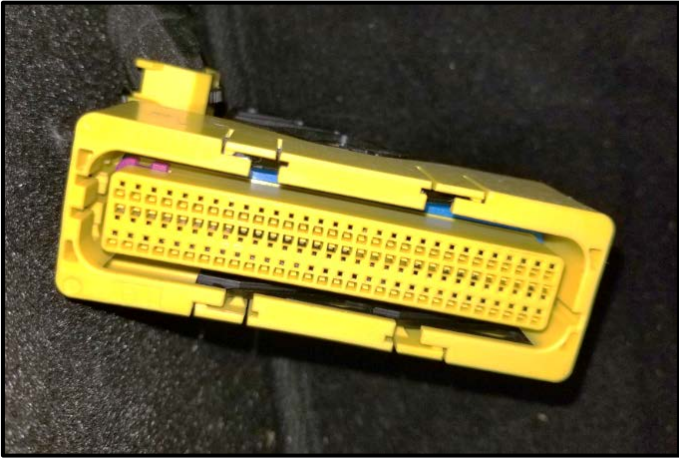
- If the airbag control module is to be replaced:
 - Inspect the pins on the old airbag control module for corrosion.
 - Inspect the airbag control module connector for signs of corrosion.
- If corrosion is found:
 - The pins in the connector must be inspected and replaced.
 - The connector cap must be replaced.
 - Create a VTA WEB ticket, attach photos of the corrosion and wait for further direction before beginning repairs.

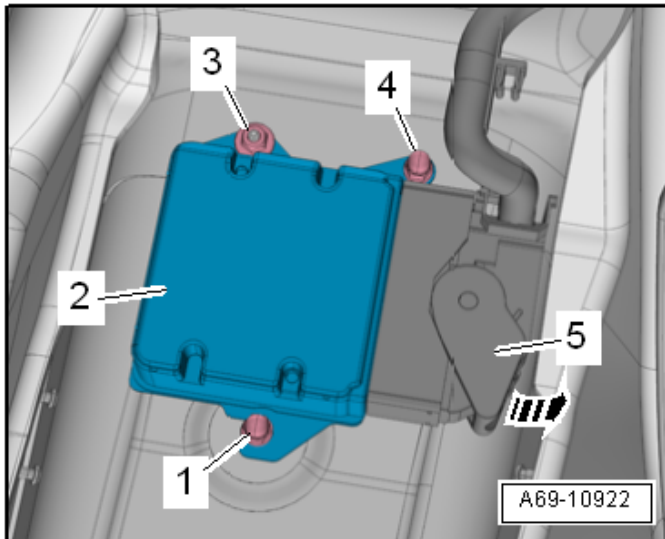
- Remove the nut <3> in the front of the driver footwell.

- Disconnect the connector in the front passenger footwell by releasing the connector safety catch and opening the locking clip <5> on the connector <arrow>.
- Remove the nuts <1 and 4>.
- Carefully lift the airbag control module <2> from the threaded pins and remove it toward the passenger side.

The battery must be disconnected before proceeding. Moving the airbag control module with the battery connected could result in unintended airbag deployment.

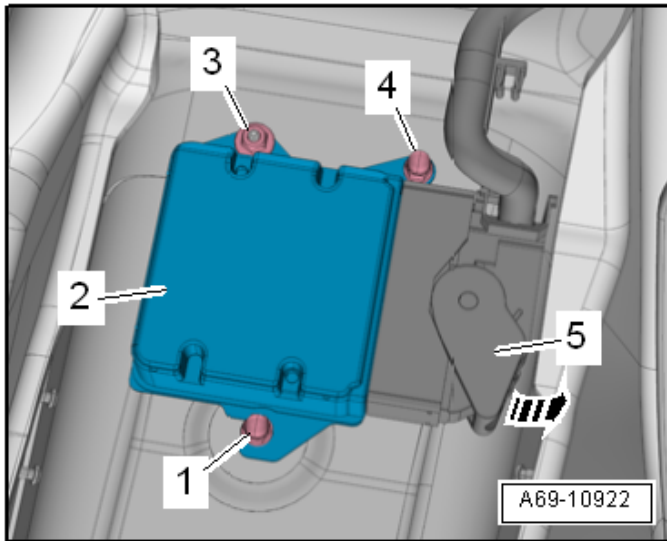
- Ensure the threads on the fasteners and studs are free of paint and dirt.

Nut and ground pin serve as a ground connection for the control module.

- Install nuts <1, 3 and 4> and torque to 9 Nm.
- Connect connector <5>.

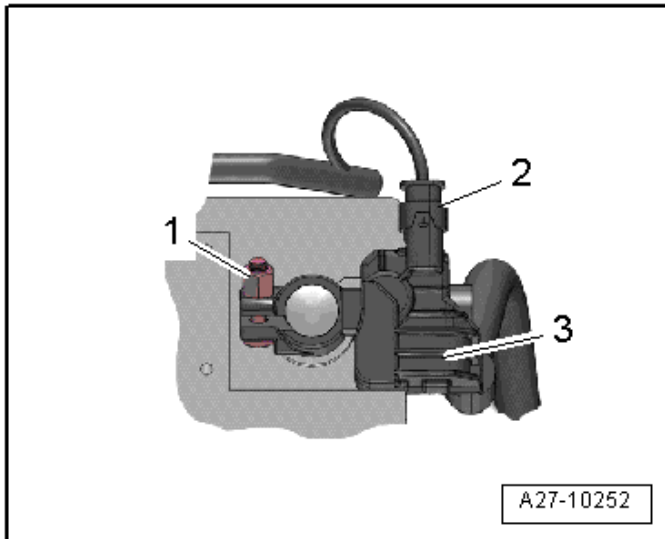
- Disconnect the connector <2> from the Battery Monitoring Control Module -J367- <3>.
- Attach the battery ground cable clamp by hand to the battery negative terminal and torque the nut <1> to 6 Nm.
- Reconnect the connector to the Battery Monitoring Control Module -J367-.
- Cycle the ignition off and back on.
- Bring driver and passenger seat to an upright position.
- Set clock to local time.
- Activate the convenience open/close functions.
- Connect the ODIS tester and check the DTC memories of all the control units and erase under-voltage faults if necessary.

Ignition must be **ON** when connecting battery. If pyrotechnic components (e.g. airbag, belt tensioner) are not repaired correctly, they may deploy unintentionally after connecting battery. There must not be anyone inside the vehicle when connecting the battery.
