RECALL BULLETIN:
180817REV

Fleetwood Pulse,
manufactured
10/9/2017 through
1/17/2018

Holiday Rambler
Prodigy,
manufactured
10/20/2017 through
3/15/2018

Inspection/
Correction
of Diesel
Generator
Exhaust Pipe
Routing

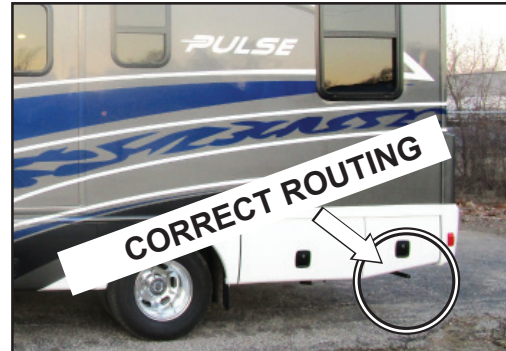
4. **Figure 1 is an example of the correct location for the generator exhaust pipe, located just below the compartment latch. Inspection procedure follows:**

Figure 1
Exhaust pipe is correctly routed as shown located exiting below the rear compartment door latch and extending beyond the sidewall.

- a) If the generator exhaust pipe extends past the outside of the sidewall (1" minimum see example in Figure 3) continue on.
- b) Using a mechanic's creeper, check underneath the vehicle to determine whether the generator exhaust pipe is routed too close to the gray waste-water tank. (A proper routing is minimum of 4" away from the gray waste-water tank).

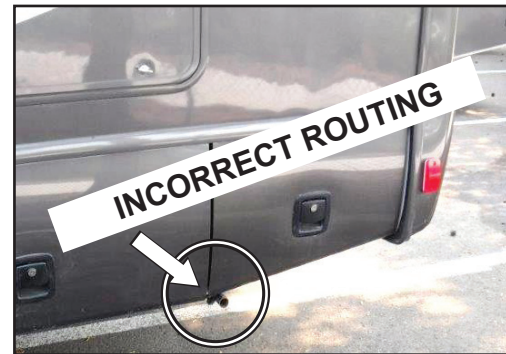
- c) **Figure 2 is an example of improper routing. Inspect the positioning of the generator exhaust pipe, if it is located between the two rear compartment doors go to step D.**
- d) Using a mechanic's creeper, check underneath the vehicle to determine whether the generator exhaust pipe is routed too close to the gray waste-water tank, (**proper routing is minimum of 4" away from the gray wastewater tank**)

Figure 2
Exhaust pipe is improperly routed at an angle and exits near the front of the last roadside luggage compartment

- e. If the generator exhaust is improperly routed, take clear photos and submit with a Prior Authorization Request (PAR) before proceeding to the Correction Procedure (Step 5).

5. If the inspection determines that the generator exhaust pipe is improperly routed, obtain Prior Authorization (PAR) and then proceed with Steps 6-12.
6. Disconnect the generator exhaust pipe at the generator exhaust outlet by removing the clamp. Set the clamp aside for reassembly.

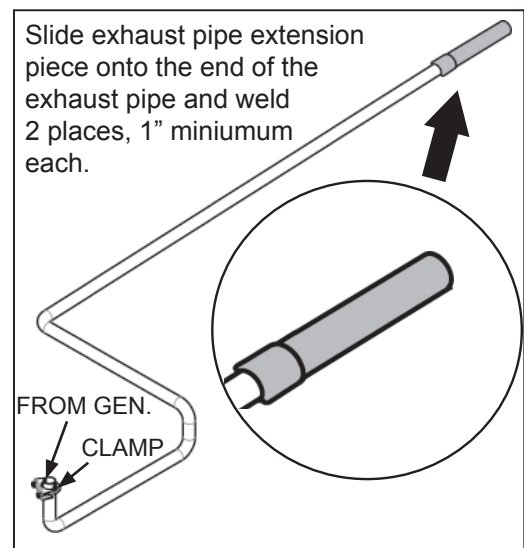
Figure 4

7. Take the exhaust pipe to a work area.
8. Locate the generator exhaust pipe extension piece, included with the recall kit. Slide the flared end of the extension piece over the end of the exhaust pipe until it overlaps a minimum of 1 1/2". Weld in two places, 1" minimum each place. Refer to Figure 4. **Extensions must be welded and NOT clamped.**
9. Return the exhaust pipe to the vehicle and reattach it to the generator exhaust outlet using the original clamp at the generator.

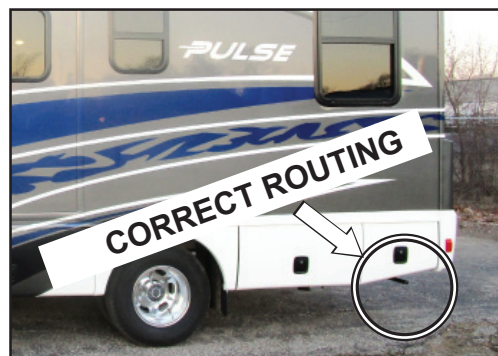
Figure 5

10. Route the exhaust pipe to exit perpendicular to the sidewall, as shown in Figure 5. Ensure it is a minimum of 4" away from the gray waste-water tank, or any other combustible components. Install exhaust hangers (included with the recall kit) to properly support the pipe.

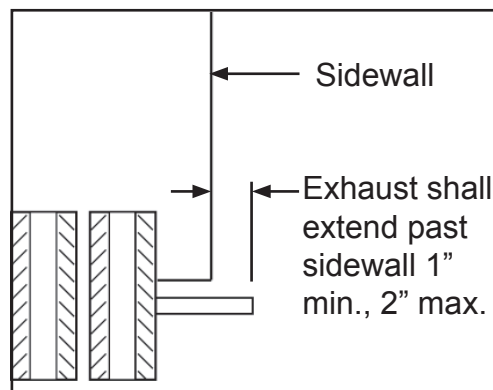
Figure 6

IMPORTANT NOTE: The exhaust pipe must extend a minimum of 1 inch (25 mm) beyond the sidewall of the vehicle. See Figure 6. Support with tailpipe hangers included with the kit. Ensure hanger brackets are securely fastened to chassis components using the bolts, flat washers, and nuts, or the screws and flat washers, included in the recall kit. (See Page 5 for Part requirements.)

11. Trim excess length from the end of the new exhaust pipe extension as necessary, **ensuring a distance of 1" minimum / 2" maximum beyond the outside of the sidewall is maintained.** See Figure 6.
12. When the repair has been completed, take photos to submit with the repair claim.

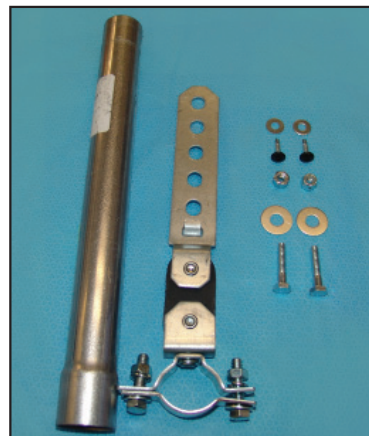
<u>Part Number</u>	<u>Description</u>	<u>Qty.</u>
10564395	Kit, Recall 180817REV - Generator Exhaust Routing	1

Recall 180817REV Repair Kit
