## TITLE: REPLACE LEFT SIDE CENTER STAND BRACKET

### RECALL

# 2018 Ninja H2™ SX SE, REPLACE LEFT SIDE CENTER STAND BRACKET

### NHTSA RECALL NO. 18V-580

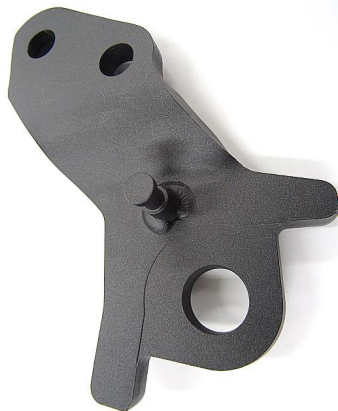
On affected units, improper welding between the center stand spring mounting pin and the left side center stand bracket may cause the pin to shift or fall off resulting in the center stand spring falling off. If the center stand spring falls off the center stand may not remain fully retracted and can drop and touch the ground while riding. This could cause loss of control increasing the risk of a crash.

Kawasaki has initiated a Recall campaign to repair all eligible units. The repair consists of replacing the left side center stand bracket on affected units.

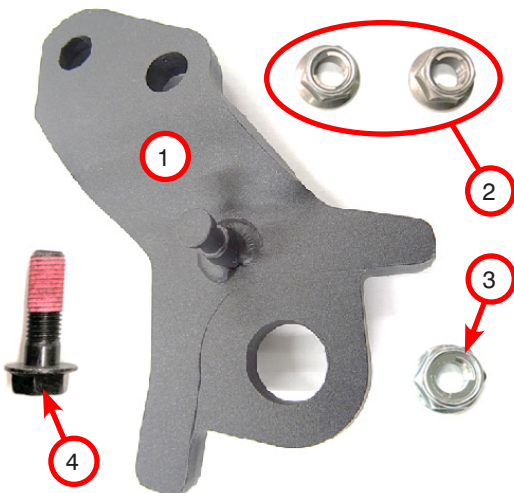
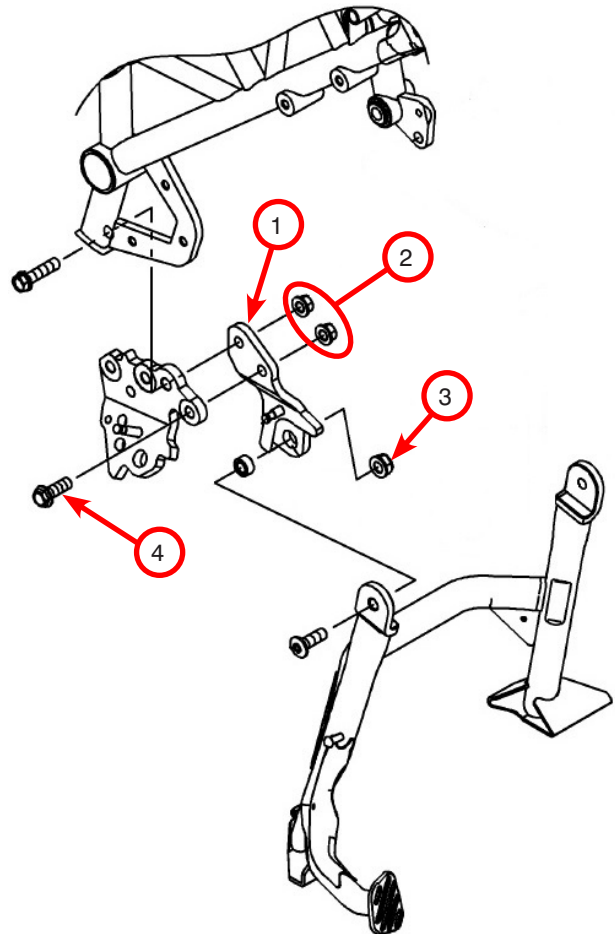
Kit, Center Stand - P/N 99999-0688		
Ref	Contents	Qty
1	Bracket, Center Stand	1
2	Nut, Bracket	2
3	Nut, Center Stand	1
4	Bolt, Bracket	1

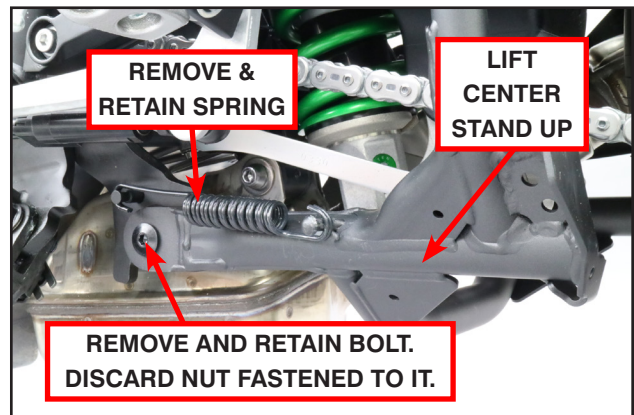
- Secure the front wheel in the tire vise of a motorcycle lift or rest the motorcycle using the side stand.
- Lift the center stand up.
- Remove and retain the spring.
- Remove and retain the center stand bolt and discard the nut that was fastened to it.

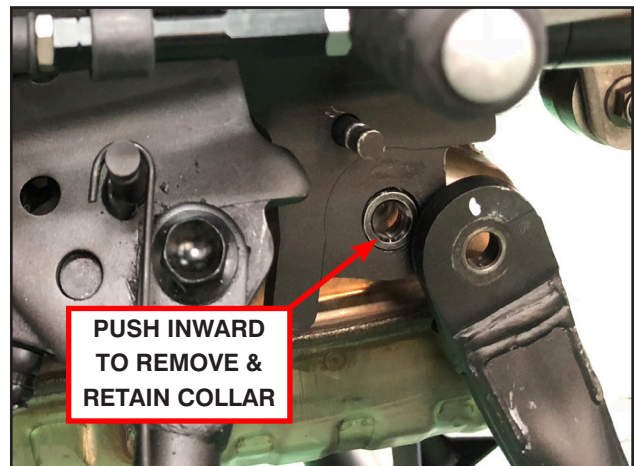
- Push inward to remove and retain the collar from the center stand bracket.

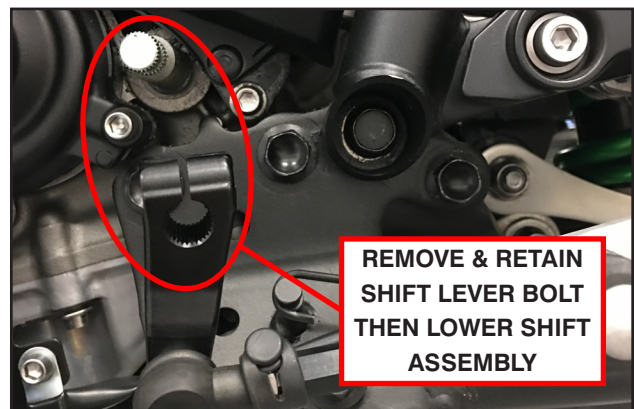
- Remove and retain shift lever bolt.
- Remove shift lever from shaft and lower it to gain access to the center stand bracket bolts.

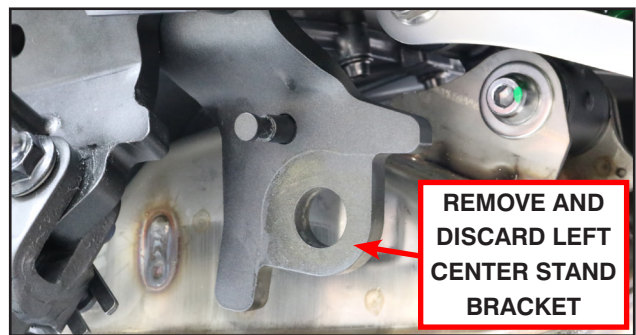
- Remove and discard left center stand bracket.

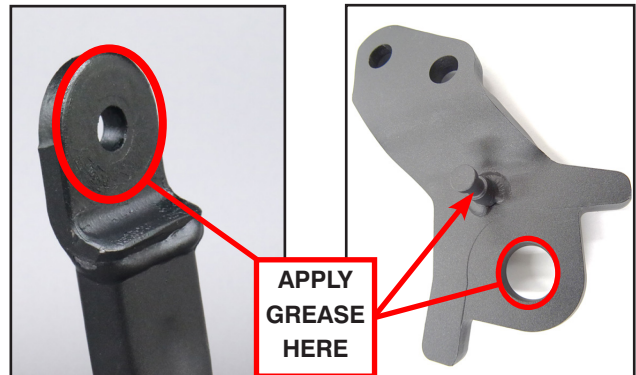
- Apply grease to the face of the sliding surface on the center stand as shown.
- Apply grease to the spring post groove and the inside of the collar mount position of the new center stand bracket as shown.

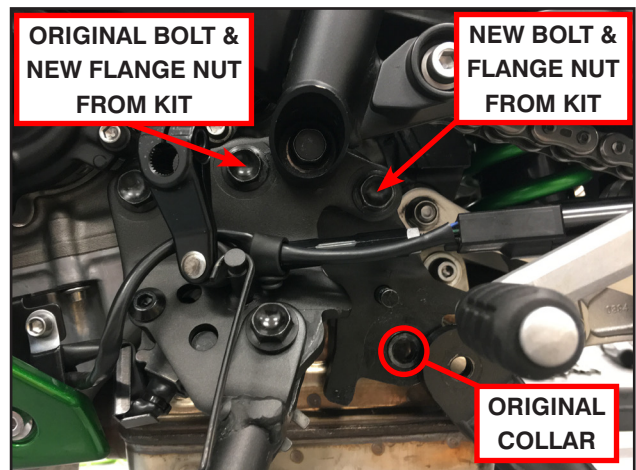
- Install the new center stand bracket using original and new hardware as shown. Do not tighten the nuts and bolts completely at this time.
- Insert the original collar in the new center stand bracket.

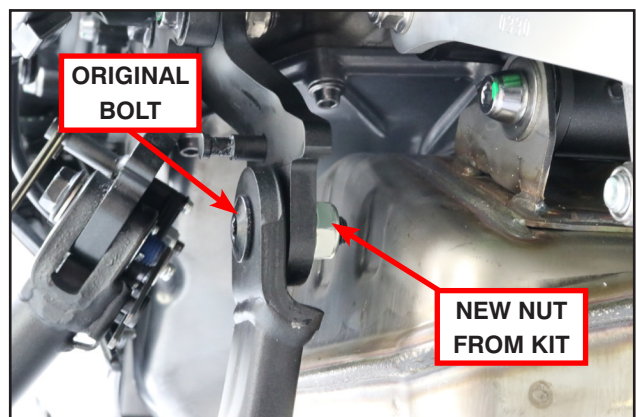
- Install the original center stand bolt and fasten with the remaining nut from the kit. Tighten to **33 ft·lb (4.6 kgf·m, 45 N·m)**.

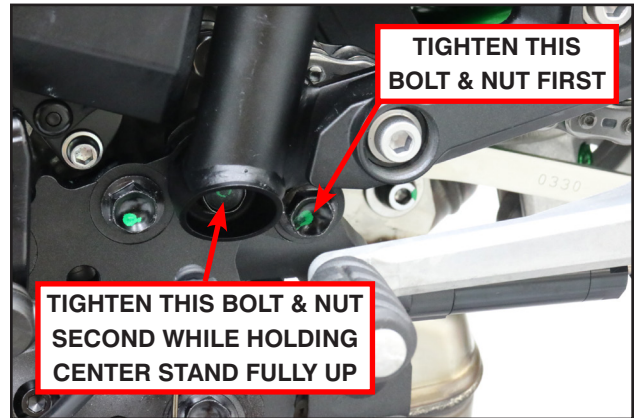
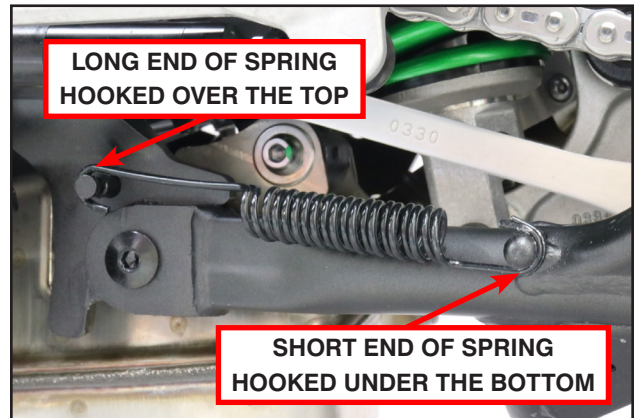
- Tighten the rear bolt & nut for the center stand bracket to **37 ft·lb (5.1 kgf·m, 50 N·m)**.
- While holding the center stand in the fully up position, tighten the forward bolt & nut for the center bracket to **37 ft·lb (5.1 kgf·m, 50 N·m)**
- Reinstall shift lever on shaft and tighten to **89 in·lb (1.0 kgf·m, 10 N·m)**.
- Install the center stand spring in the orientation shown with each spring hook fully seated in the groove of the spring post.

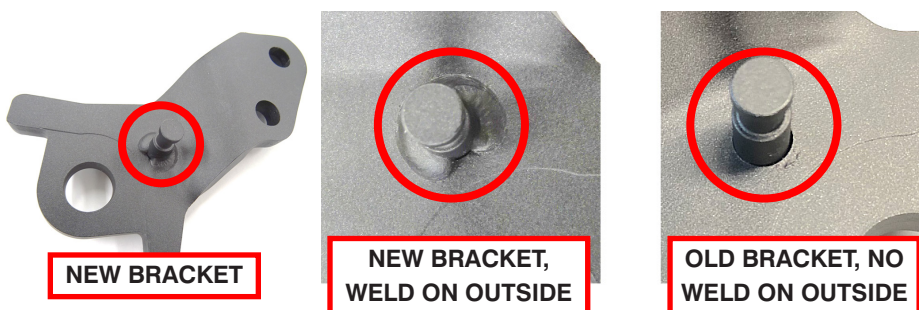
The new center stand bracket will serve as repair verification and can be identified by the weld on the outside surface as shown
