May 2019
FL788A-O
NHTSA #18V-582
Transport Canada #2018-468
REVISED NOTICE

Subject: FCCC Motorhome Chassis Rear PDMs

Models Affected: Specific Freightliner Custom Chassis X-Line chassis manufactured November 23, 2015, through June 29, 2018, and equipped with a certain PDM.

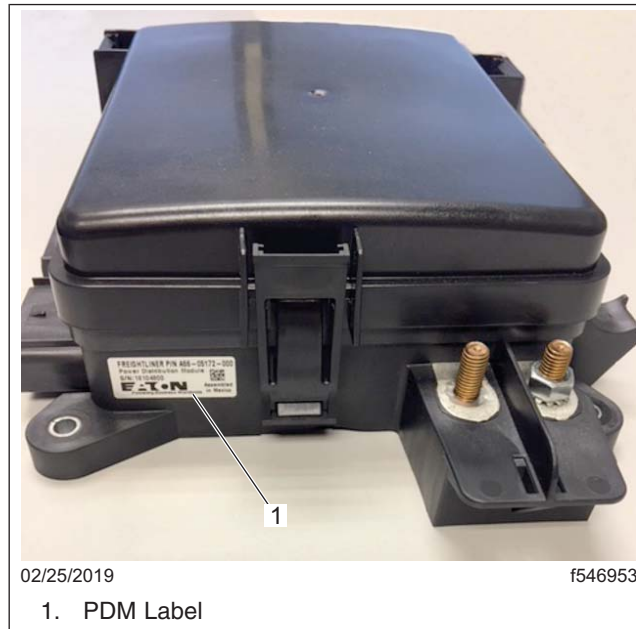
Fig. 1, PDM Label

4. Locate the PDM to be tested and check the serial number located on the PDM label. See **Fig. 1**. If the vehicle has less than 1500 miles (2414 km) and the PDM serial number is less than 18103500 do not perform the rear PDM circuit test—go to 'PDM Replacement' on page 9, for instructions to replace the PDM. **Applicable sections of the two-page 'PDM Inspection and Test' form must be completed and attached to the recall claim. Removed PDMs will be returned following Warranty Failed Parts Tracking shipping instructions for the disposition of all removed parts.**

If the PDM serial number is greater than 18103500, go to step 18 on page 9.

If the vehicle has more than 1500 miles (2414 km) and the PDM serial number is less than 18103500, continue to step 5.

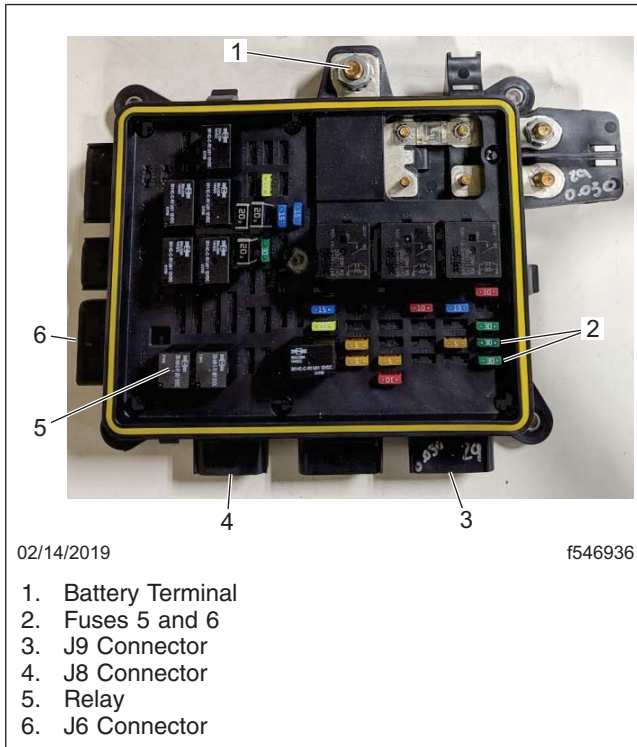
Fig. 2, PDM Components

IMPORTANT: The tester will work with a PDM connected to the vehicle or removed and placed on a work bench. If the PDM is being bench tested (PDM is not on the vehicle), ensure that 12V of power is supplied to the battery terminal. See [Fig. 2](#), item 1.

5. Remove the PDM cover and locate the circuits to be tested. See [Fig. 2](#).
6. Remove the two fuses and one relay from the PDM. See [Fig. 2](#), items 2 and 5.

REVISIONS: The NHTSA number has been corrected to 18V-582, and the work instructions have been updated. On step 8 of the work instructions the probe locations have been corrected from F6 & F7 to F5 & F6 as well as fig. 2 has been updated to match the correct locations.

If the voltage reading is less than 55MV, go to the next step.
15. Remove all of the test box connectors and install the relay and fuses removed earlier. For relay and fuse locations see [Fig. 2](#).
16. Replace the PDM cover.
17. Lower the vehicle and remove the jack stands.
18. Clean a spot on the base label (Form WAR259). Write the recall number, FL788, on a completion sticker (Form WAR260), and attach it to the base label to indicate this recall has been completed.

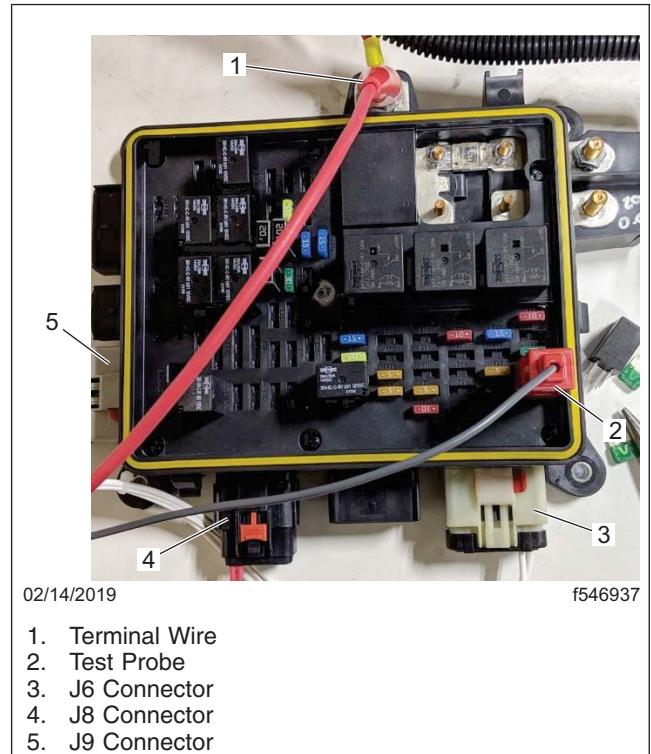
Fig. 3, Tester Connected to the PDM

7. Connect the tester to the PDM. This includes three J-connectors and the test probe, along with the power and ground terminals. See [Fig. 3](#). Not shown in [Fig. 3](#) is the ground terminal connected to the negative terminal on the battery.
8. With the test probe plugged into the F5 and F6 locations of the PDM, ensure that the tester rocker switch is on the J6 location. See [Fig. 4](#), ref. A and item 1.
9. Move the momentary toggle switch on the tester to the ON-PIN6 location. See [Fig. 4](#), ref. B and item 2. This will read the voltage drop on the J6 connector in the Pin 6 location.

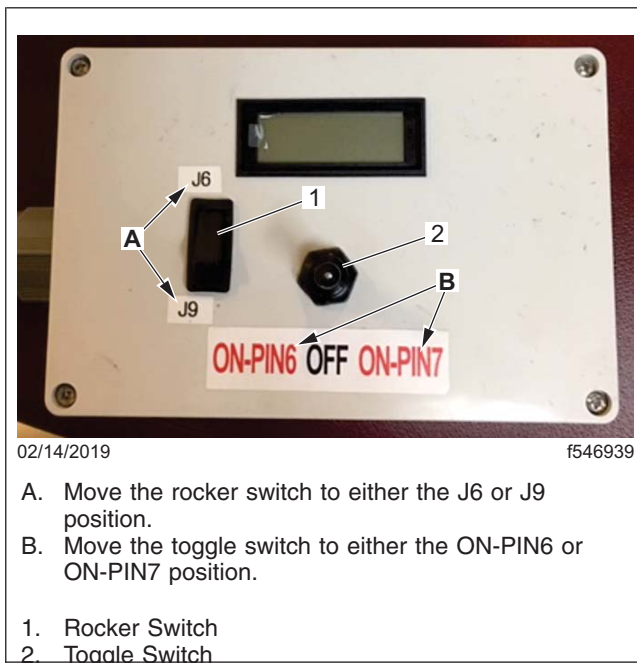
Fig. 4, Tester Components

Failure criteria is a voltage reading greater than 55MV or a meter reading of 1 or -1V (it is an open circuit). If any of these readings are shown go to 'PDM Replacement' for instructions.

10. Move the momentary toggle switch to the ON-PIN7 location. See [Fig. 4](#), ref. B and item 2. This will read the voltage drop on the J6 connector in the Pin 7 location.

12. With the test probe plugged into relay 18, ensure that the tester rocker switch is on the J9 location. See [Fig. 4](#), ref. A and item 1.
13. Move the momentary toggle switch on the tester to the ON-PIN6 location. See [Fig. 4](#), ref. B and item 2. This will read the voltage drop on the J9 connector in the Pin 6 location.

If the voltage reading is less than 55MV, go to the next step.
14. Move the momentary toggle switch to the ON-PIN7 location. See [Fig. 4](#), ref. B and item 2. This will read the voltage drop on the J9 connector in the Pin 7 location.

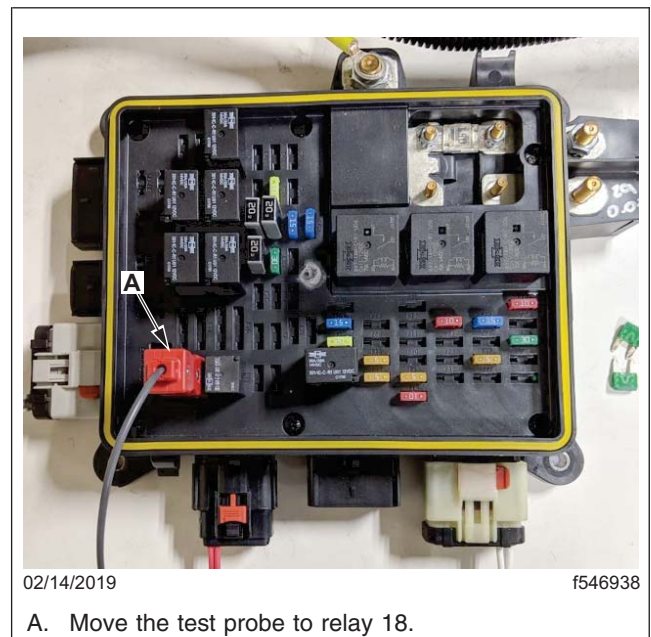
Fig. 5, Test Probe Moved to Relay 18

11. Move the test probe to the location for relay 18. See [Fig. 5](#). This will test the J9 connector Pin 6 and Pin 7.
