Safety Recall: 2017-18 NSX Fuel Tank

Supersedes 18-053, dated October 11, 2018, to revise the information highlighted in yellow

The welds in the fuel tank for the crossover pipe are improperly sealed. Clients may notice a strong fuel smell.

Replace the fuel tanks.

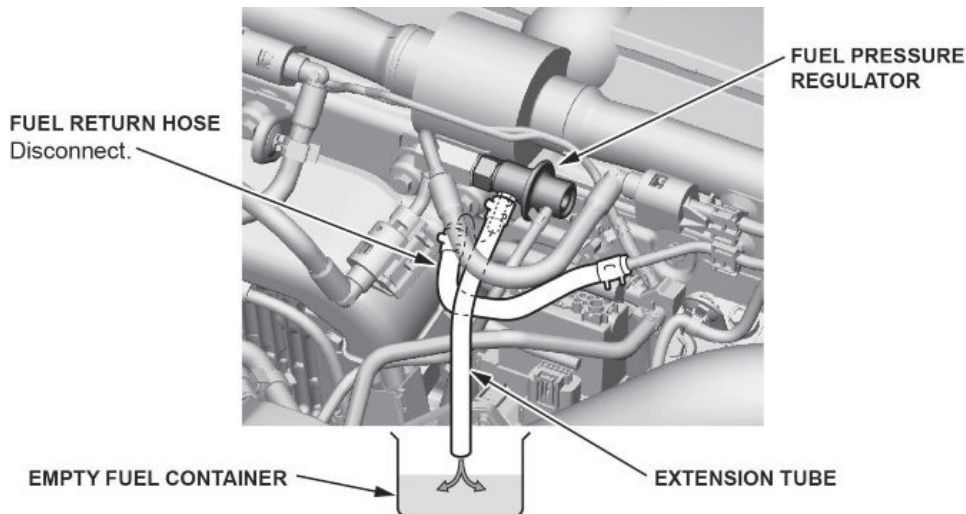
1. Set the vehicle on the lift. Refer to the service information.
2. Protect and cover the body panels surrounding the engine compartment.
3. Remove the engine room covers. Refer to the service information.
4. Remove the driver's side air cleaner assembly. Refer to the service information.
5. Drain the fuel from both fuel tanks.
 - 5.1. Remove the PGM-FI main relay 3 (UNDER HOOD).
 - 5.2. Remove the PGM-FI main relay 2 (CABIN).
 - 5.3. In **Maintenance Mode** do the **Forced PI Idling Mode**, then let the engine idle until it stalls.
 - 5.4. Remove the fuel return hose from the fuel pressure regulator, and add an extension tube to an empty fuel container.

- 5.5. Jump the PGM-FI main relay 3 (UNDER HOOD) 4-pin connector terminal No.1 and No. 2 with a jumper wire, and turn the ignition to ON.

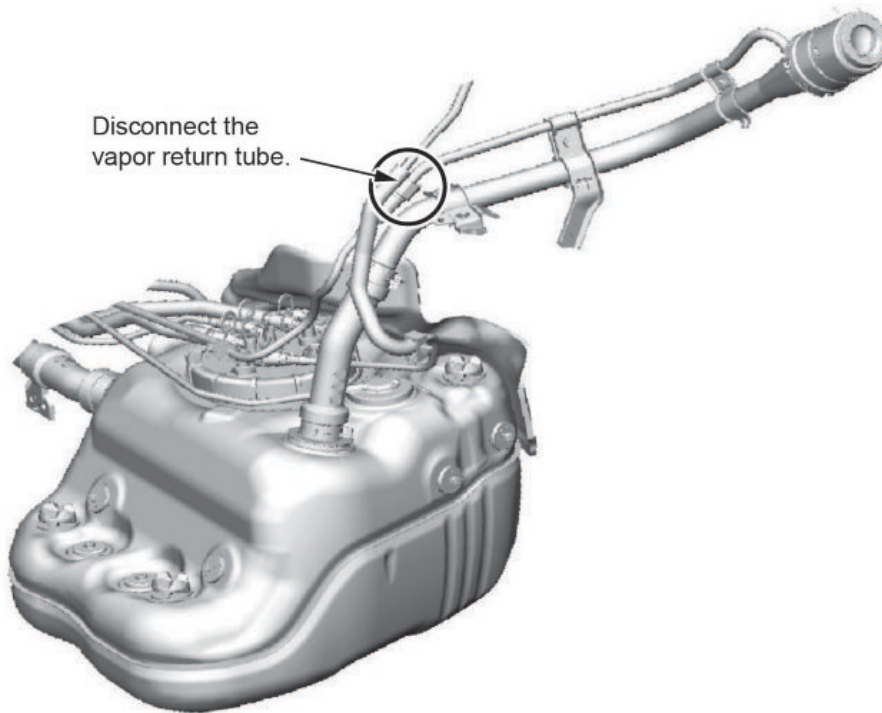
6. Disconnect the fuel vapor line (located below the removed driver's air cleaner assembly).

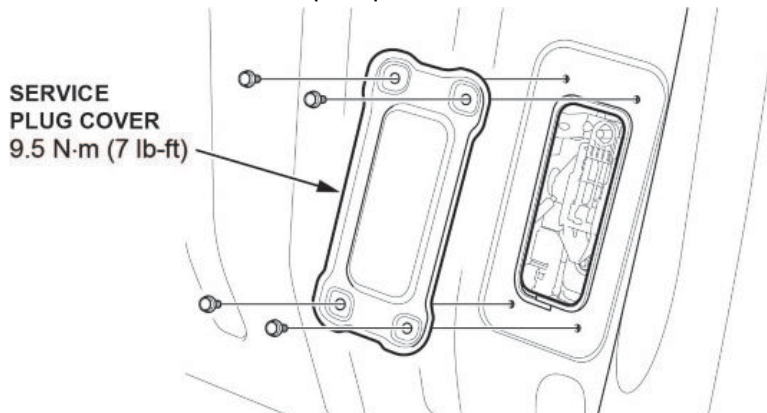
7.5. Pull the rear bulkhead carpet up to access and remove the service plug cover.

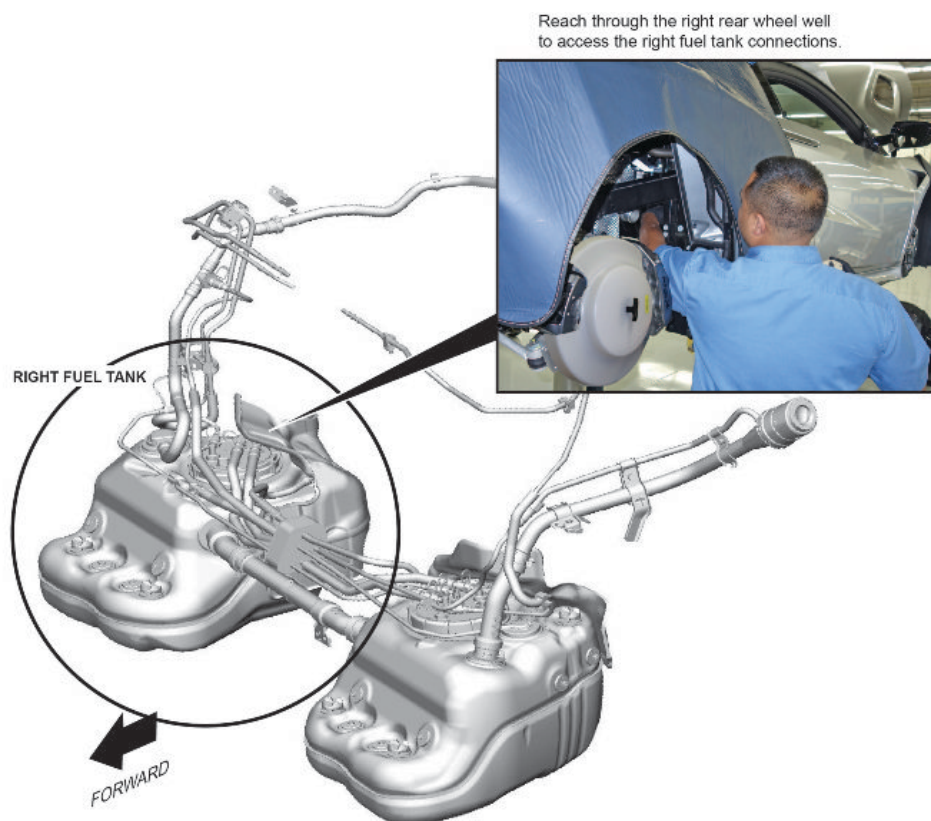
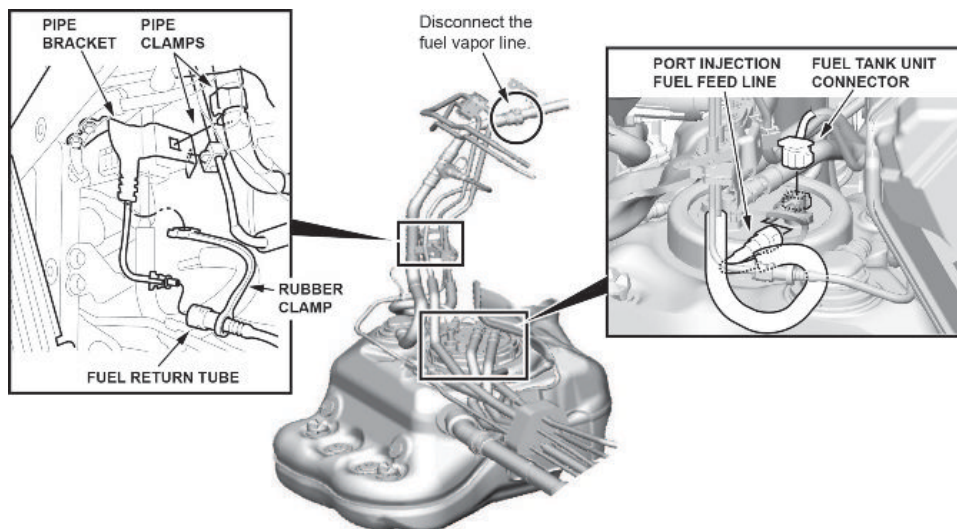
12. On the passenger side rear wheel well, disconnect the following:

- OVR tube (next to frame beam)
- Lower intercooler hose (Unclamp and move.)
- PI fuel feed pipe
- Fuel tank unit connector
- Clip harness tab for the OVR
- Clip harness tab for the fuel line return

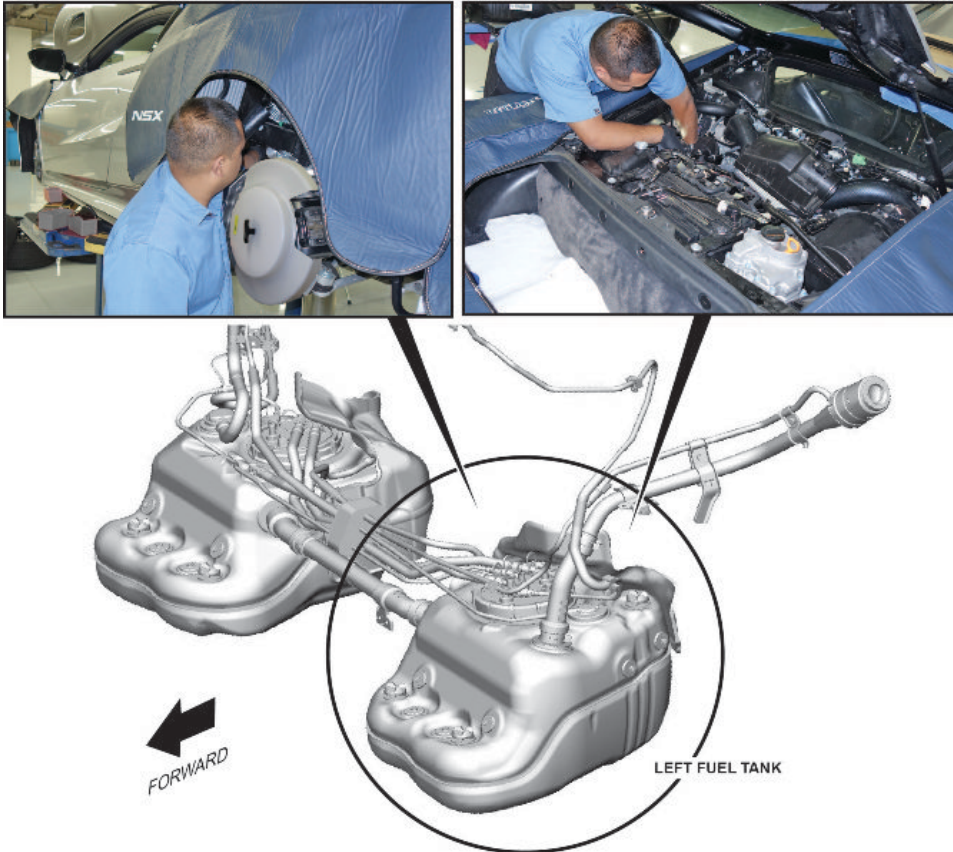
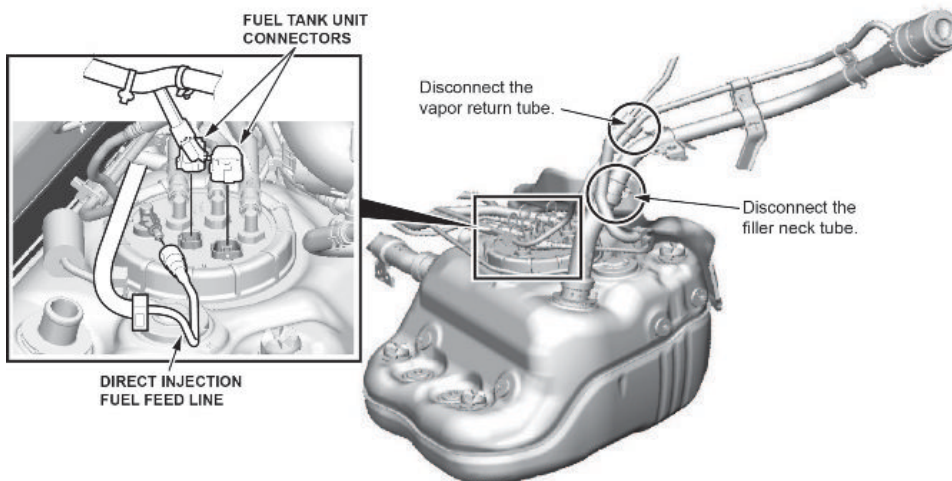
13. On the driver's side rear wheel well, do the following:

Reach through the left rear wheel well and the engine compartment to access the left fuel tank connections.

- Unclamp and move the intercooler hose.
- Remove the black bracket holding the fuel tank (top side fasteners).
- Disconnect the two electrical connectors.
- Disconnect the fuel filler neck.
- Disconnect the PI fuel feed pipe to the fuel pump.
- Unhook the tube clamp on the firewall side.

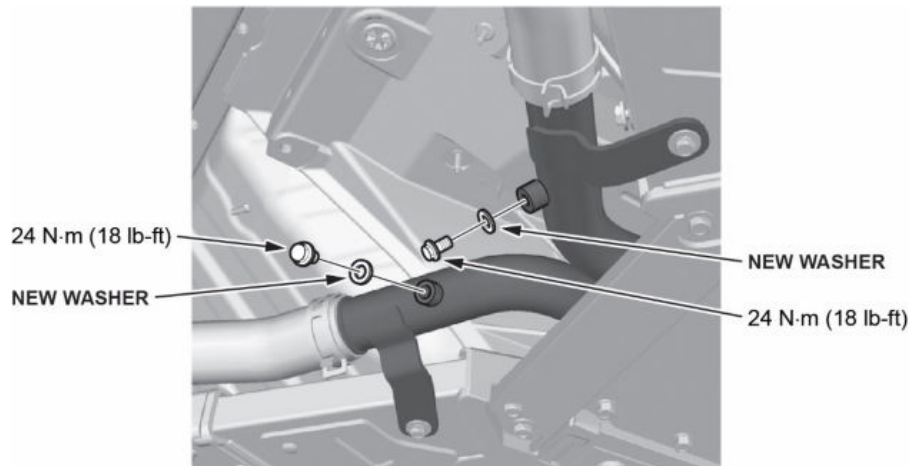
18. Drain the engine coolant only from the water pipe underneath the vehicle.

After the coolant has drained, reinstall the drain bolts with new washers included in the kit.

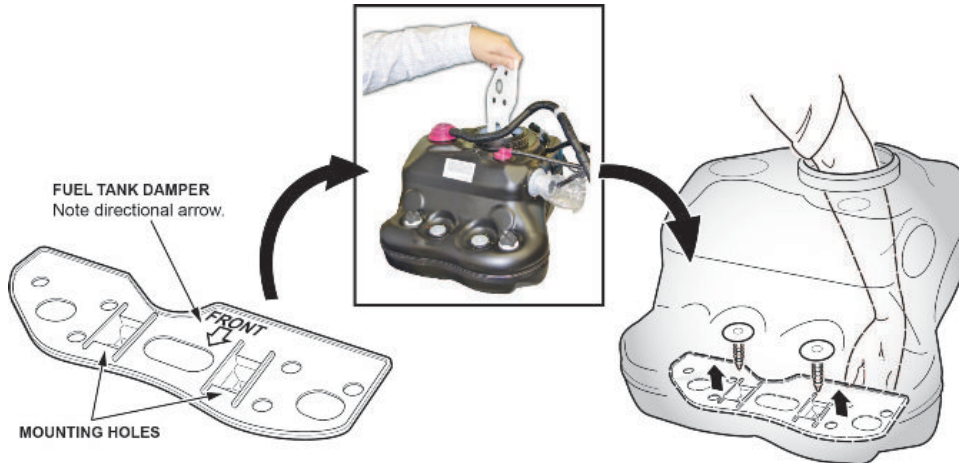
30. Install the fuel tank damper (supplied with the new fuel tanks) as shown.

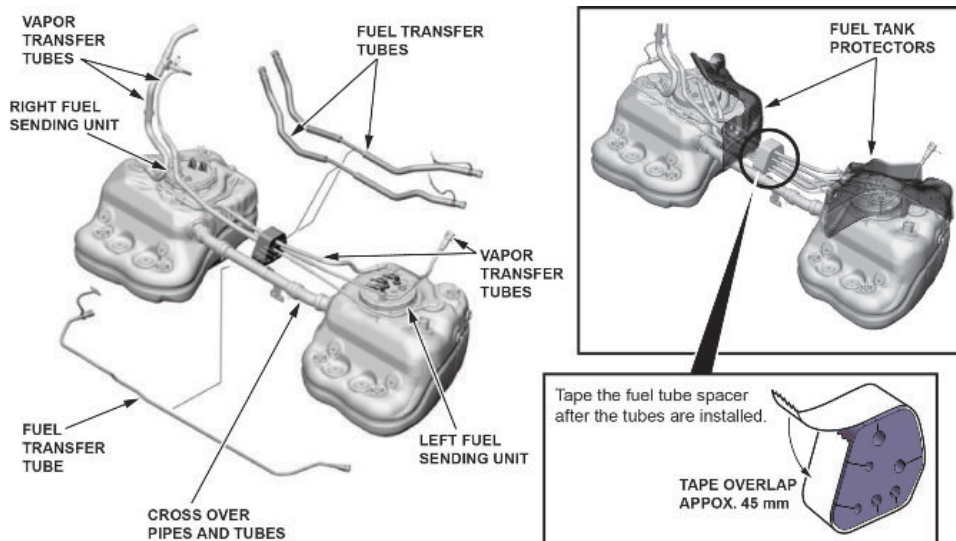
Install the supplied tape around the fuel tube spacer as shown.
