Safety Recall

Code: 34J1

Subject	Gearbox Ventilation Hose
Release Date	October 03, 2018
Affected Vehicles	U.S.A. & CANADA: Certain 2017-2018 Model Year Audi R8 Spyder & R8 Coupe <i>Check Campaigns/Actions screen in Elsa on the day of repair to verify that a VIN qualifies for repair under this action. Elsa is the <u>only</u> valid campaign inquiry & verification source.</i> <ul style="list-style-type: none">✓ Campaign status must show "open."✓ If Elsa shows other open action(s), inform your customer so that the work can also be completed at the same time the vehicle is in the workshop for this campaign.
Problem Description	Transmission fluid may leak from the gearbox ventilation hose during extreme racetrack driving/maneuvering situations. Leaking transmission fluid can contact hot engine parts, causing smoke and possibly a fire.
Corrective Action	Replace the single gearbox ventilation hose with a double ventilation hose that has a higher oil expansion volume.

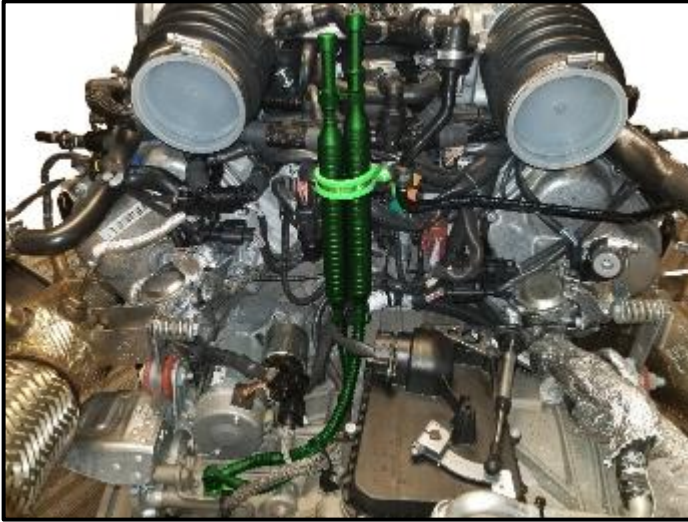
Repair Overview

- Install updated gearbox ventilation hose.

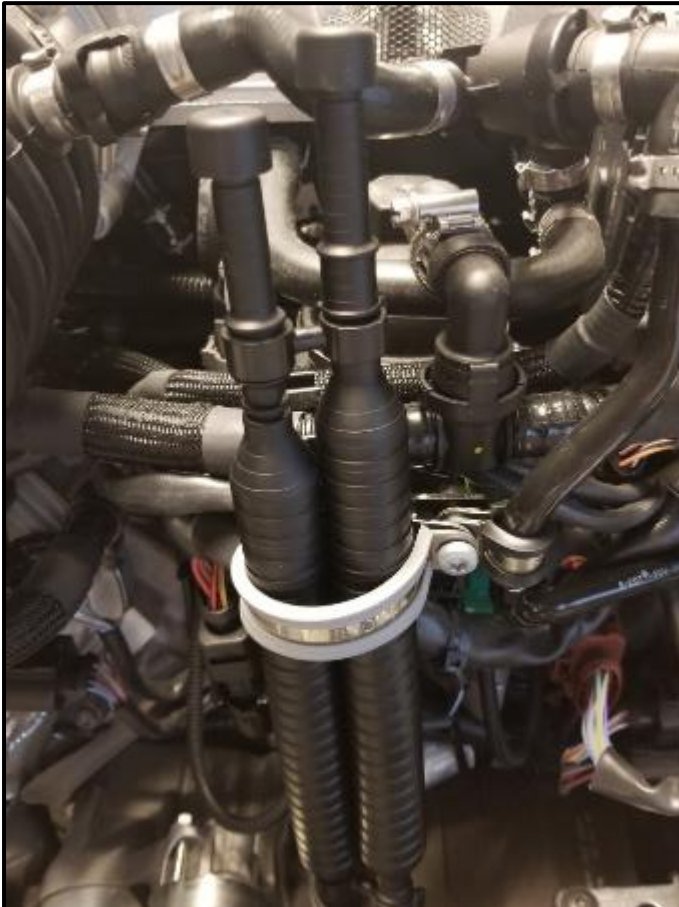
- If a dual ventilation hose is present (as shown):
 - No further work is required.
 - Reinstall oil reservoir cover.
 - **Proceed to Section H.**
- If a single ventilation hose is present:
 - The ventilation hose requires replacement.
 - **R8 Coupe (Criteria 01) - Proceed to Section C**
 - **R8 Spyder (Criteria 02) – Proceed to Section D**

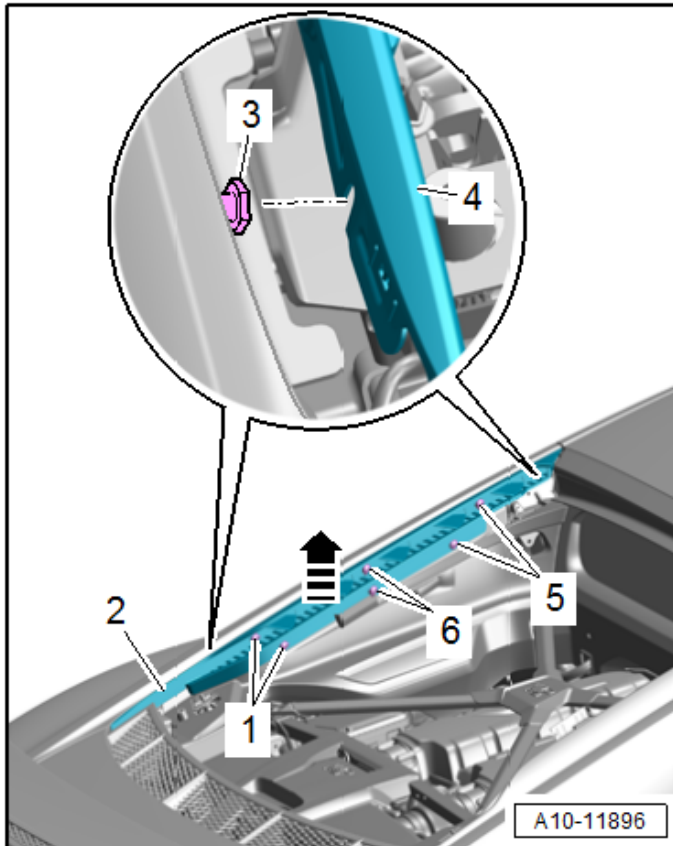
Removal for the left side is illustrated. The procedure for the right side is identical.

- Remove the bolts <1, 5 and 6>.
- Remove the engine compartment cover upper section <2> upward in direction of <arrow>, and the mounts <4> will be pulled out of the guides <3> at the same time.

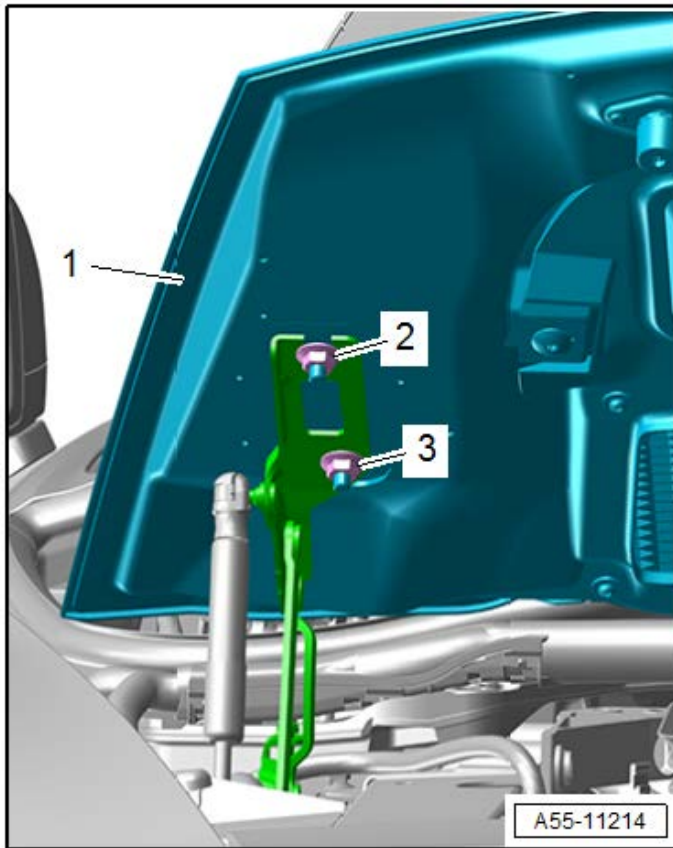
- Mark the engine compartment lid installation position for reinstallation.
- Remove the nut <3>.
- Loosen the nut <2> eight turns.
- Remove the engine compartment lid <1> with help from a second technician.

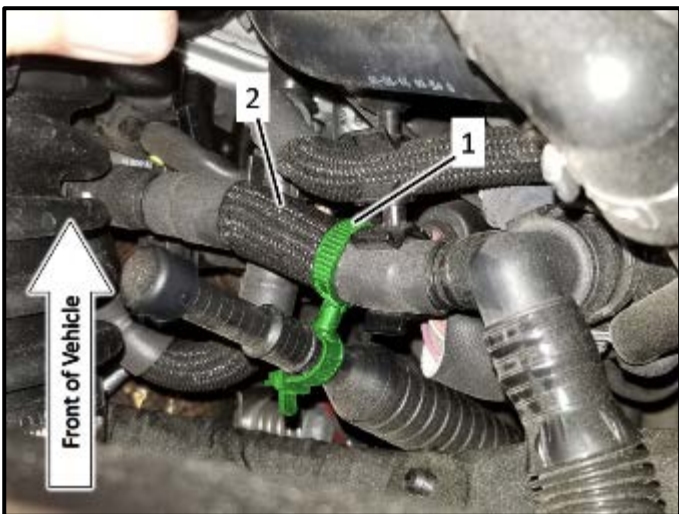
- Cut tie wrap <1> from hose <2>.

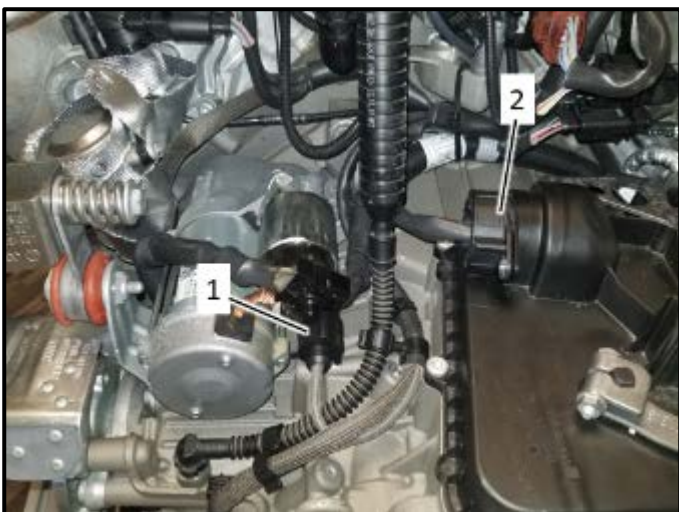
- Disconnect starter connector <1>.
- Disconnect parking lock actuator connector <2>.

- Engine shown removed for clarity.
- Disconnecting the connectors allows for easier removal and installation of the ventilation hose.

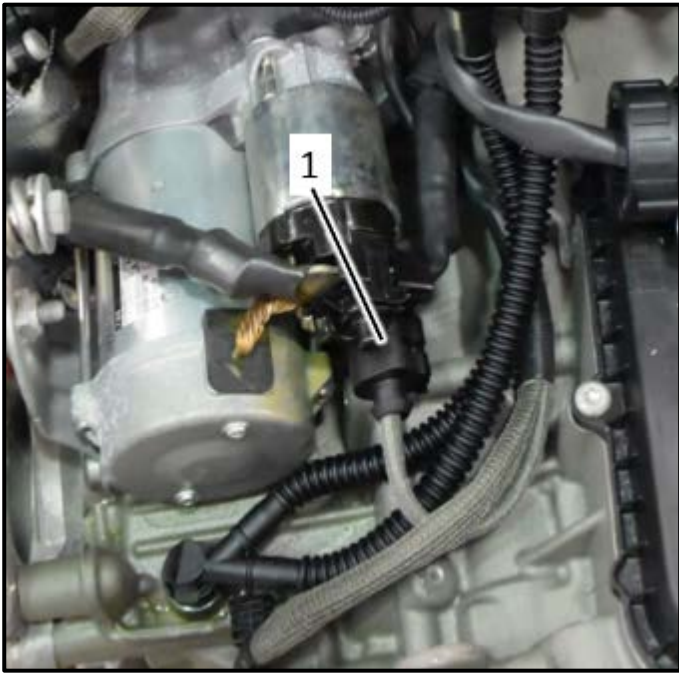
- Route starter connector wiring around ventilation hoses as shown.
- Connect starter connector <1>.

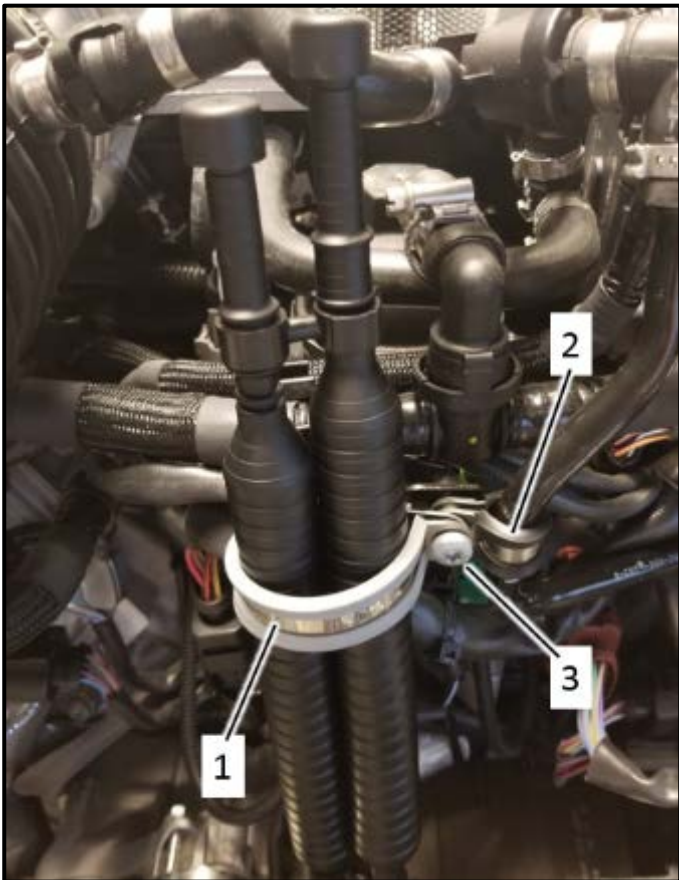
- Install new clamp <1> over the existing clamp <2>.
- Install new bolt <3> and torque to 8 Nm.

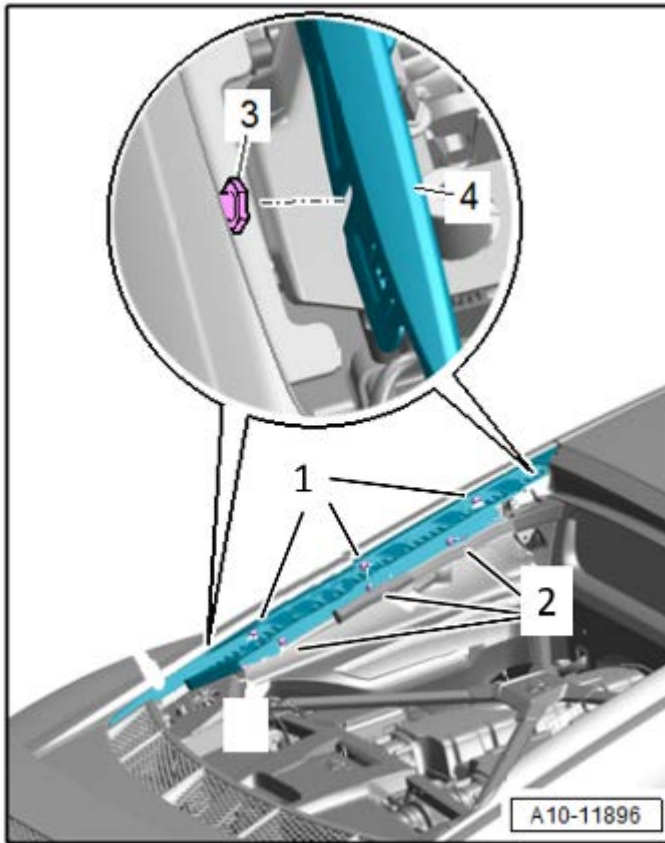
- Install the engine compartment cover <4> onto guides <3>.
- Install bolts <1> and torque to 8 Nm
- Install bolts <2> and torque to 6 Nm.
