Technical Service Bulletin

NUMBER
18-01-033

MODEL(S)
SANTA FE (TM)

SUBJECT: 2019 SANTA FE (TM)
CURTAIN AIRBAG (RECALL CAMPAIGN 177)

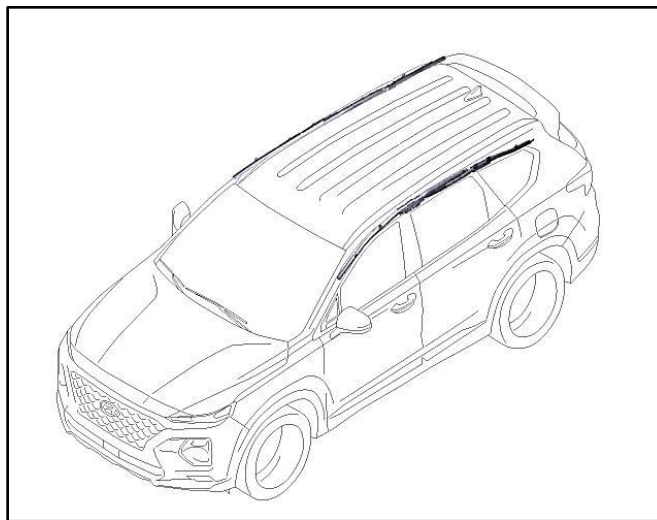
Certain Santa Fe (TM) vehicles are equipped with curtain airbags that were installed using bolts that could interfere with and damage the airbags during deployment. If the curtain airbag becomes damaged during deployment, the airbag may not inflate properly during a crash, increasing the risk of injury.

This bulletin describes the procedure to install covering to the curtain airbag bolts to protect the curtain airbags in the event of inflation.

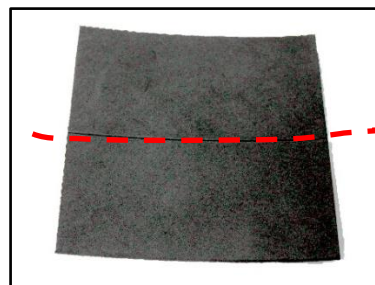
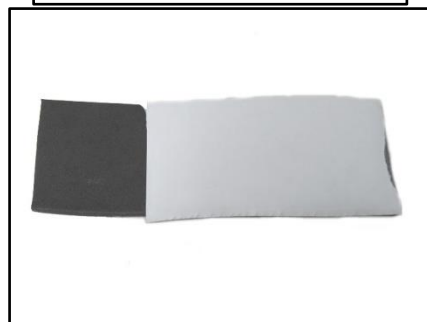
1. Cut the pad in half to make 2 pieces of 80X40mm pads.

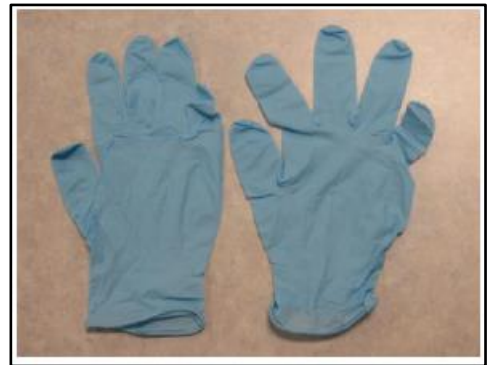
1. Wear a set of clean rubber gloves before starting the procedure.

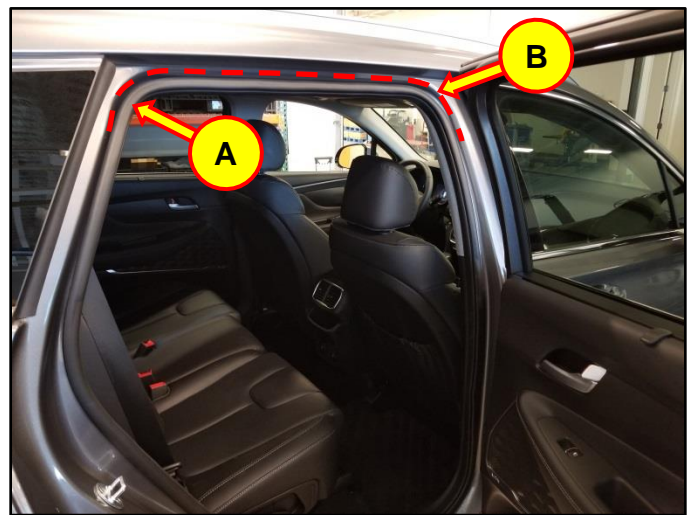
2. Open the RH rear door fully and carefully pull down the body side weather strip (A) along the top of the door opening (B).

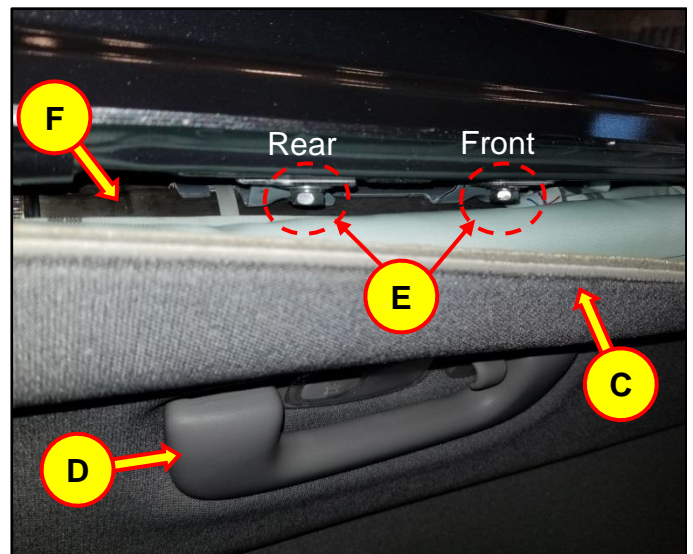
3. Carefully pull the headliner (C) down along the door opening, adjacent to the assist handle (D), to access the two bolt heads (E) under the curtain airbag Inflator (F).

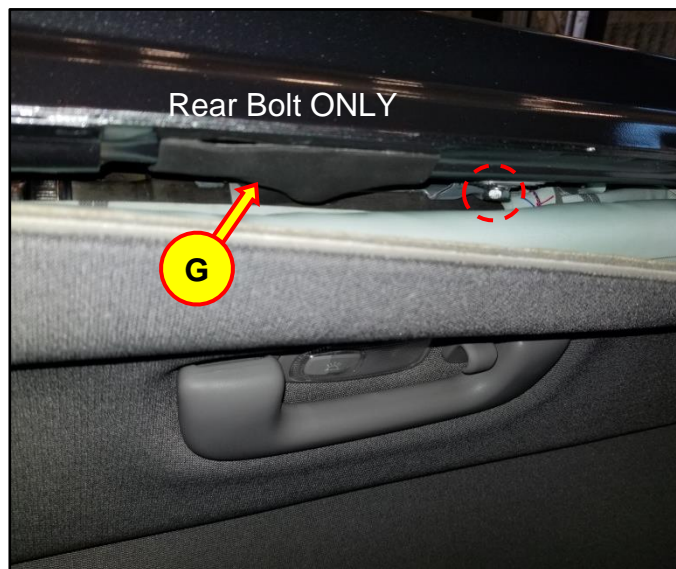
4. Place the pad (G) horizontally centered over the REAR bolt head ONLY and firmly press all edges of the pad to the curtain airbag inflator mounting plate and the rear bolt head.

Pad must be fully secured to the rear bolt head and curtain airbag inflator mounting plate. Do not leave any edges lifted/unseated.

Rear bolt head must be fully covered by the pad. If not fully covered, the rear bolt head could damage curtain airbag during deployment.
