607 NW 27th Ave Ocala, FL 34475 Phone : (352) 629-5020 Fax : (352)-629-2902	FIELD REPAIR INSTRUCTIONS				P/N	FSG-WI-00245
	TYPE	HARNES REPAIR			PAGE	1 OF 5
	DEPARTMENT	PORTABLES	BY	ROBERT HE	REV	D

Portable Pumps with Kubota 24 HP or 39 HP diesel engines, may have non-functional LED warning lamps for oil pressure and coolant temperature due to improper wire connections.

The purpose of this document is to provide step by step instructions to test that the LED warning lamps function properly, and if a problem is detected, how to repair the connections. The estimated total time for the tests and repair is less than (1) hour. This applies to harness 200799_REV_C and its prior revisions, which are used on the control panel.

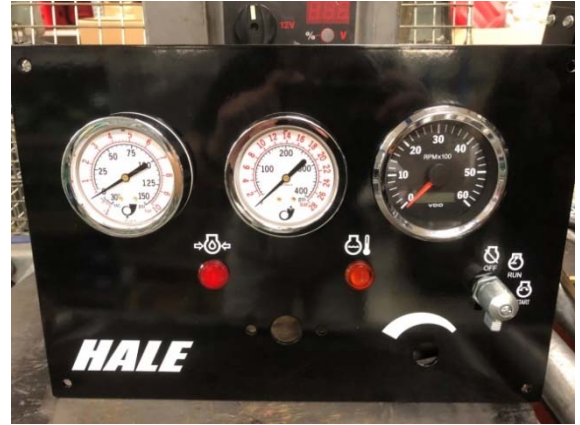
Figure 1.

The instructions apply to the Hale wire harness part number 200799, Rev C as well as its earlier revisions. The harness usually comes with the control panel (Part number 168-0072-98-0) shown on Figure 1, for Kubota diesel engines.

There are two LED lamps on the panels, the lamp in red color is for engine oil level warning and the lamp in amber color is for engine coolant temperature warning.

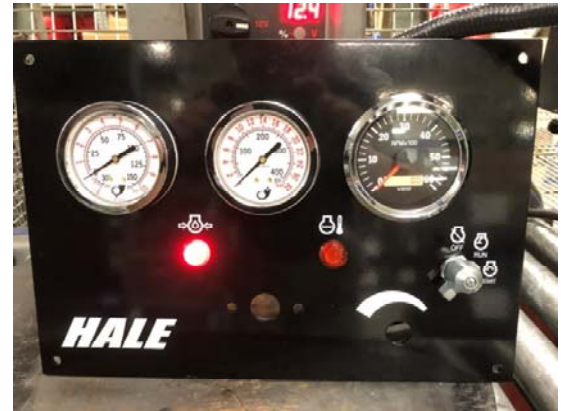
Figure 2.

1. If it turns on as shown on

Figure 2, lamp functions properly and no repair is needed.
2. If not, that indicates lamp wire requires repair. (See **Repair Instructions** on page 4.)

- C. Check that engine oil level warning illuminates. (

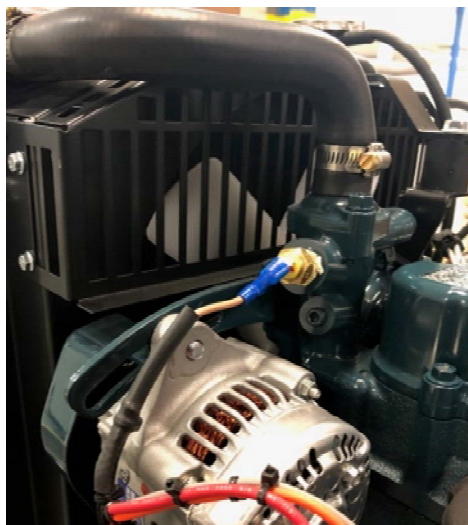
Figure 3. The sensor is located on the coolant outlet manifold which connects a coolant hose to the radiator.)

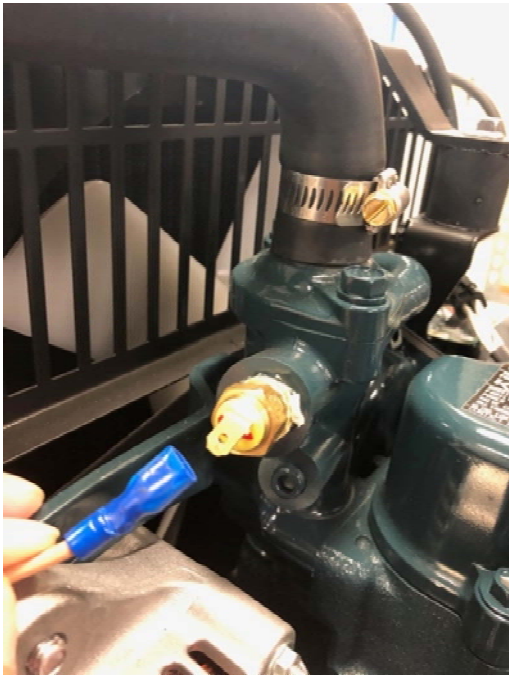
3. Using care, unplug sensor connector as shown on Figure 4.

4. Turn on control engine **RUN/START** switch to **RUN** position.
5. Using a jumper wire connect the metal terminal inside blue connector to a bare metal surface on engine such as the hex on the sensor.

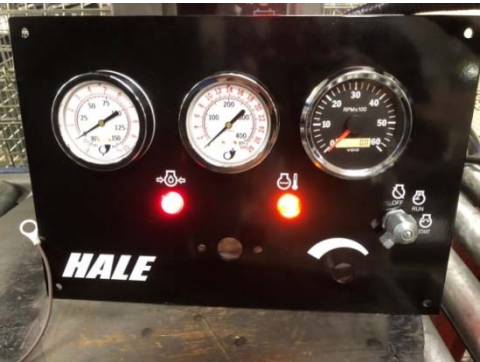
Figure 5.

If amber lamp turns on as shown on

6. Figure 5, the lamp functions properly and no repair is needed. (If not, the lamp wire needs repair. See the repair instructions below.)

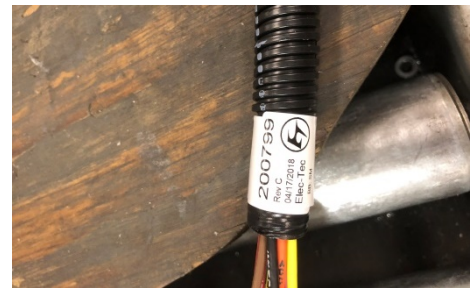
Figure 6.

- A Phillips screw driver for the control panel removal and installation
 - A wire with an alligator clip on each end for testing
 - Tools (Repair Option 1)
 - A wire cutter (for 18 GA wire)
 - A wire stripper (for 18 GA wire)
 - A wire crimper
 - A thermal (heat) gun
- A. Turn off power supply to control panel and disconnect negative battery terminal.
 - B. Remove four (4) control panel mounting screws. (Located at corners of panel.)
 - C. Carefully pull panel out to provide sufficient room to perform repair.
 - D. On back of panel, identify part number of main harness is 200799. See Figure 6 for reference. (If not, stop and call Hale Products at 1-800-533-3569.)

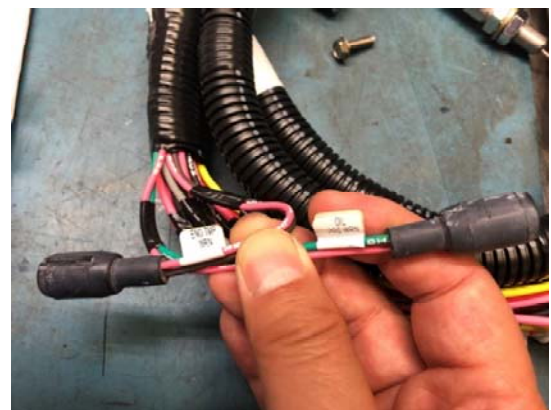
Locate the two branches with a Sure Seal rubber connector that split out of the main harness (harness is marked 200799). One is tagged as ENG TMP WRN; and other is tagged as OIL PRS WRN. (See Figure 7.)

Repair Option 1: Perform the following repair to the wires shown on Figure 7.

- A. Disconnect Sure Seal rubber connectors.

- B. Cut both wires about 2-inches from end of connector.
- C. At both ends of both wires, strip insulation.

- D. Reverse wires by connecting stripped end of one wire to stripped end of opposite wire, using a sealed butt splice for 18 GA wire (shown on Figure 8).

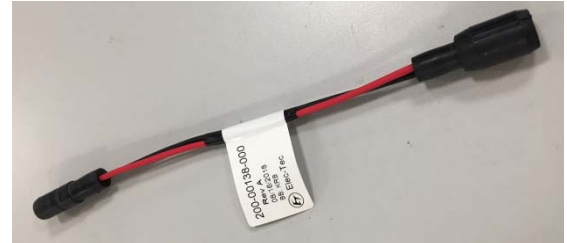
Figure 9.

Locate the harness adapters (see Figure 9), from the repair kit, each pair of defective wires (failed the indicator tests) will need a wire adapter.

A. Disconnect failed indicators Sure Seal rubber connectors.

B. Connect a wire adapter into harness side connector. (There is a stripe on the female connector and a dot on the male connector for connector alignment (see Figure 10).

C. Connect other end of wire adapter into indicator side connector.
