Product Safety Recall

18359 Cab Tilt Handle Orientation

Reference Number: N182198690

Release Date: December 2018
Revision: 00

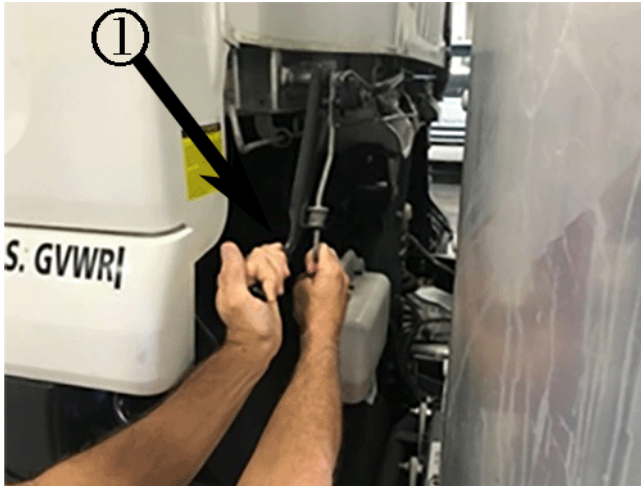
5186631

2. Place the tilt cab locking lever in the down/released position (1).

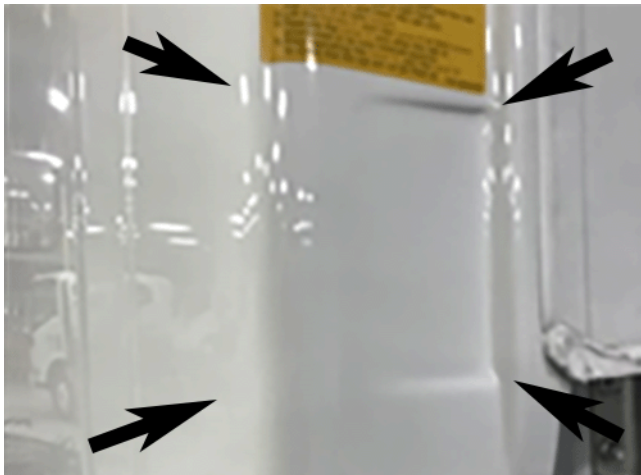
5186635

3. Thoroughly clean the area indicated above with isopropyl (rubbing) alcohol and a clean lint free cloth. Be sure to clean around the curve of the cab going forward.

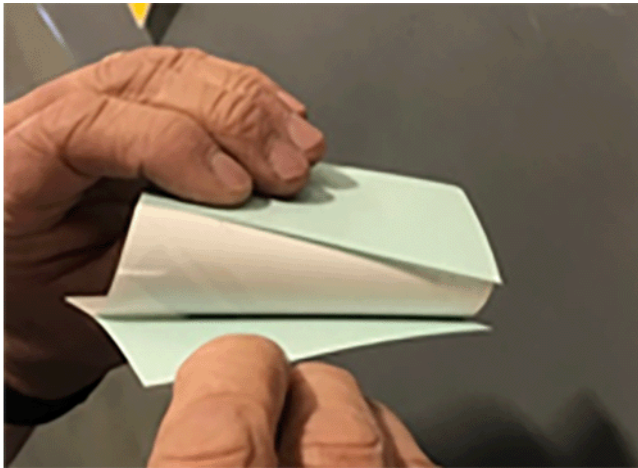
5186637

4. Remove the backing film from the center of the new tilt lock caution label as shown.

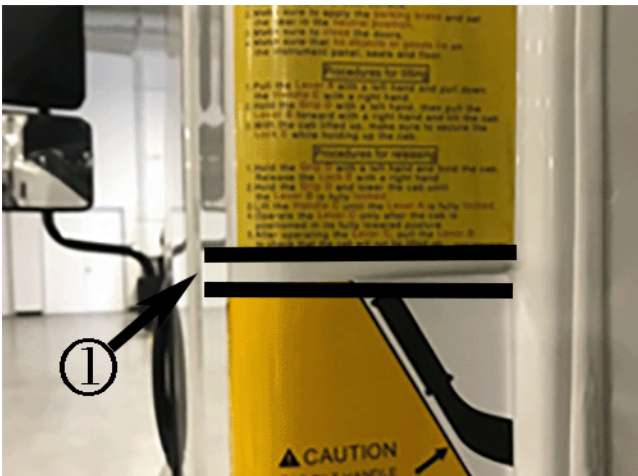
5186638

5. Carefully apply the label 8mm (0.31 in) down from the indentation (1) in the cab and directly below the existing tilt cab instruction label as shown. Guide the upper edge of the label along the horizontal contour of the indentation. Smooth out any air bubbles with a squeegee.

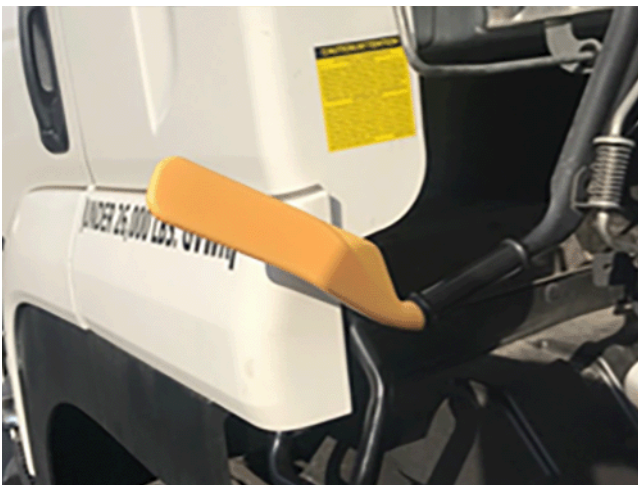
5186649

Correct

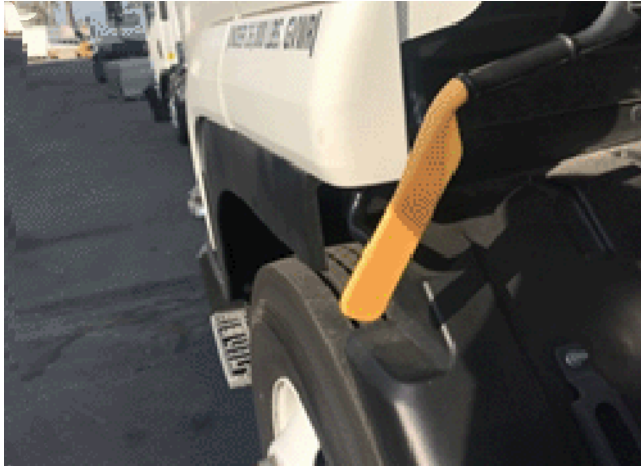
5186670

Incorrect

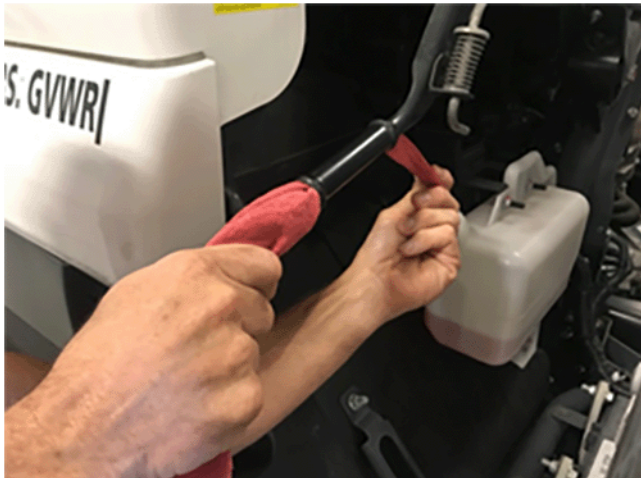
5186673

6. Test fit the cab unlock marker into the hollow end of the cab lock lever handle grip. It may be easiest to install the marker where it locks in by twisting in place. However, the marker needs to have the end pointing upwards at the final installation.
7. Remove the cab unlock marker from the cab lock lever handle grip.

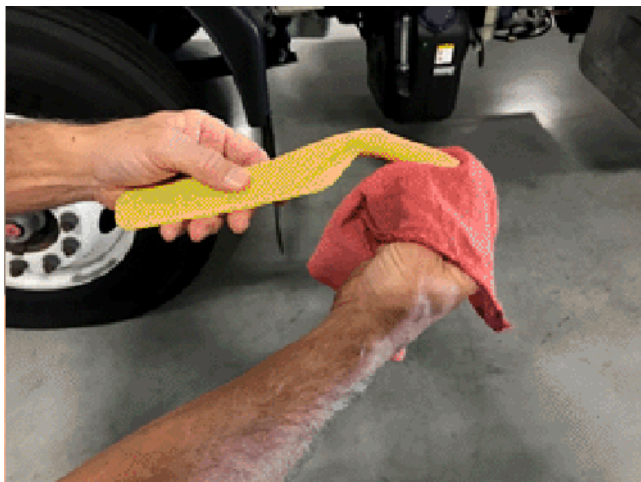
5186676

8. Clean the inside of the hollow grip area of the cab locking lever using isopropyl (rubbing) alcohol and a clean shop towel. Clean the grip area of the cab unlock marker using the same towel.

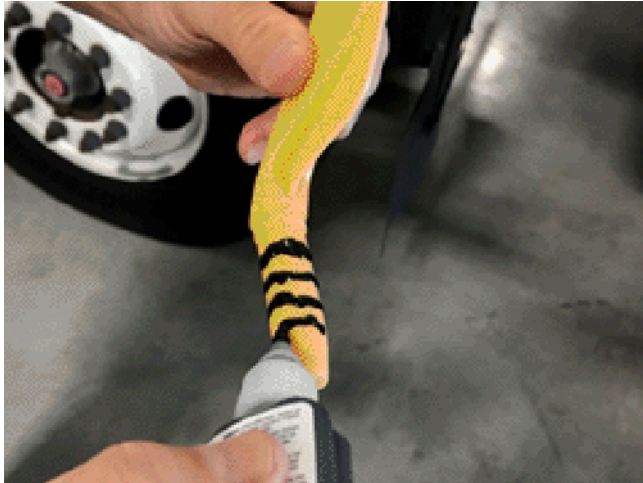
5186679

9. Apply the Loctite 4211 adhesive in 5mm (0.197 in) beads placed 10mm (0.39 in) apart on the grip area of the unlock marker.

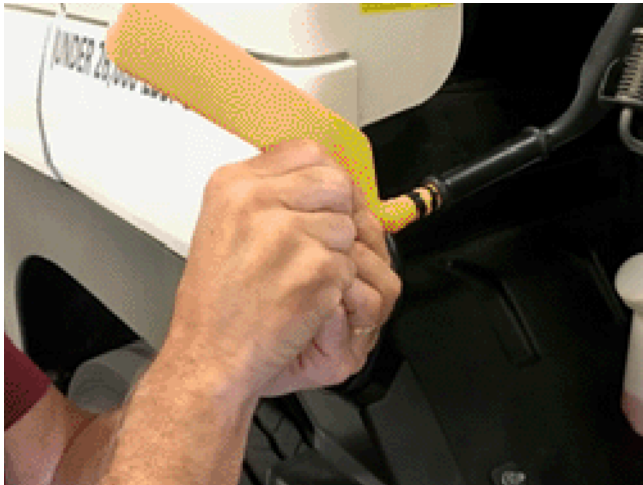
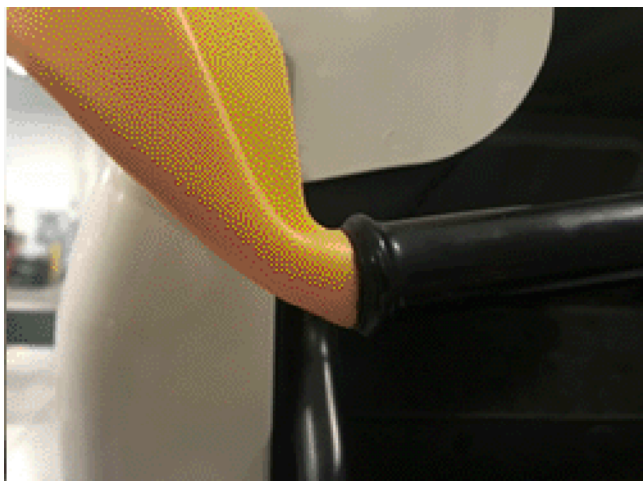
5186685

10. Insert the cab unlock marker into the tilt cab locking lever grip with the end pointing upward and parallel with the rear of the cab. Push on the marker until it locks fully into place. Twist the marker as necessary to lock it in place, but ensure it is pointing upwards when locked. Wipe off any excessive adhesive.
11. Immediately push the tilt cab locking lever upwards into the locked position before the adhesive is fully set.

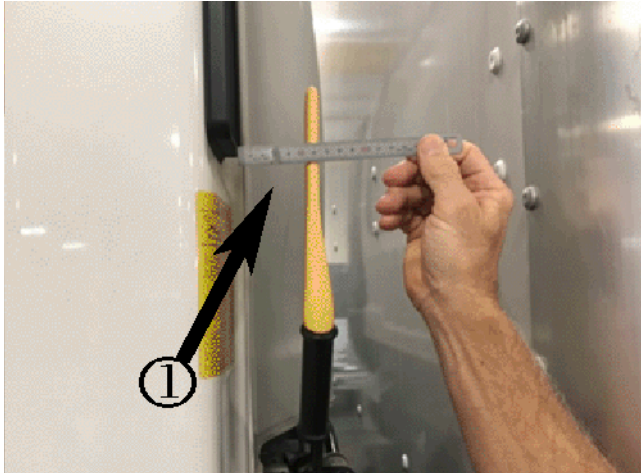
5186693

12. Ensure that the end of the cab lock marker is at least 40mm (1.57 in) from the ventilation duct on the rear of the cab (1). Adjust the marker by slightly twisting it clock-wise as necessary. Any adjustment must be made within four minutes, otherwise the adhesive will set.

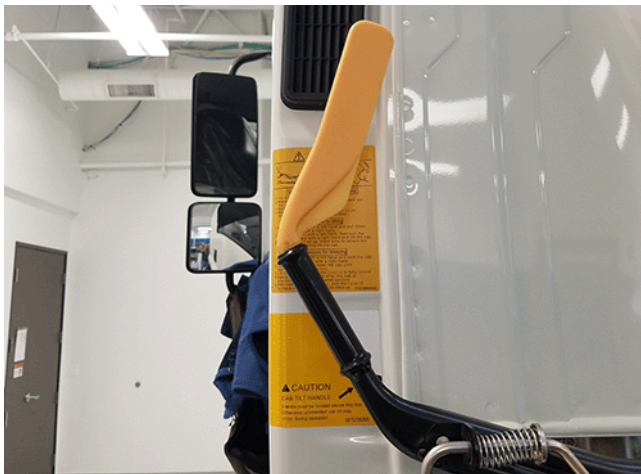
5186697

13. When the cab lock lever is properly locked as shown, the handle will match its correct positioning as noted on the tilt lock caution label.
14. Locate the owner's manual and insert the supplemental pages. If the supplemental pages are not provided, use the graphics at the end of this bulletin to print the pages.

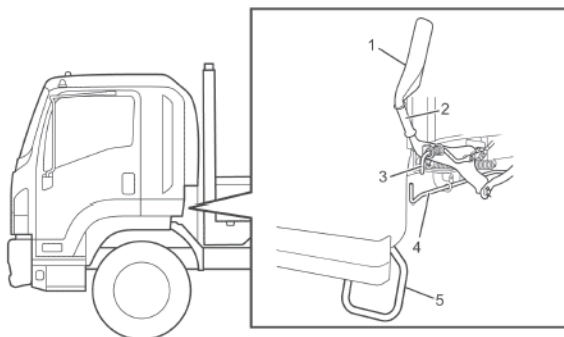
Cab Tilt Levers and Grip

1. Cab Unlock Marker
2. Handle
3. Upper Lever
4. Lower Lever
5. Grip

2. Pull the upper lever (2) with your left hand and turn down the handle (1) by pulling it toward you with your right hand to release the cab lock. The cab will rise slightly at this time.

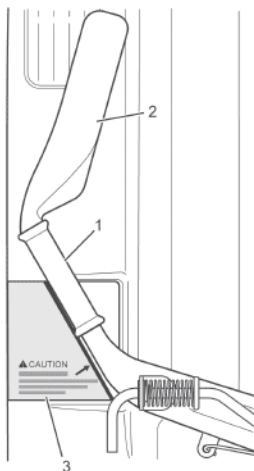
- 6.1. Handle
- 6.2. Cab Unlock Marker
- 6.3. Handle Location Label

- To help avoid personal injury or death, confirm the handle (1) is located in locked position as indicated on the cab tilt handle location label.
- When the cab unlock marker is protruding from the cab, the cab is not locked. Securely lock the handle (1).

7. The cab unlock marker (1) only indicates that the cab (2) is unlocked. Do not use the cab unlock marker to lock or unlock the cab.
