# Campaign Service

**BULLETIN NUMBER:**  
CB18-E-001

## IMPORTANT SAFETY RECALL

**FTR TILT CAB LOCK LEVER POSITION REMINDER – 18V-758**  
(Transport Canada 2018-590)

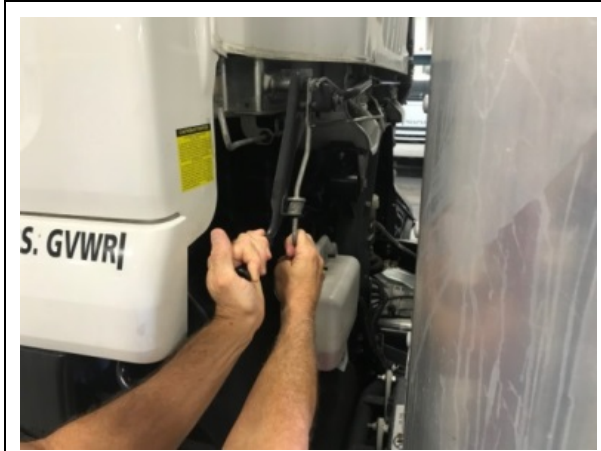
Figure 1

1. Park the vehicle on a flat surface, shift to park, turn off the engine, and engage the parking brake.
2. Place the tilt cab locking lever in the down/released position (See Figure 1).

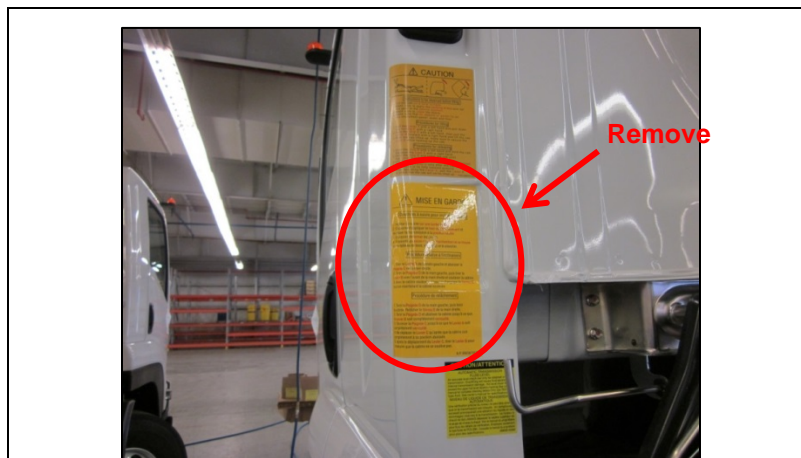
Figure 2

3. For US vehicles, skip to Step 8. For Canada vehicles, the French instruction label that was previously installed below the English label (See Figure 2) must be relocated to install the new tilt lock caution label. Carefully peel as much of the label off as possible and discard. Remove any remaining residue with adhesive remover and a clean lint free cloth.

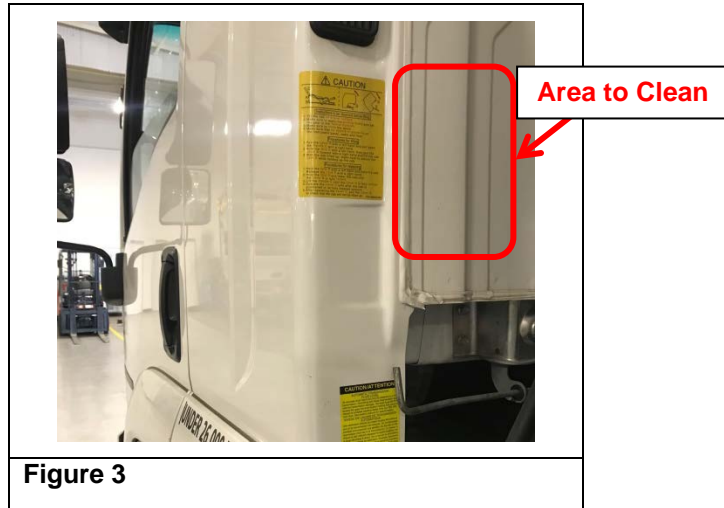
- Using isopropyl (rubbing) alcohol and a clean lint free cloth, thoroughly clean the area slightly larger than the French tilt cab instruction label just to the right and inboard of the body seal (See Figure 3).

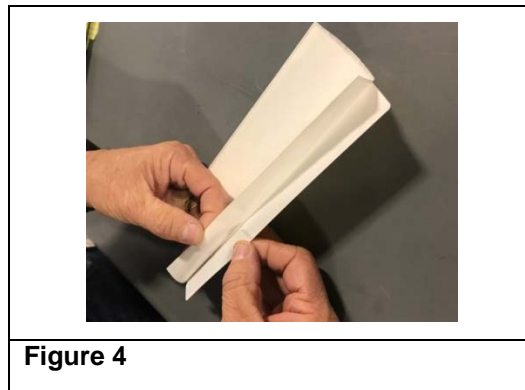
- Fold back about 10mm on the left side of the replacement French label's backing as shown in Figure 4.

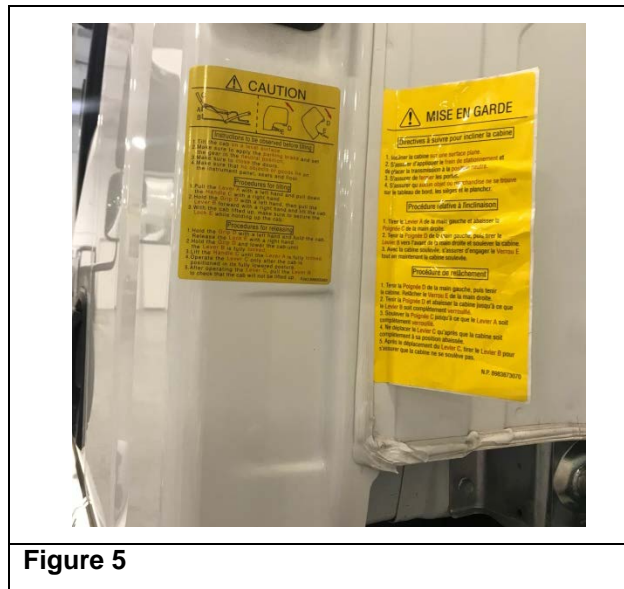
- Place the left edge of the replacement French label to the right edge of the body seam with the top of the label level with English label (See Figure 5).

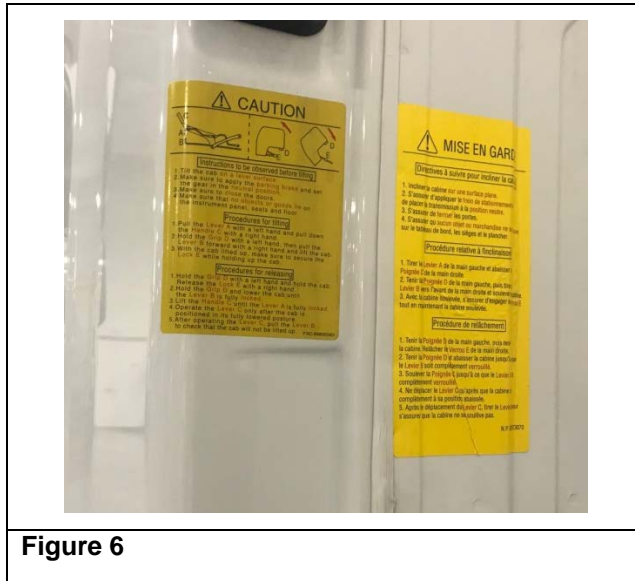
- Using a squeegee, affix the label while removing the backing. Press down from top-to-bottom and left-to-right. Ensure that the label is seated into all the body contours (See Figure 6).

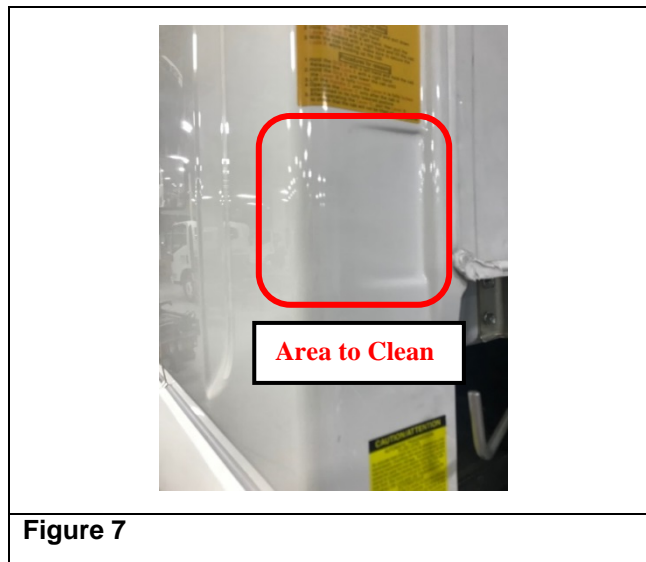
- Thoroughly clean the area indicated in Figure 7 with isopropyl (rubbing) alcohol and a clean lint free cloth. Be sure to clean around the curve of the cab going forward, so the label can also adhere to this area.

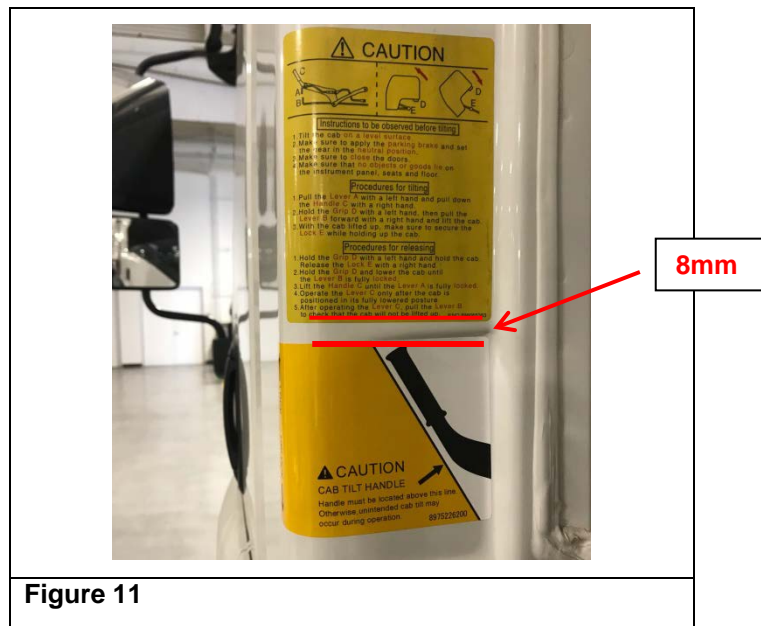
10. Carefully apply the label 8mm down from the indentation in the cab and directly below the existing tilt cab instruction label as shown in Figure 11. Guide the upper edge of the label along the horizontal contour of the indentation. Smooth out any air bubbles using a squeegee.

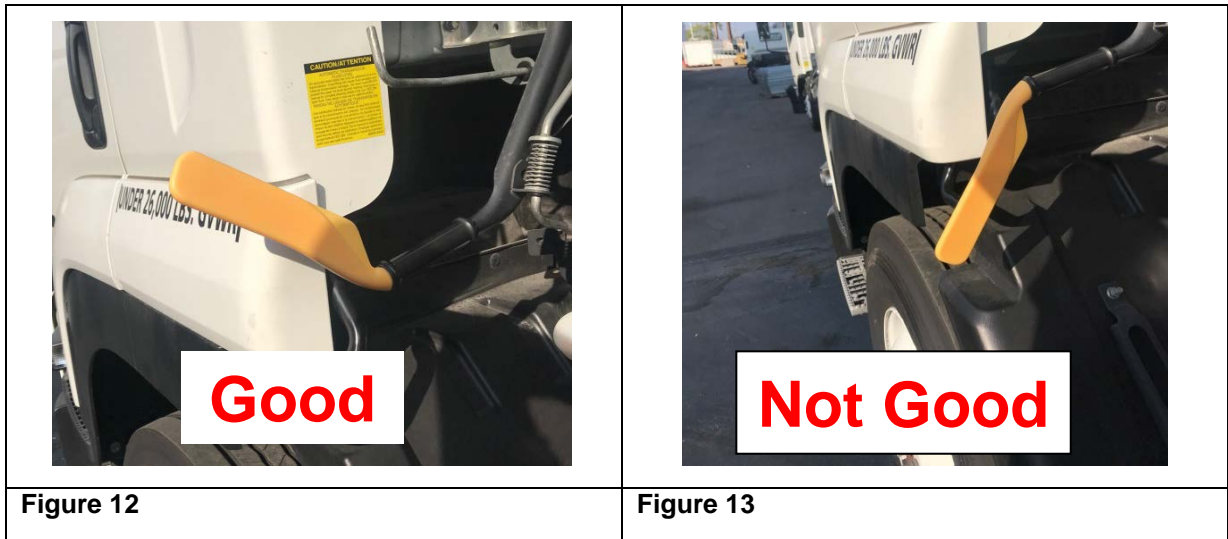
11. Test fit the cab unlock marker into the hollow end of the cab lock lever handle grip. It may be easiest to install the marker where it locks in by twisting in place. However, the marker needs to have the end pointing upwards at final installation (See Figures 12 and 13).

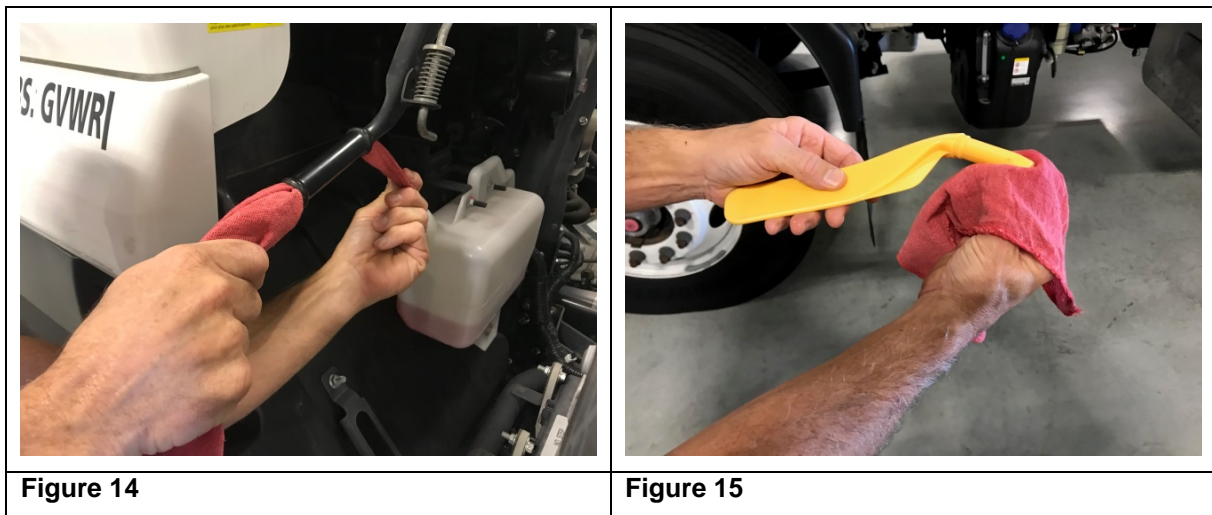
13. Clean the inside of the hollow grip area of the cab locking lever using isopropyl (rubbing) alcohol and a clean shop towel (See Figure 14). Clean the grip area of the cab unlock marker with the same towel (See Figure 15).

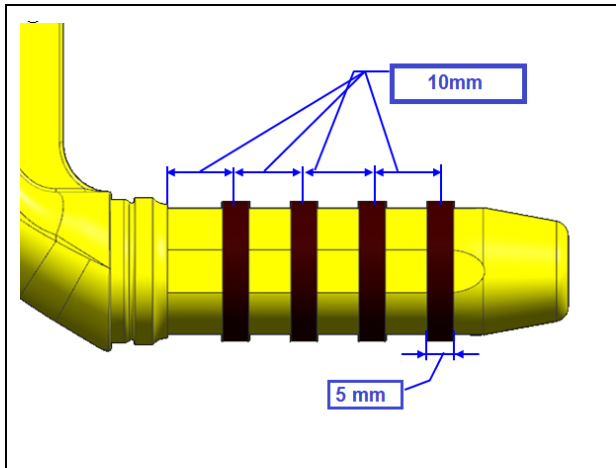
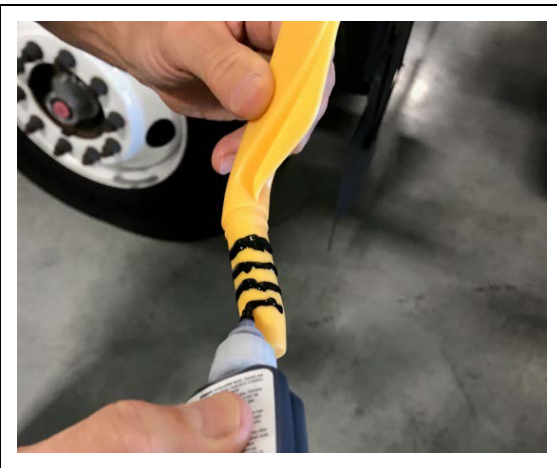
14. Apply Loctite 4211 adhesive in approximately 5mm beads placed about 10mm apart on the grip area of the cab unlock marker (See Figures 16 and 17).

***IMPORTANT: Make sure to insert the cab unlock marker into the tilt cab locking lever grip and adjust the position within two (2) minutes and then adjust the position within two (2) minutes. The adhesive starts to cure immediately and will be fully set within four (4) minutes.***

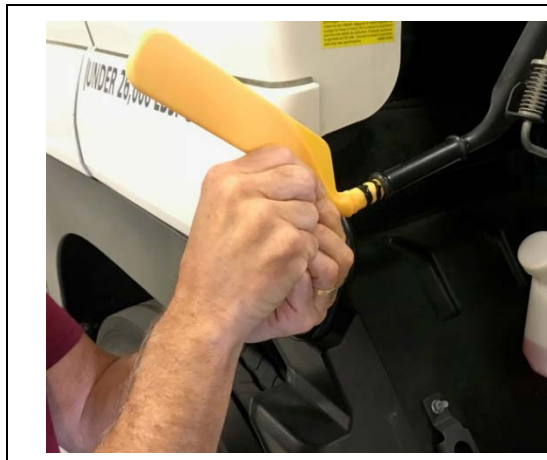
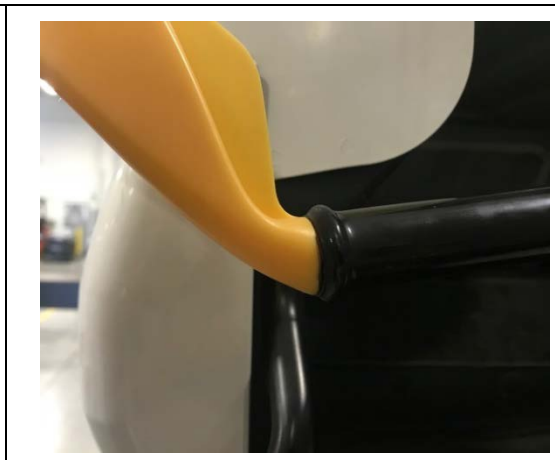
15. Insert the cab unlock marker into the tilt cab locking lever grip with the end pointing upwards and parallel with the rear of the cab (See Figure 18). Push on the marker until it locks fully into place (See Figure 19). Twist the marker as necessary to lock it in place, but ensure it is pointing upwards when locked in. Wipe off any excess adhesive.

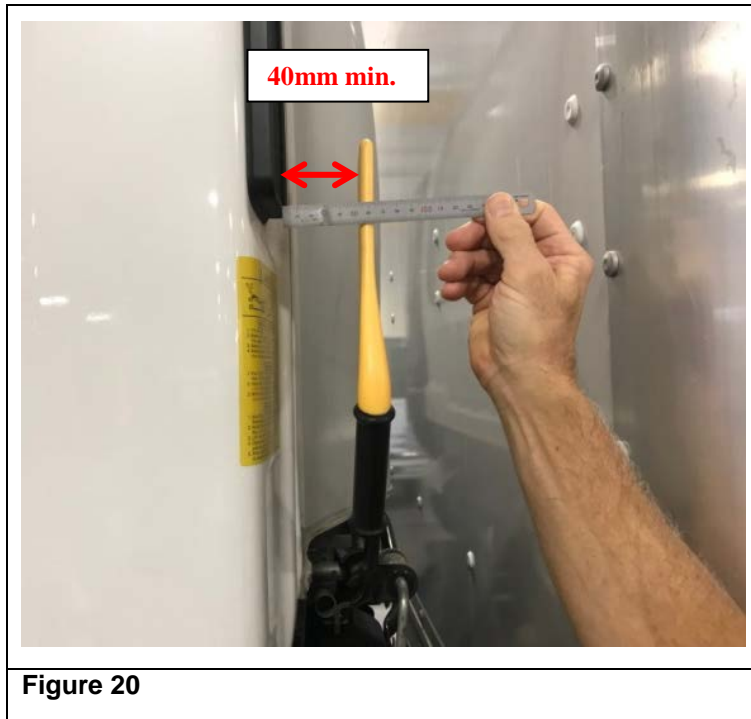
17. Ensure that the end of the cab unlock marker is at least 40mm from the ventilation duct at the rear of the cab (See Figure 20). Adjust the marker by slightly twisting it clock-wise as necessary. Any adjustments must be made within four (4) minutes, otherwise the adhesive will set.

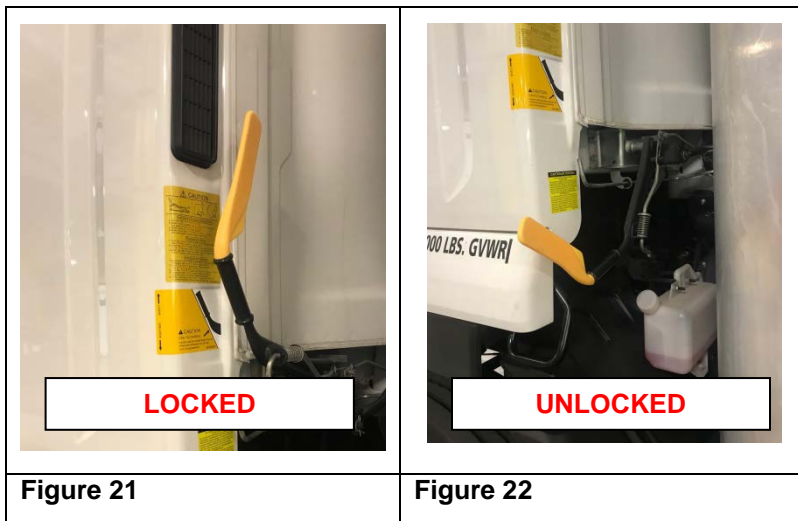
18. When the cab lock lever is properly locked (as shown in Figure 21) the handle will match its correct positioning as noted on the tilt lock caution label. Figure 22 shows the cab lock lever is in its unlocked position.
