November 9, 2018

Heartland Warranty
2831 Dexter DR
Elkhart IN 46514

In an effort to clarify the warranty procedure so that information can be accurately reported, and create as little confusion as possible please follow the following Guidelines in completing this recall.

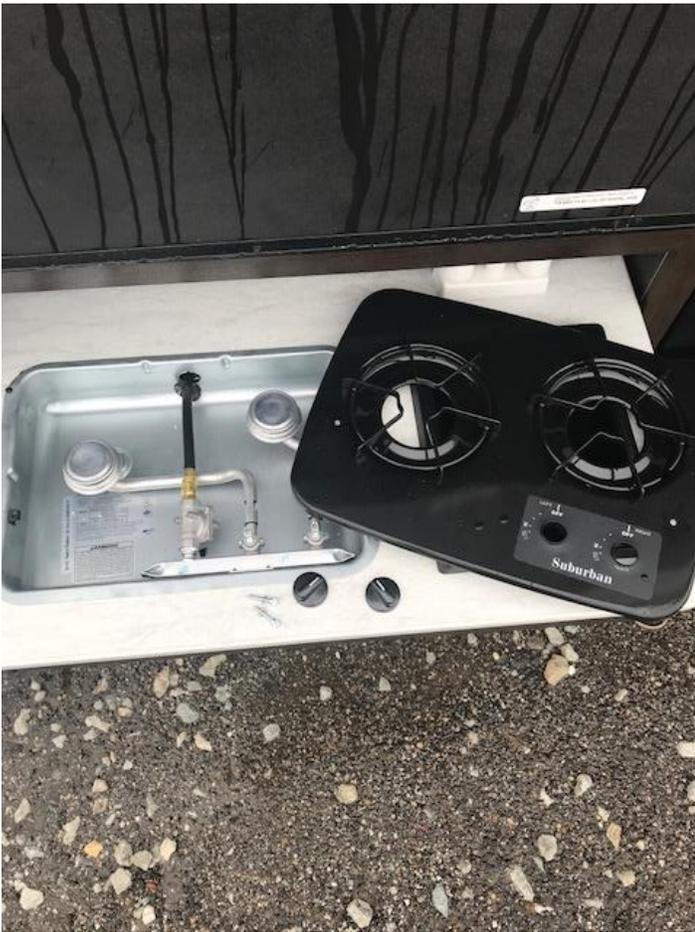
Pull out the tray which holds the two burner cooktop.

Remove the grill grates, burner knobs, and 2 silver cover screws.

Then remove the black cover plate to expose firebox and LP line connection.

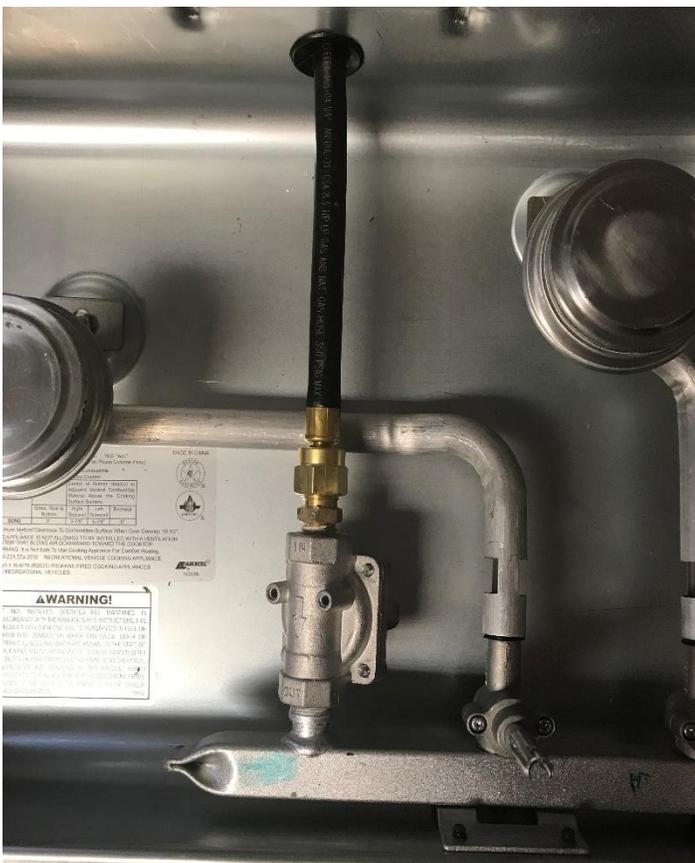
The internal burner box should look similar to the image on the left.

Make sure the gas is turned off at the main bottles, and the quick disconnect LP line from the cooktop is not attached to the system.

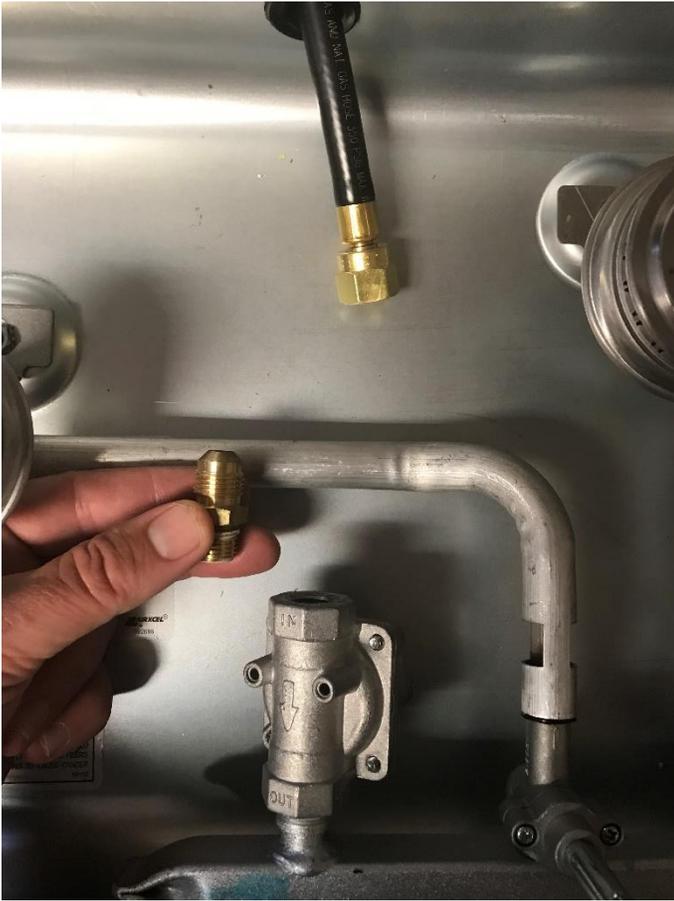
With an adjustable or open ended crescent wrench, disconnect the flex line from the flared coupler, as well as the coupler from the cooktop manifold.

The coupler can be discarded as it will not be used for the corrective action.

Pull the flex line out of the back of the burner box through the black grommet.

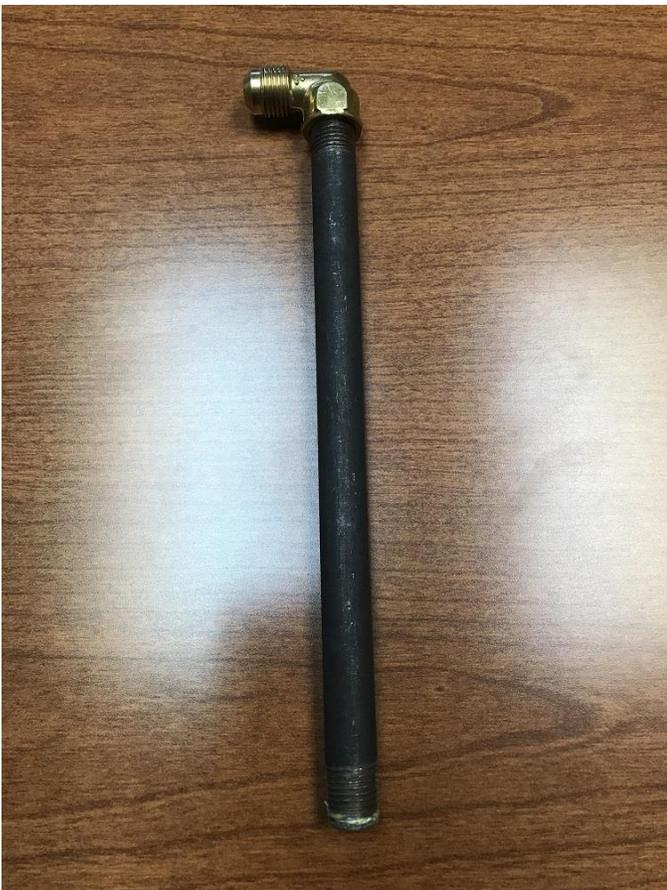
The image to the left is the supplied piece which will replace the flared coupler and create a rigid pipe section throughout the entire burner box of the 2 burner cooktop. The 90 degree elbow will be oriented outside of the cooktop burner box.

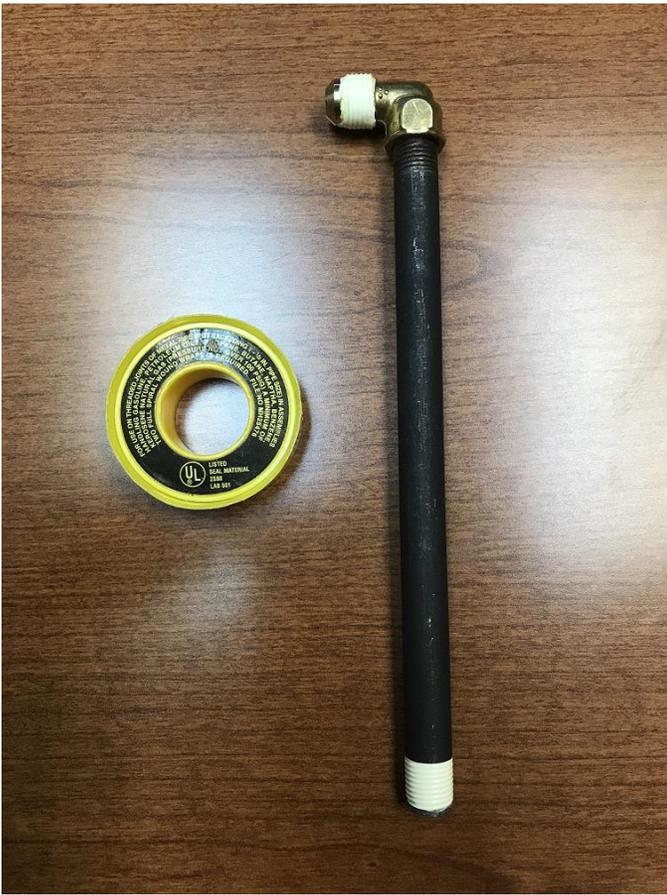
As a safety precaution, LP rated Teflon tape or pipe dope may be used to ensure a tight connection.

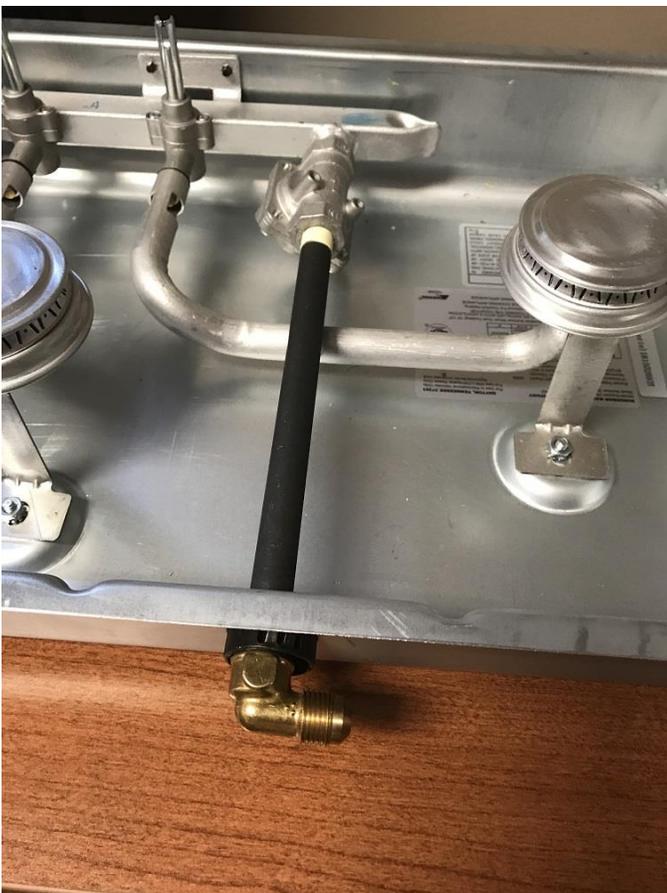
Note: in order to install the new pipe section, the 90 degree elbow can be fed through the grommet at the back of the burner box, or for easier installation, the entire 2 burner cooktop can be removed from the pullout tray by removing the screws from the side flange. (Cooktop removed in this image for visual clarification.)

Once the pipe is fed through the grommet with the 90 degree elbow out the back of the burner box, insert the threaded end into the cooktop manifold and turn to tighten. Make sure all fittings are completely tightened with a crescent/ open wrench. Please note the configuration of the 90 degree elbow can be facing any direction but upward.

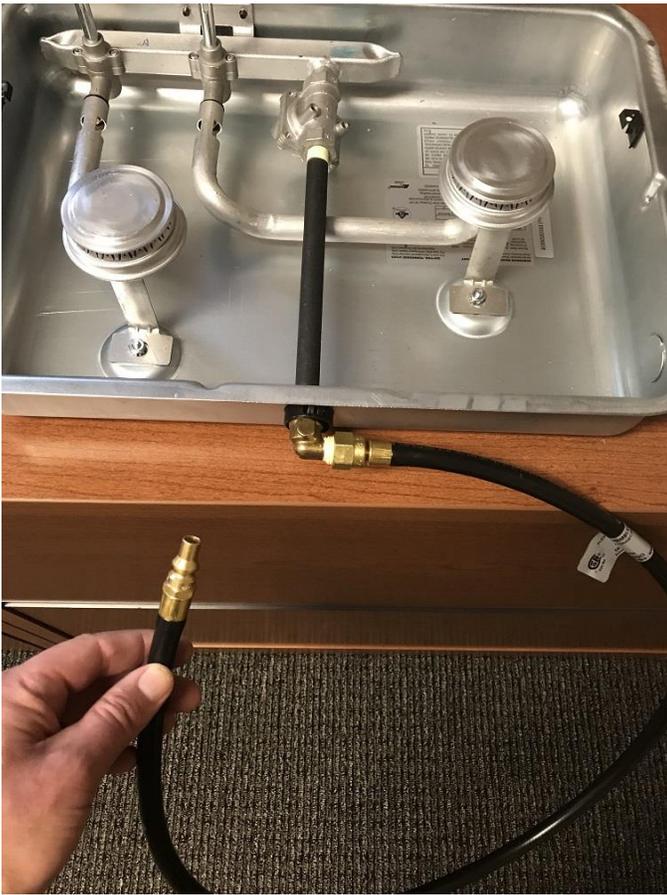
The female portion of the quick disconnect hose can now be attached to the threaded end of the 90 degree elbow, and again wrench tightened.

The other end (left hand) is for connection to the main system via the quick disconnect.

This completes the gas line portion of the corrective action. If the cooktop has been removed from the pullout tray, it can be placed back in and secured.

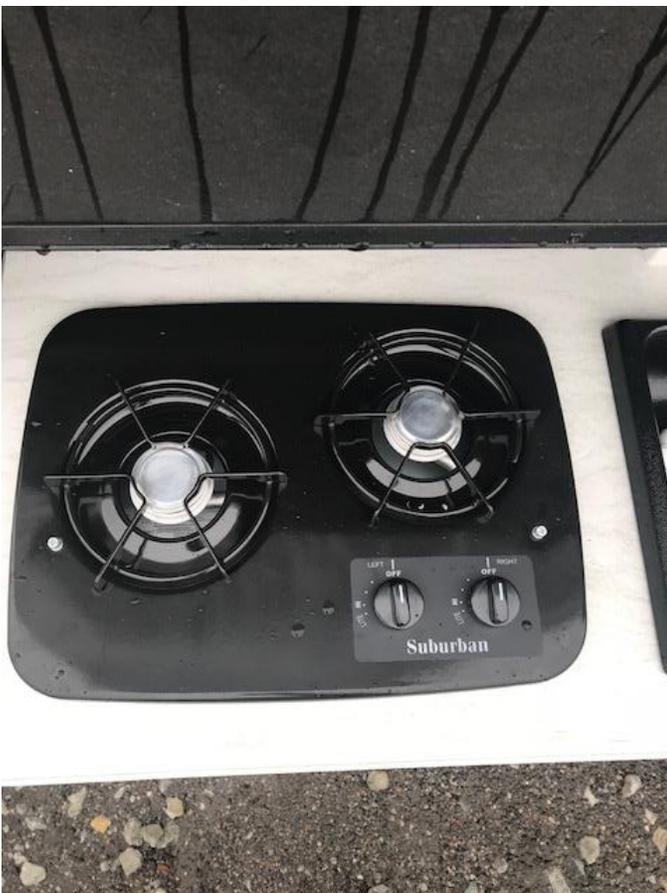
Note: At this point it is recommended to attach the quick disconnect gas line to the LP system, turn on the gas, (not at the cooktop itself, just the main system and the shut off valve at the quick disconnect) and test for leaks around the connection in the burner box with a soapy water solution. (If bubbles are evident, re-check and ensure all connections are tight/secure)

Once verified that all connections are sealed, turn off gas, unhook the quick disconnect line from the LP system. The black cover plate, silver cover screws, knobs and grates can all be reinstalled.
