GROUP <b>Safety Recall Campaign</b>	MODEL <b>2019MY Forte (BDm)</b>
	NUMBER <b>SC171 (Rev 1, 01/04/2019)</b>	DATE <b>December 2018</b>
<b>SAFETY RECALL CAMPAIGN</b>		
SUBJECT: <b>LED HEADLAMP INSPECTION AND REPLACEMENT (SC171)</b>

## LED HEADLAMP INSPECTION AND REPLACEMENT (SC171)

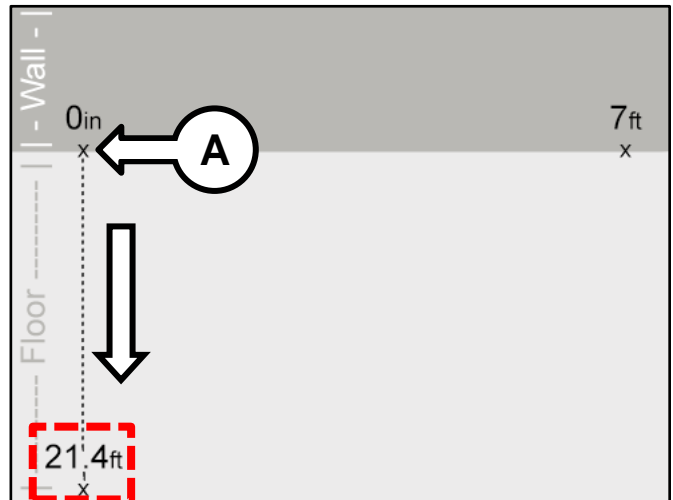
2. From the 0in mark (A) at the wall, measure and mark a spot 21.4ft. (257.25in.) away from and perpendicular to the wall.

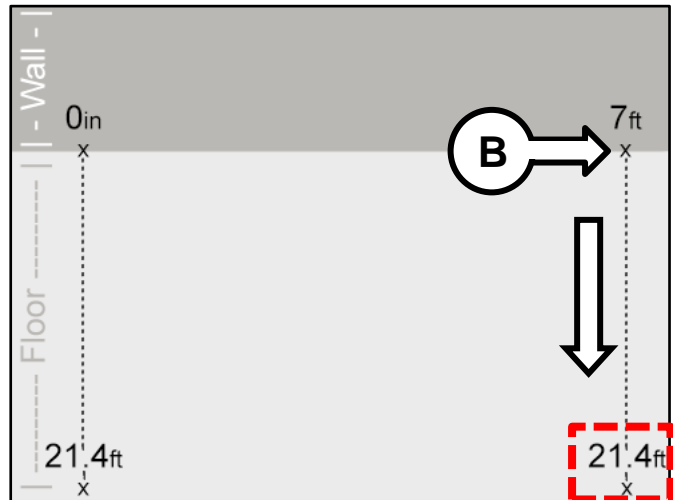
3. Repeat step 2 but from the 7ft. mark (B) at the wall.

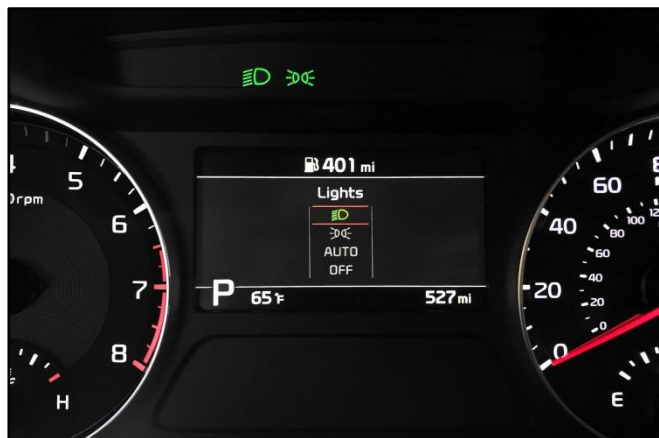
6. Start the vehicle and turn on the low beams.

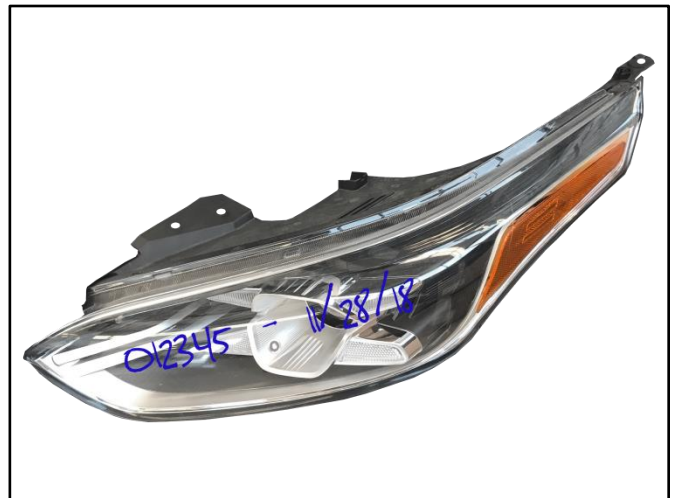
Example shown -

2. With a permanent marker, clearly write the last six numbers of the VIN and RO open-date on the lens.

- Last six of VIN: 012345
- RO Open Date: 11/28/18

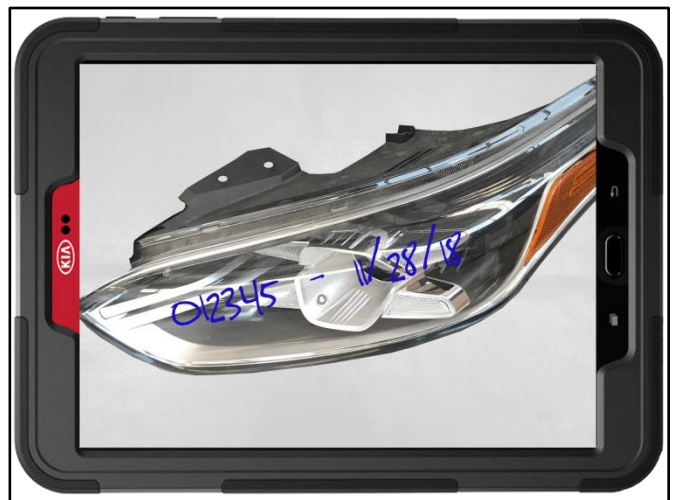
3. Take and submit one (1) KVID\* photo of each drilled and marked headlamp to attach to Warranty claim.
  - Drilled hole, last six of VIN, and RO open date **MUST** be clearly visible in photo(s).
    - If replacing one headlamp **one** photo is required for warranty claim submission.
    - If replacing both headlamps **two** individual photos are required for warranty claim submission.

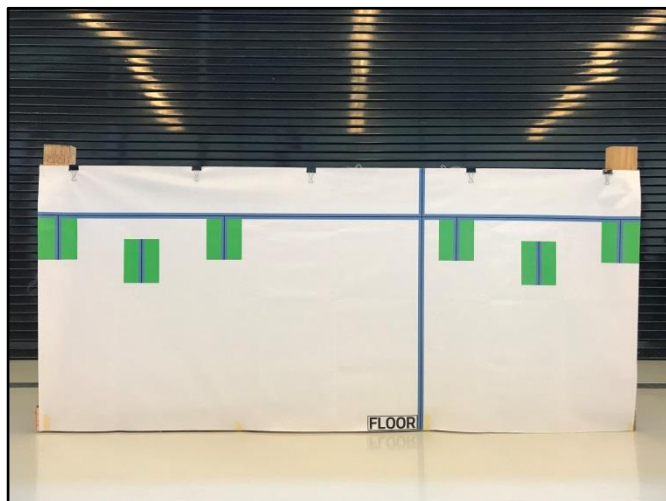
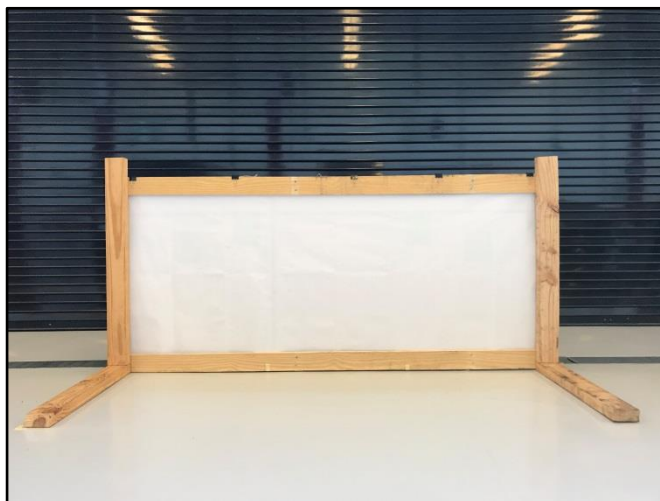
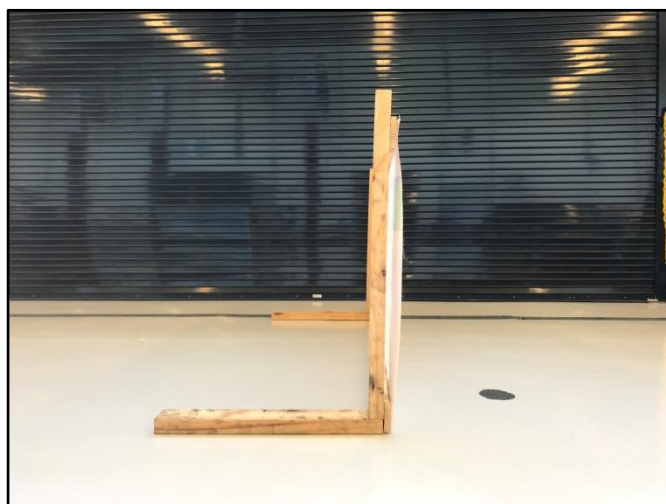
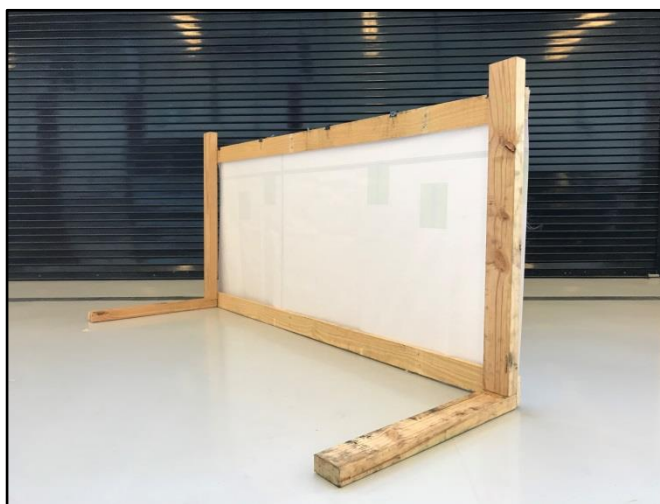
**Attachment 1:**

\*If a blank wall is not available, refer to Attachment 1 on page 8 for an example of a custom mobile stand.
