Safety Recall: Power Sliding Door Rear Latches

Year	Model	Trim	VIN Range
2018-19	Odyssey	ALL except LX	Check the iN VIN status for eligibility.

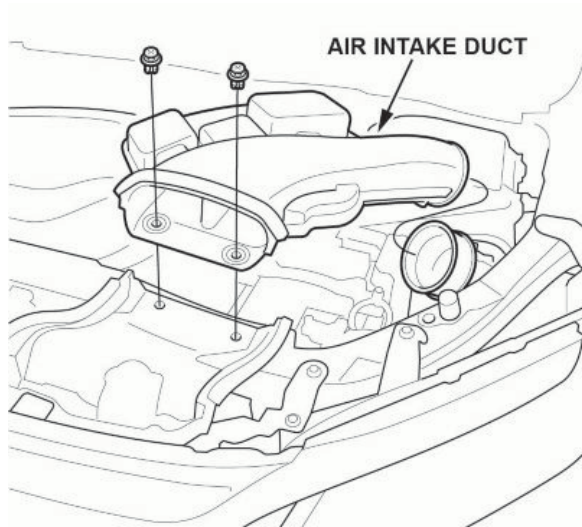
2. Lower both power sliding door windows to the fully open position.
3. Remove the air intake duct.

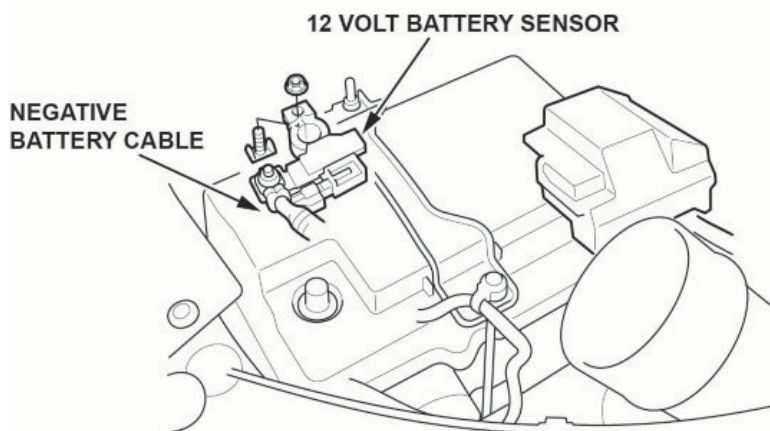
4. Disconnect the 12-volt battery.

- Always disconnect the negative terminal first.

- To protect the battery sensor connector from damage, do not hold it when removing the terminal.
 - Do not disconnect the 12-volt battery sensor from the cable.
- 4.1. Make sure the ignition is turned to OFF.
 - 4.2. Disconnect and isolate the negative cable with the 12-volt battery sensor from the 12-volt battery.

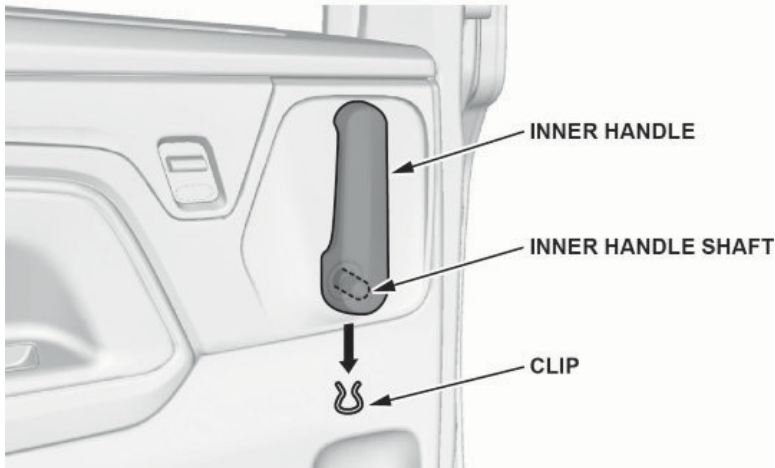
5. Using a wire hook, pull the clip off of the inner handle shaft, and remove the inner handle.

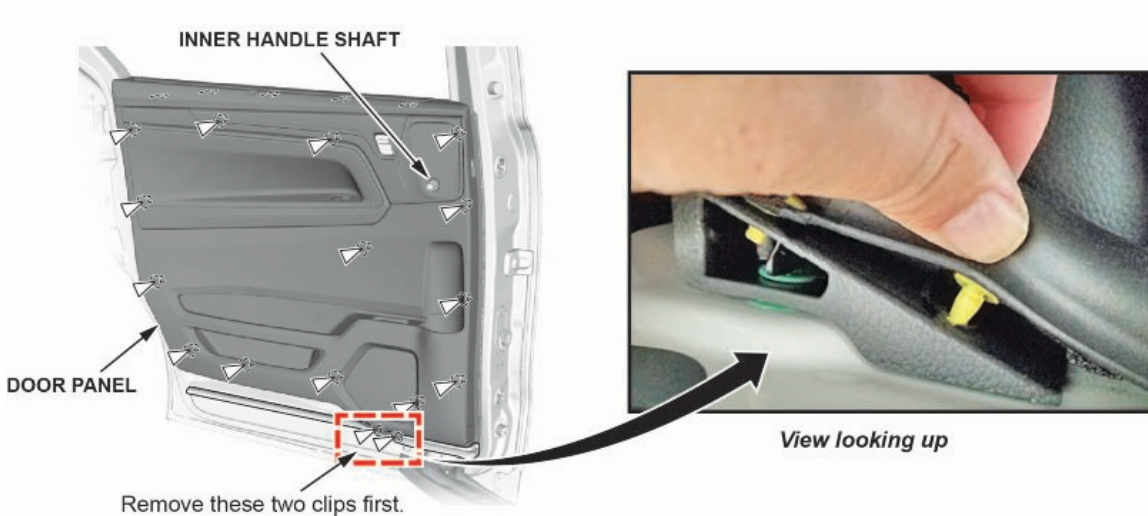
6. Remove the two clips at the bottom of the door panel first to release the lower door seal from the door panel.

Removing the two clips prevents pulling the door seal off of the door as the door panel is lifted and removed.

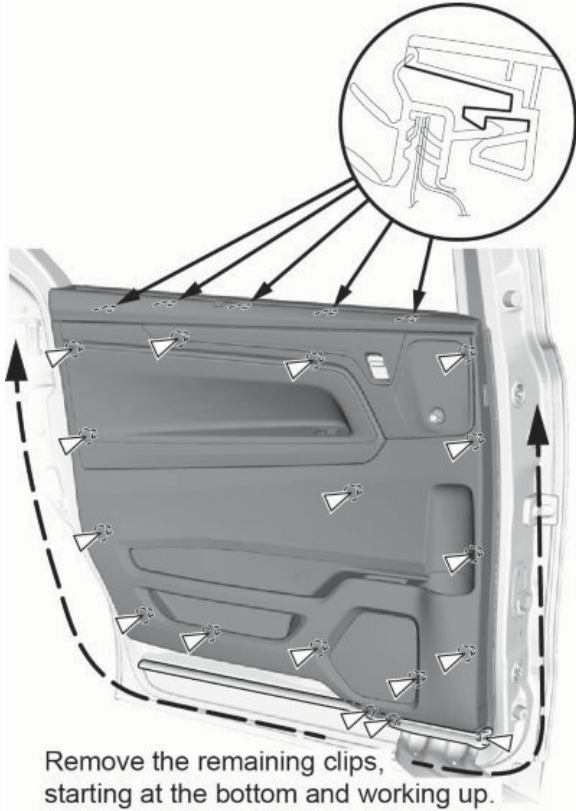
7. Starting at the bottom edge of the door panel, remove the remaining clips with a commercially available trim pad remover.

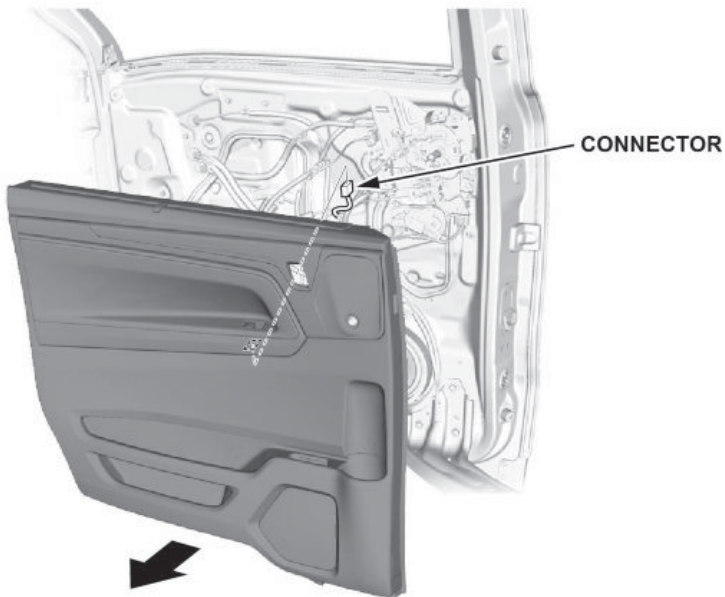
8. Starting at the rear, pull the door panel upward while making sure the clips from step 6 are free and not pulling on the lower door seal. Pull the door panel away from the inner handle shaft, and lift it upward.
9. While holding the sliding door panel away from the door, disconnect the connector. Then, remove the door panel.

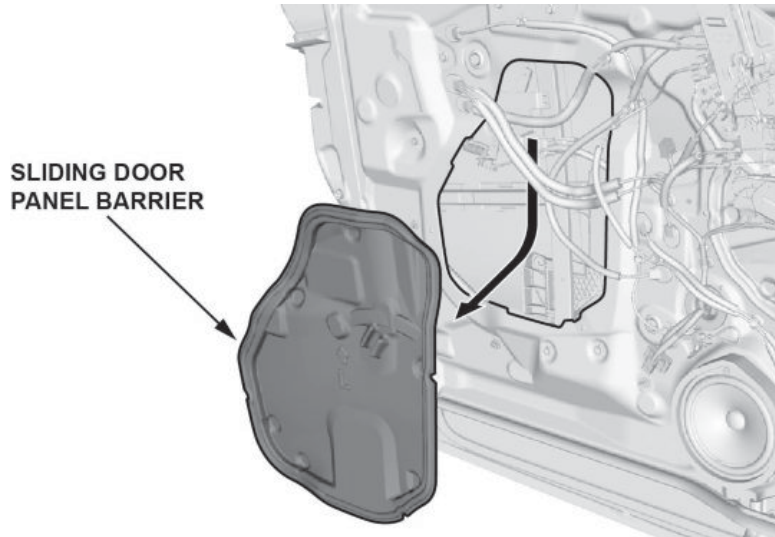
10. Remove the sliding door panel barrier.

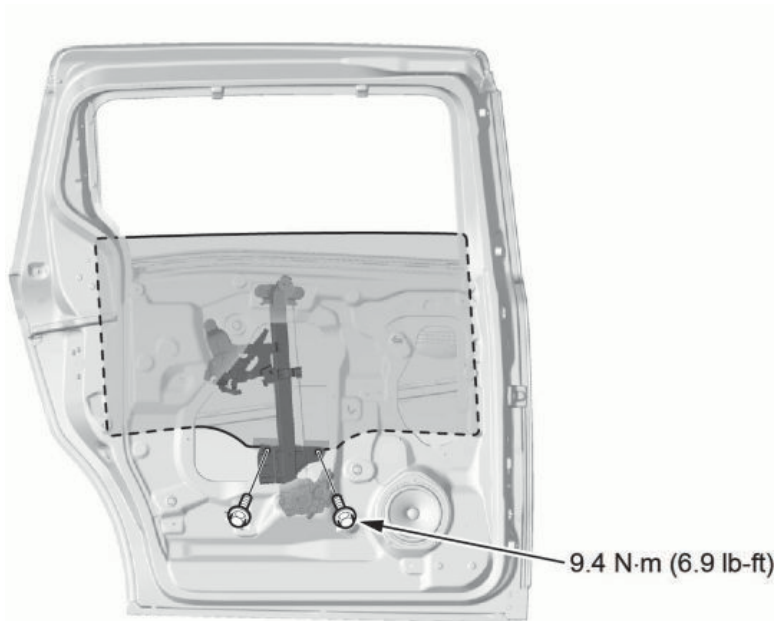
11. Remove the sliding door glass bolts from the regulator.

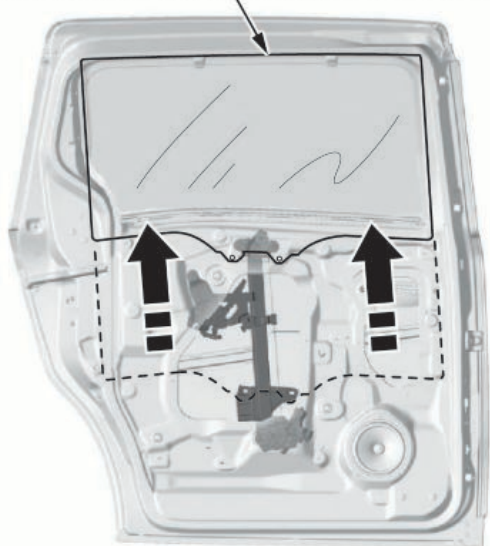
12. Slide the window up, and apply low-tack tape to the outside of the glass and the sliding door as shown to hold the window in the fully closed position.

Pull the window up to the fully closed position.

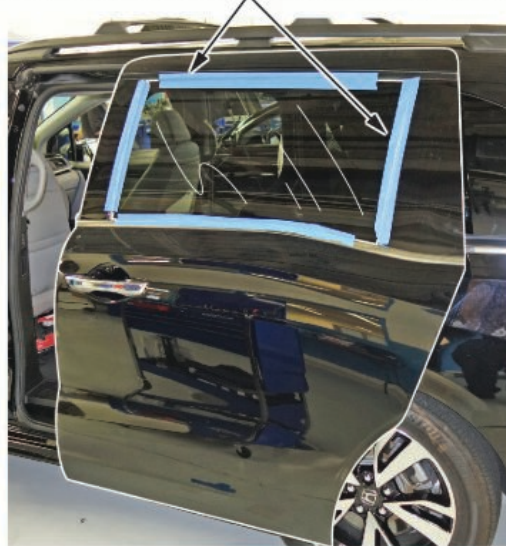
Apply tape on the outside to hold the window in place.

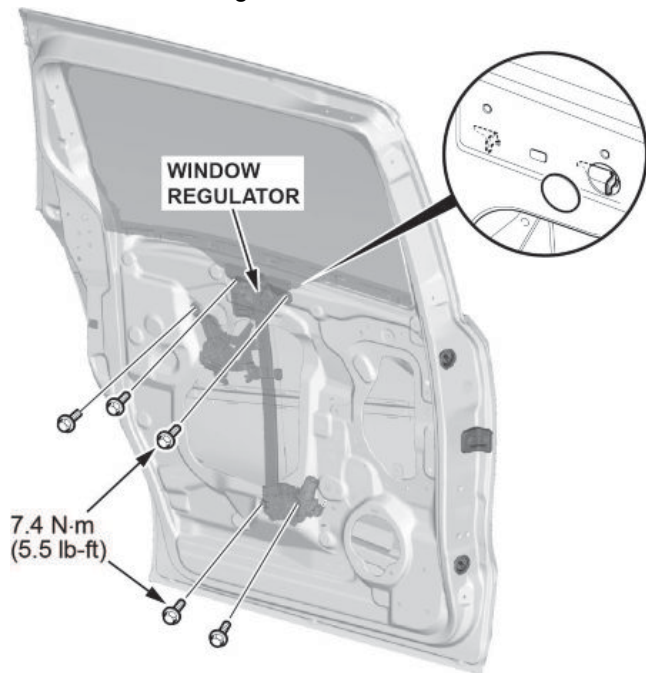
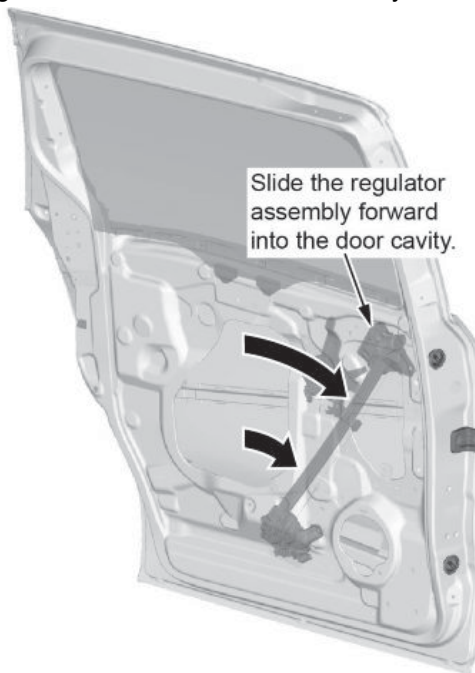
13. Remove the five regulator bolts, and slide the window regulator forward into the door cavity as shown.

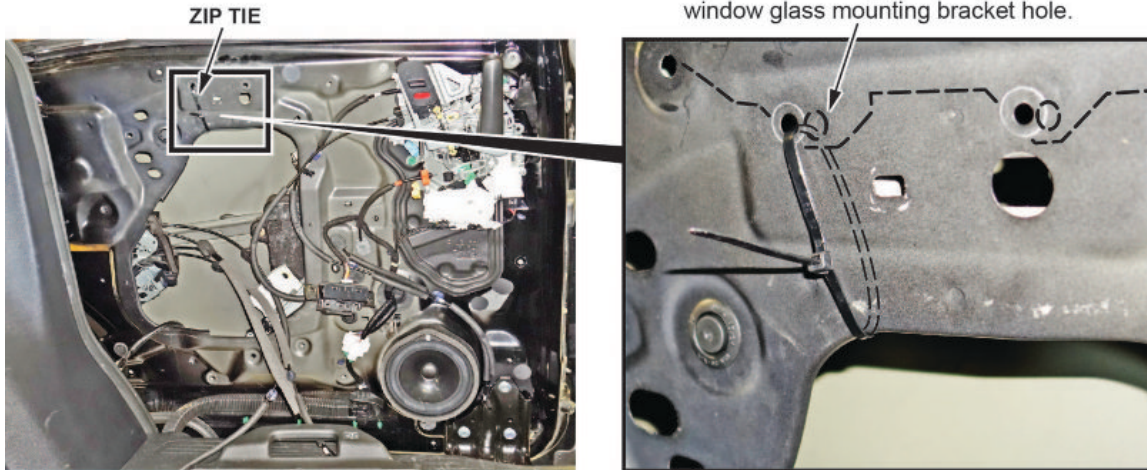
14. Install a zip tie through the window glass mounting bracket hole and the body as shown.

Loop the tie through the body and the window glass mounting bracket hole.

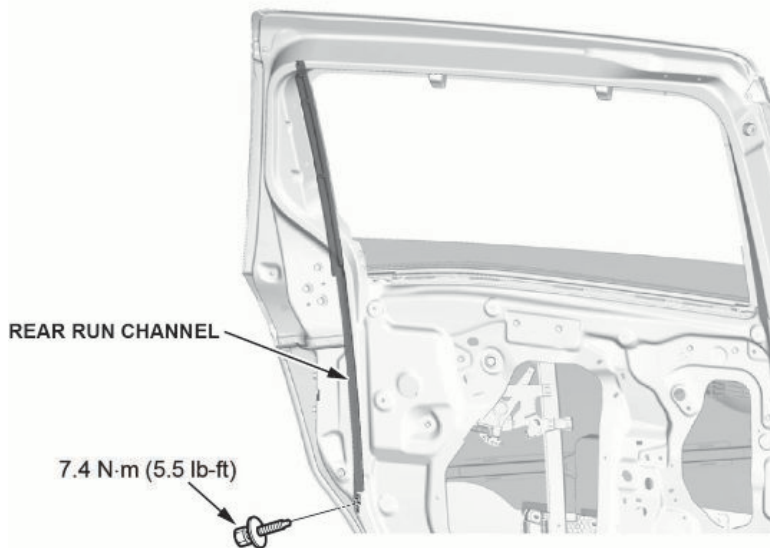
15. Remove the lower bolt from the sliding door rear run channel.

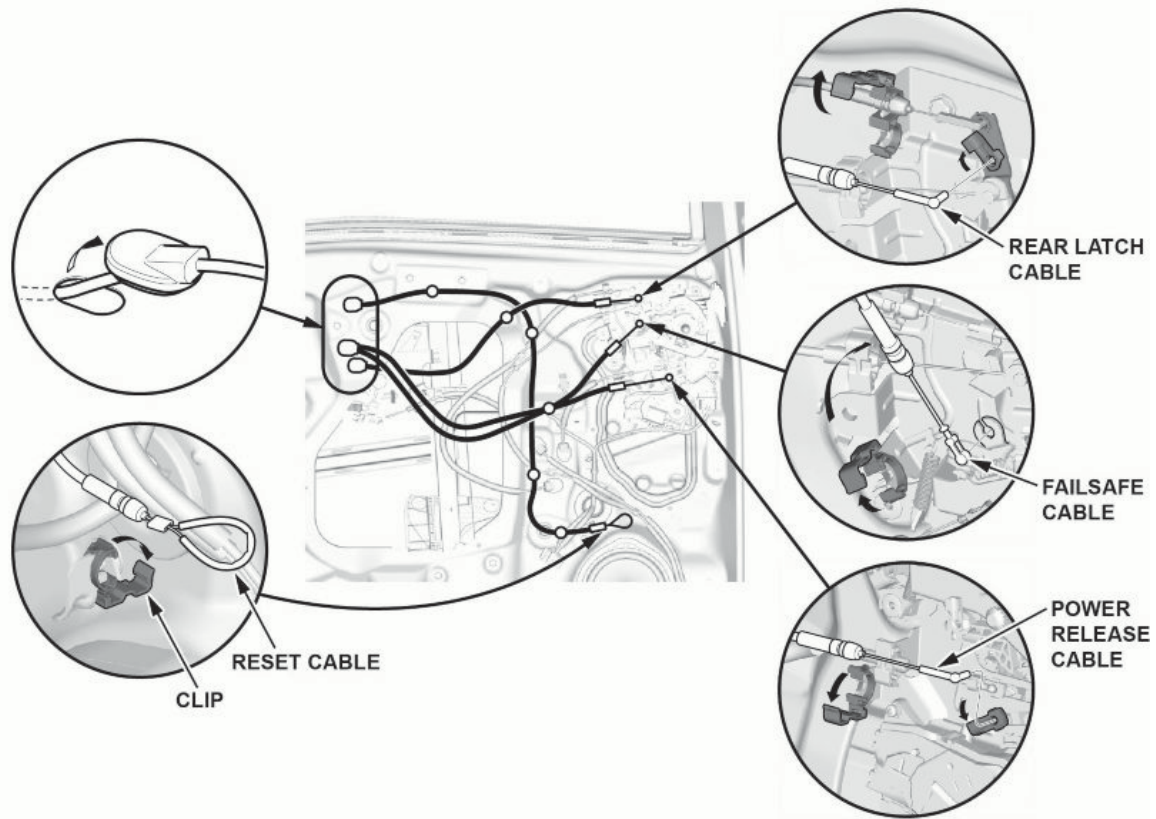
16. Release the cable holders and the cable fasteners.

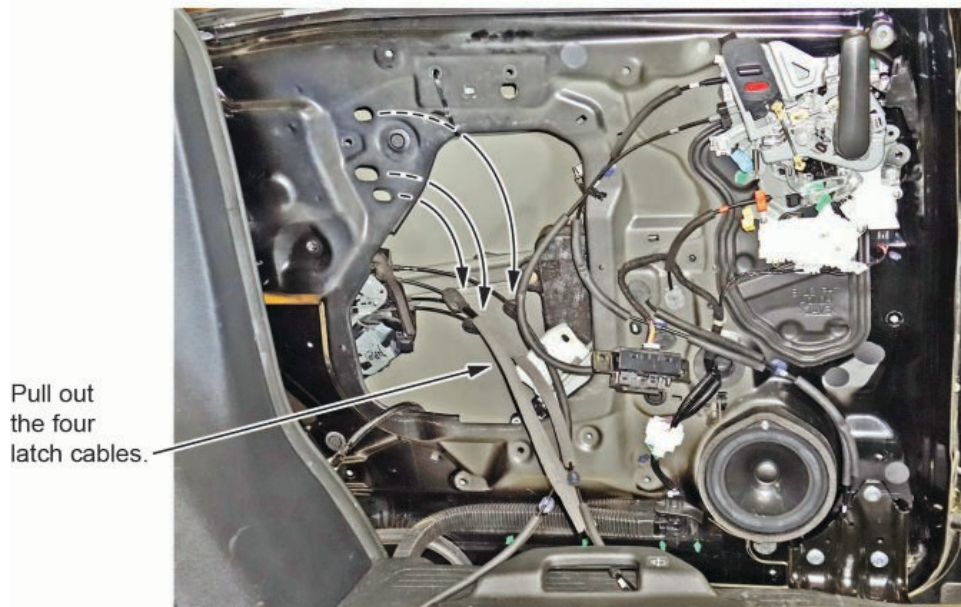
17. Disconnect the rear latch cable, the failsafe cable, the power release cable, and the reset cable.

18. Push the cable grommets in through the cable openings. Then, pull the cables into the door cavity and out through the sliding door panel barrier opening.

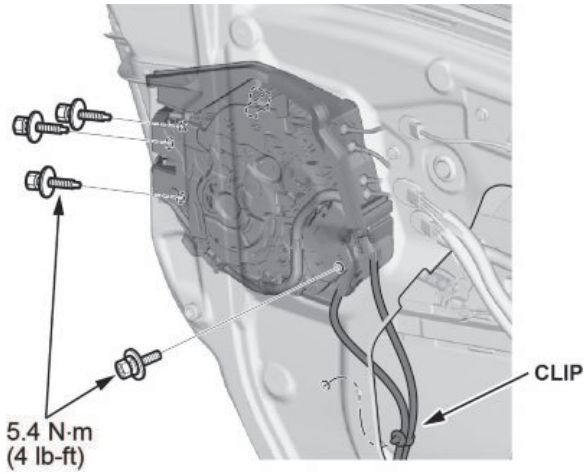
19. Remove the four rear latch fastener bolts and the clip.

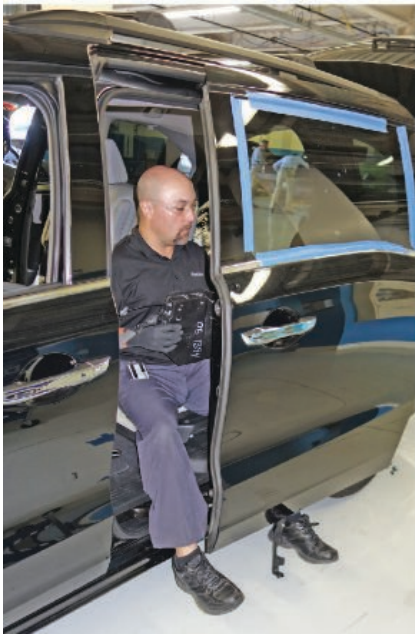
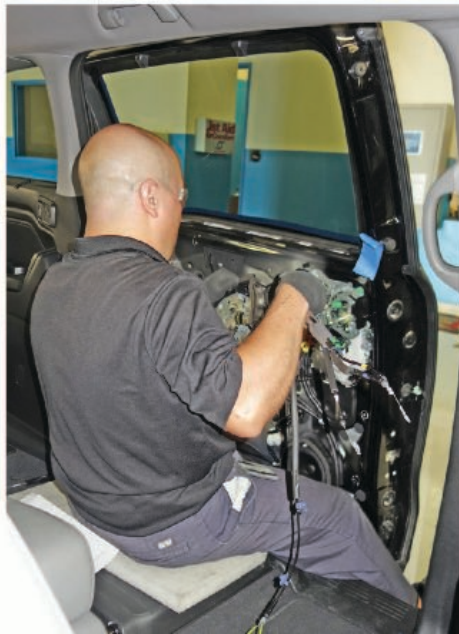
20. Sit in the open door with one leg on either side of the lower roller bracket, and pull the door forward to access the rear latch opening as shown.

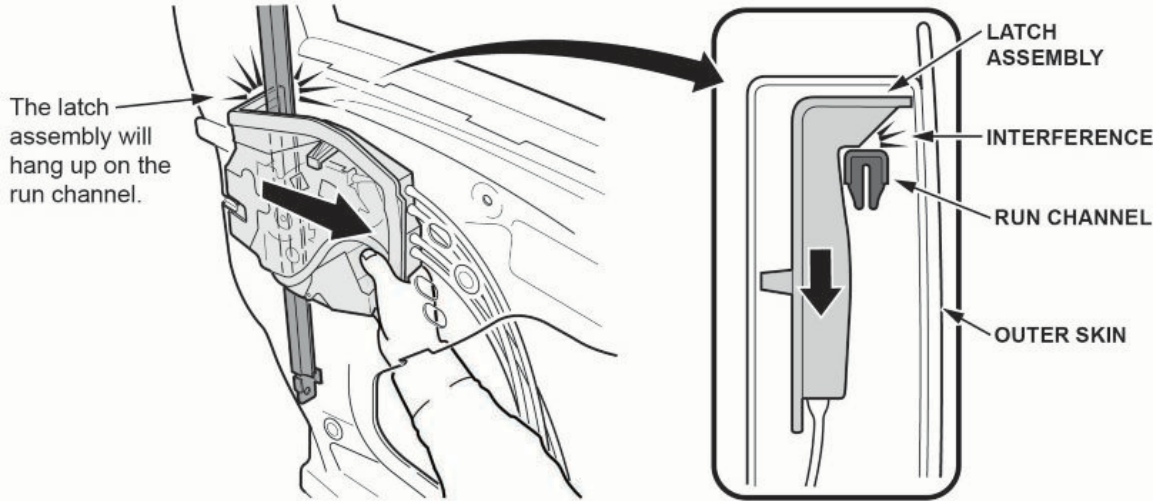
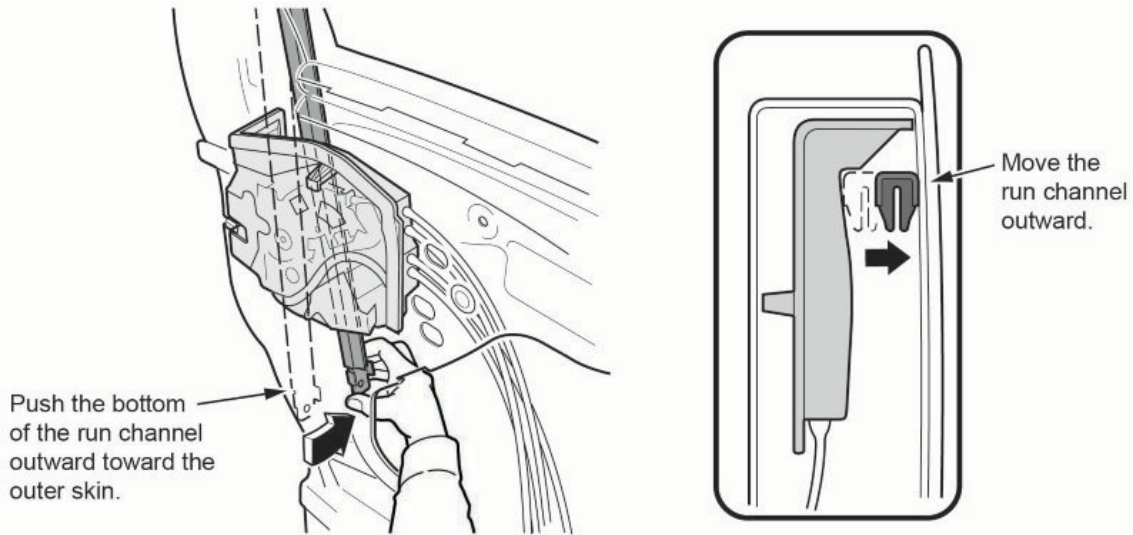
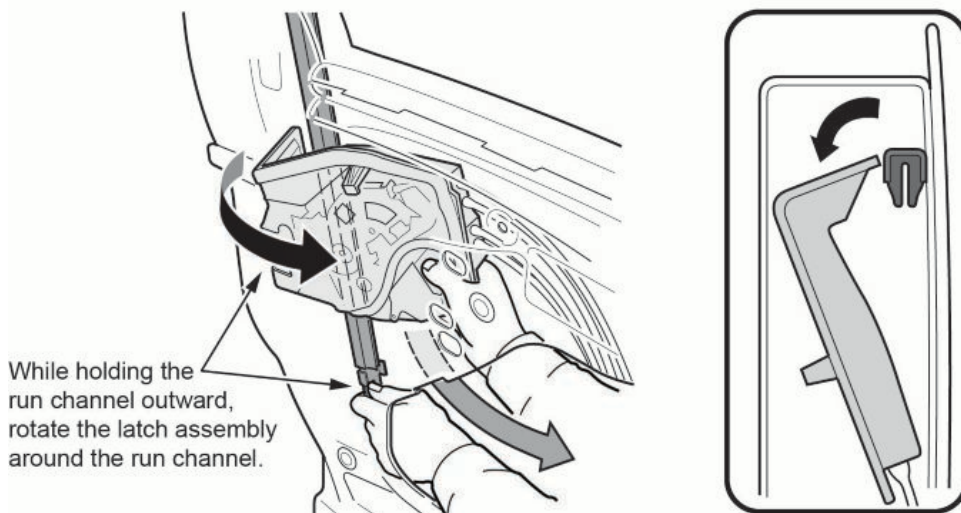
21. While pushing the bottom of the sliding door rear run channel outward, pull the rear latch forward into the door cavity.

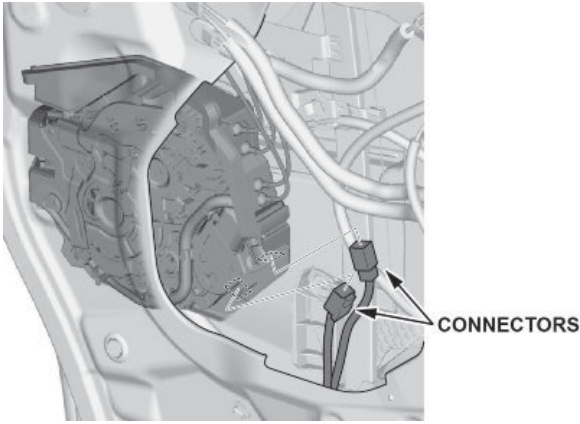
22. Once the latch is in the opening, disconnect the connectors, then remove the latch.

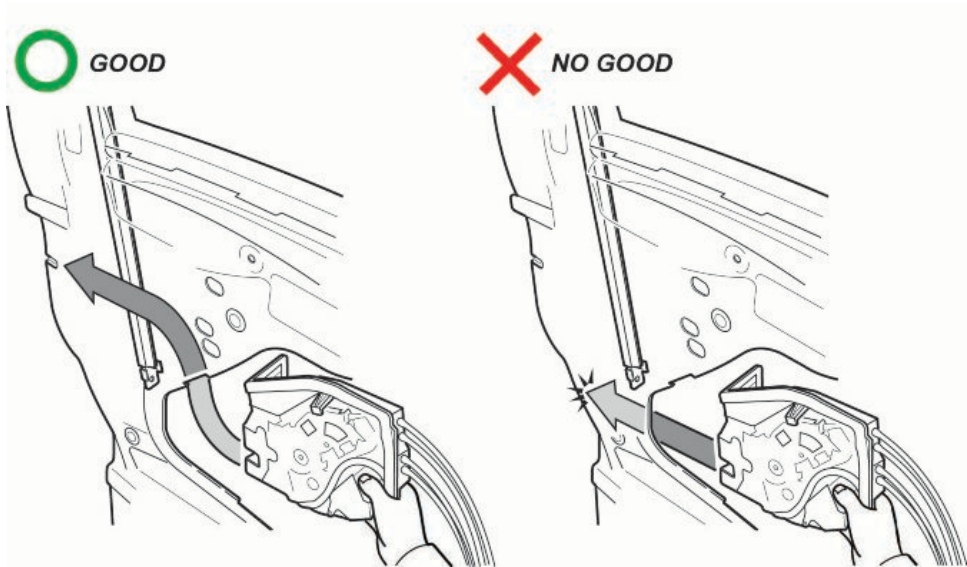
24. While pushing the bottom of the sliding door rear run channel outward, push the new latch rearward, rotating it around and behind the run channel, lining up the latch mechanism with the latch opening in the door skin.

The latch cannot be inserted past the sliding door rear run channel if the latch is inserted below this position.

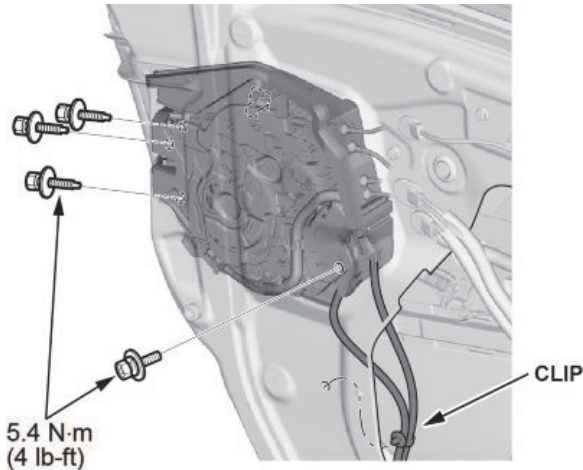
25. Install and torque the four rear latch fastener bolts to **5.4 N·m (4 lb-ft)**, and install the clip.

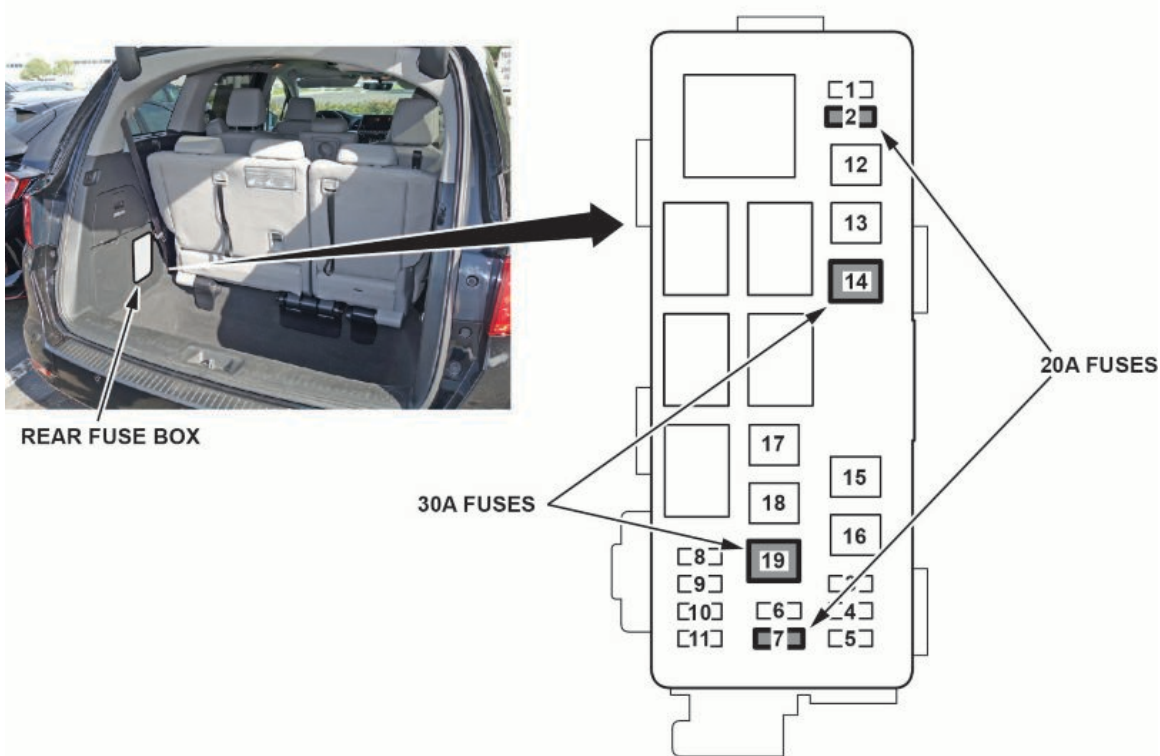
26. Install the remaining removed parts in the reverse order of removal, tightening all fasteners to the specified torque.
27. Repeat steps 5 thru 26 to replace the rear latch on the opposite door.
28. Remove the rear fuse box access panel. Check if fuses F2, F7, F14, and F19 are installed.
 - If the fuses are installed, go to step 30.
 - If the fuses are not installed, go to step 29.

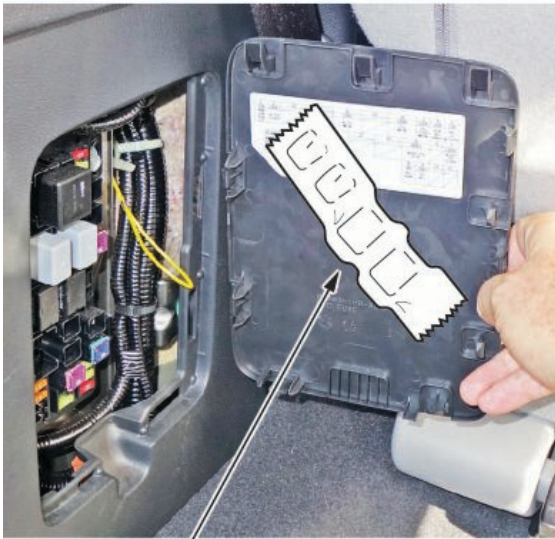
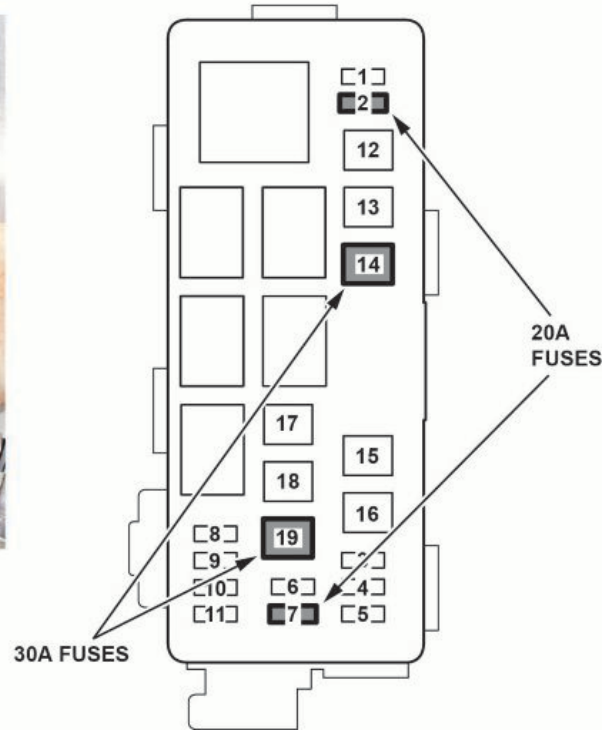
29.1. The fuses should be taped to the inside of the fuse box panel. Remove the fuses from the tape and install the 20 amp fuses into the F2 and F7 locations, then install the 30 amp fuses in locations F14 and F19.

REMOVED FUSES TAPED TO THE INSIDE OF THE REAR FUSE BOX PANEL

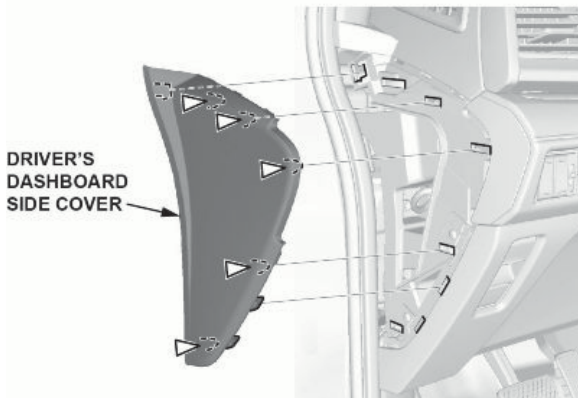
29.2. Remove the driver's dashboard side cover.

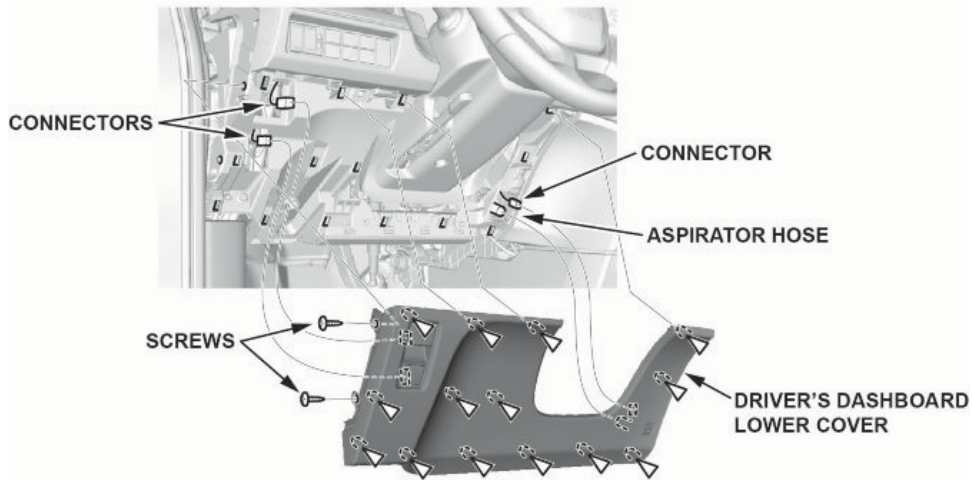
29.3. Remove the driver's dashboard lower cover.

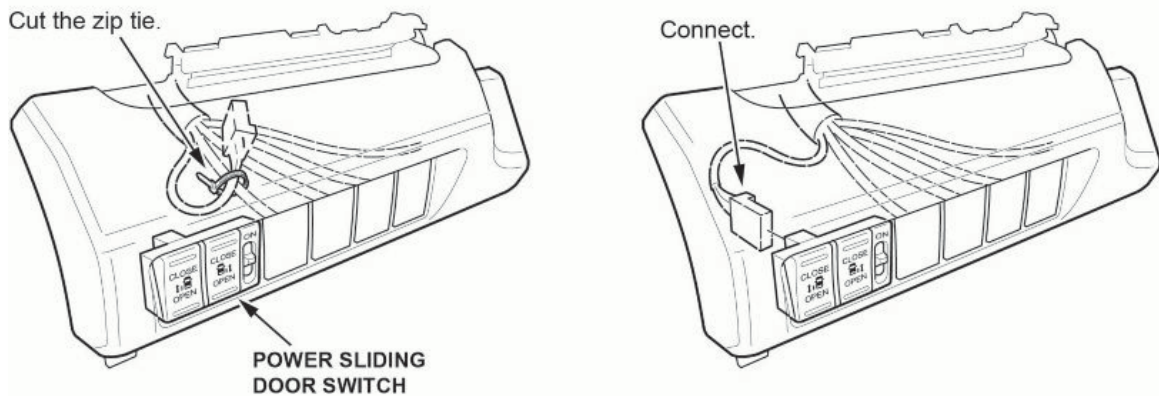
29.4. Cut the zip tie, and connect the power sliding door main switch connector.

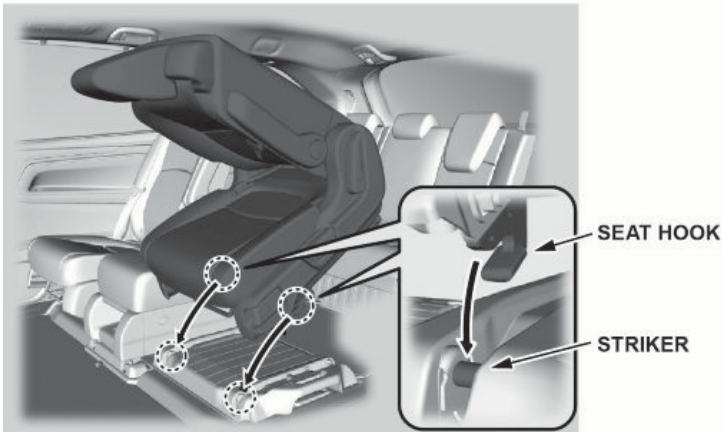
31.1. Insert the front seat hooks into the front floor strikers.

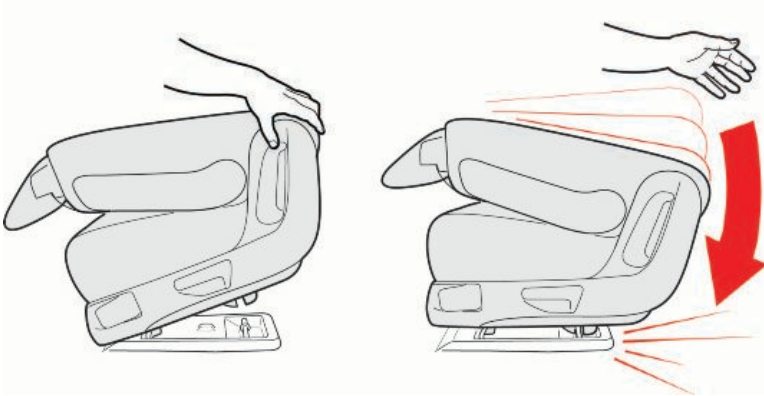
31.2. After confirming both front hooks are fully inserted into the front strikers, begin to lower the seat then allow it to drop and lock to the rear strikers.

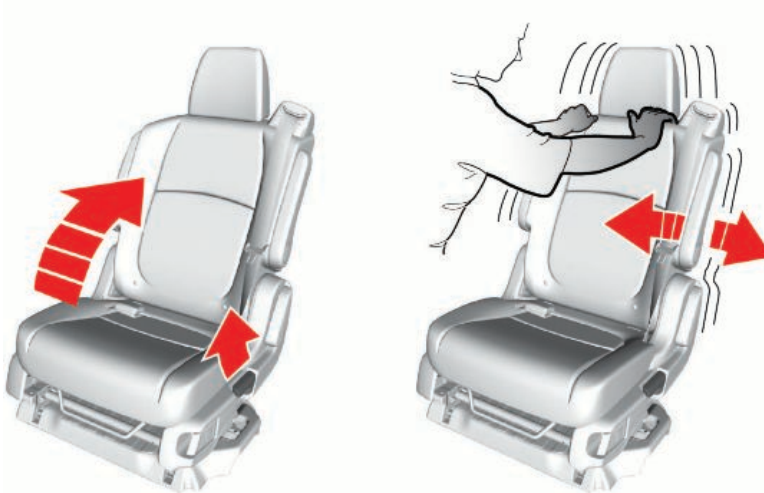
31.3. Raise the seat-back to an upright position, then rock the seat back and forth to confirm both the inner and outer latches are securely locked into position.

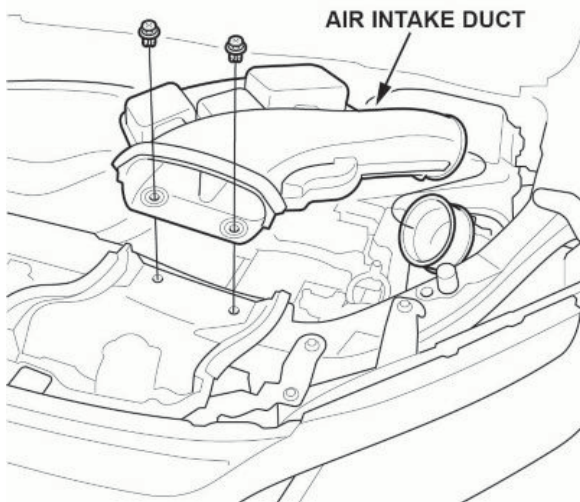
- **Make sure the service advisor has received the customer's approval before doing the POWER SLIDING DOOR DISABLE PROCEDURE.** For more information, refer to Job Aid [Safety Recall: Power Sliding Door Rear Latches - Frequently Asked Questions](#).
 - Make sure you follow these steps in order to disable the power sliding door. If you do not, you may set DTCs and/or sliding door warning messages in the MID.
1. Close both power sliding doors, and confirm both the front and rear latches are fully engaged.
 - If both of the power sliding door rear latches fully engage, go to step 2.
 - If at least one of the power sliding door rear latches does not fully engage, **do not disable the power sliding doors**. Both rear latches must be replaced.
 2. Remove the air intake duct.

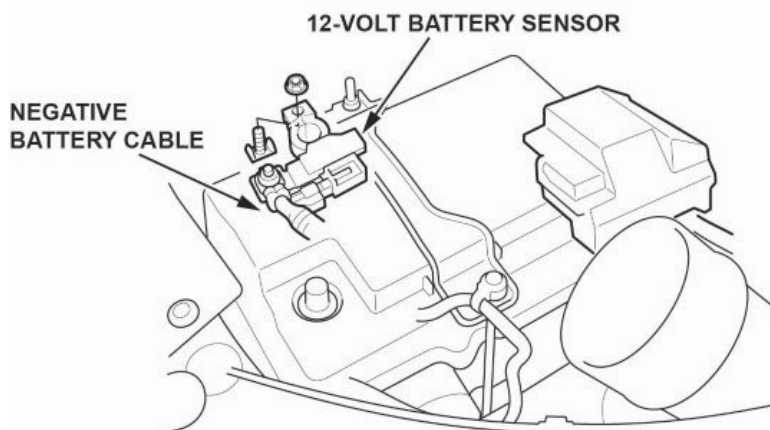
3. Disconnect the 12-volt battery.

- Always disconnect the negative terminal first.

- To protect the 12-volt battery sensor connector from damage, do not hold it when removing the terminal.
 - Do not disconnect the 12-volt battery sensor from the cable.
- 3.1. Make sure the ignition is turned to OFF.
 - 3.2. Disconnect and isolate the negative cable with the 12-volt battery sensor from the 12-volt battery.

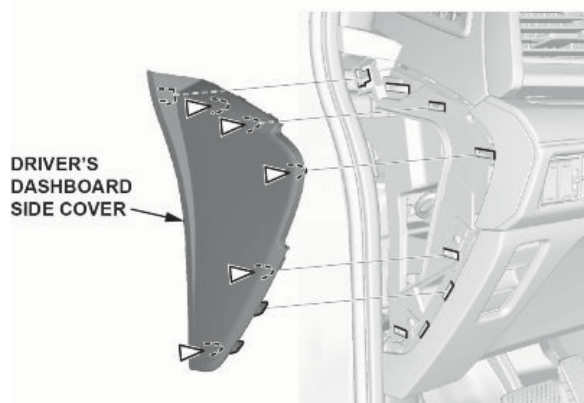
4. Remove the driver's dashboard side cover.

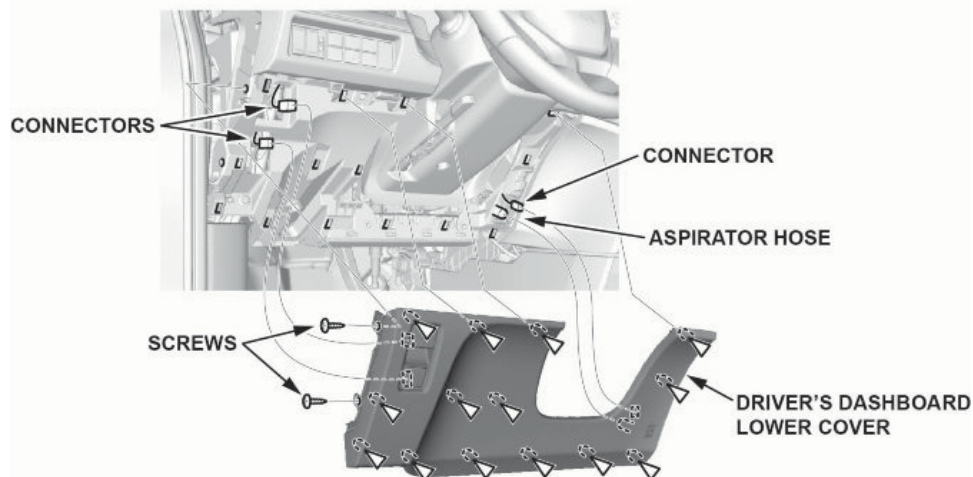
5. Remove the driver's dashboard lower cover.

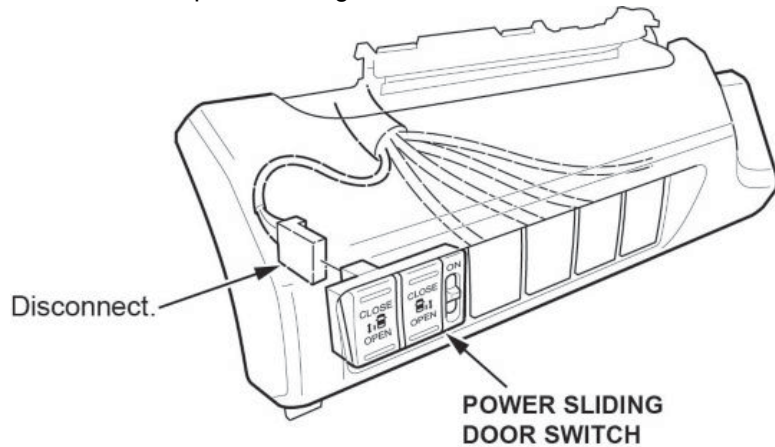
6. Disconnect the power sliding door main switch connector.

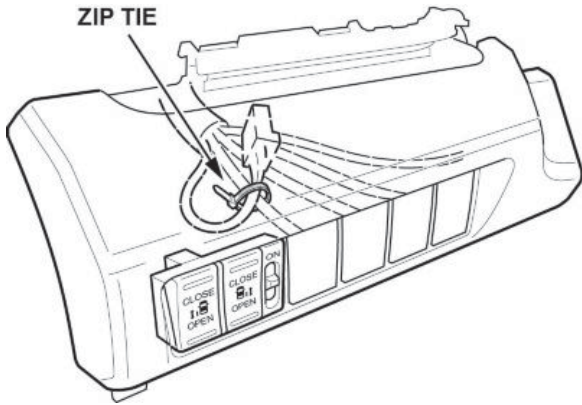
7. Secure the connector with a zip tie as shown to prevent it from rattling.

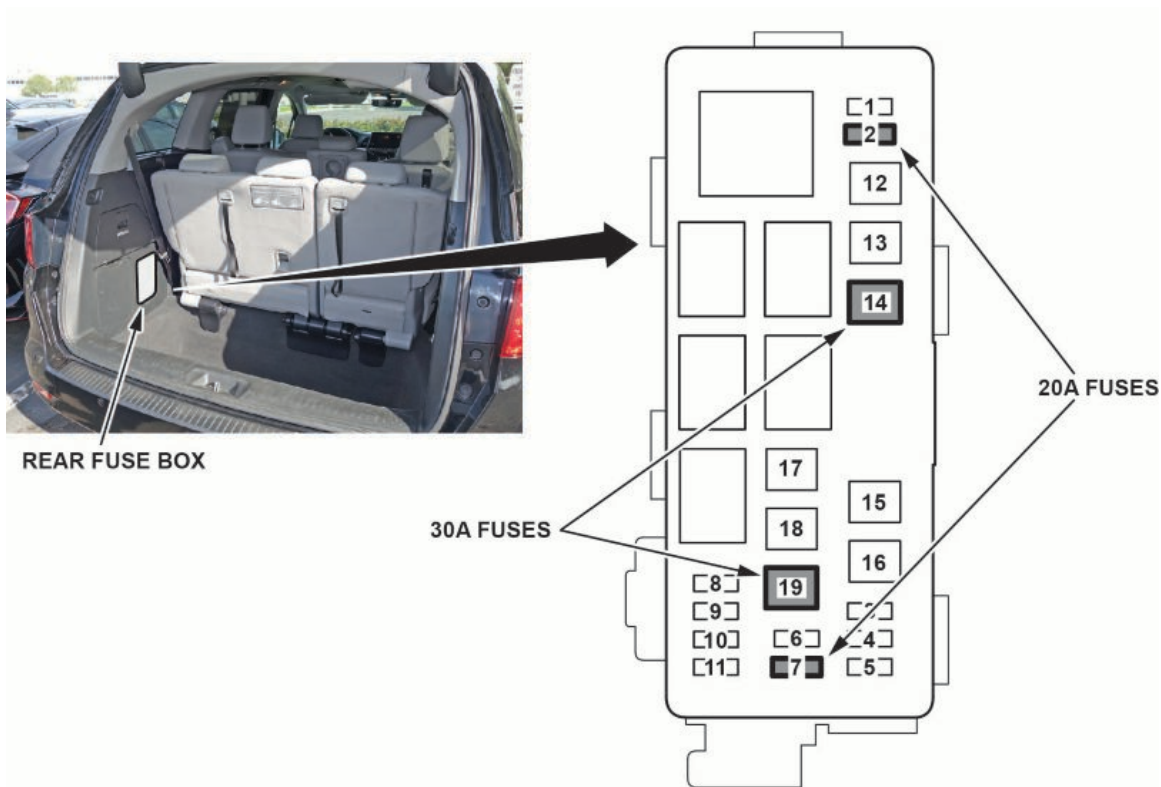
8. Install the driver's dashboard lower cover and the driver's dashboard side cover.
9. Remove the rear fuse box panel and remove the 20 amp fuses from F2 and F7 and the 30 amp fuses from F14 and F19 as shown.

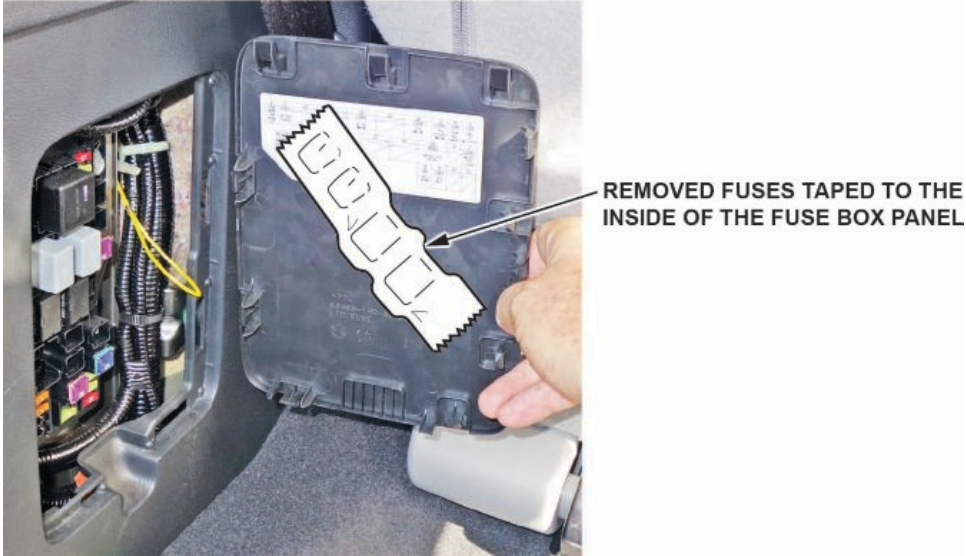
10. Tape the fuses to the inside of the fuse box panel as shown because when the new latches are installed, the fuses will be needed to restore the power sliding door function.
