## Safety Recall: Power Sliding Door Rear Latches

Supersedes 18-128, dated November 10, 2018, to revise the information highlighted in **yellow**.

Year	Model	Trim	VIN Range
2018-19	Odyssey	ALL except LX	Check the iN VIN status for eligibility.

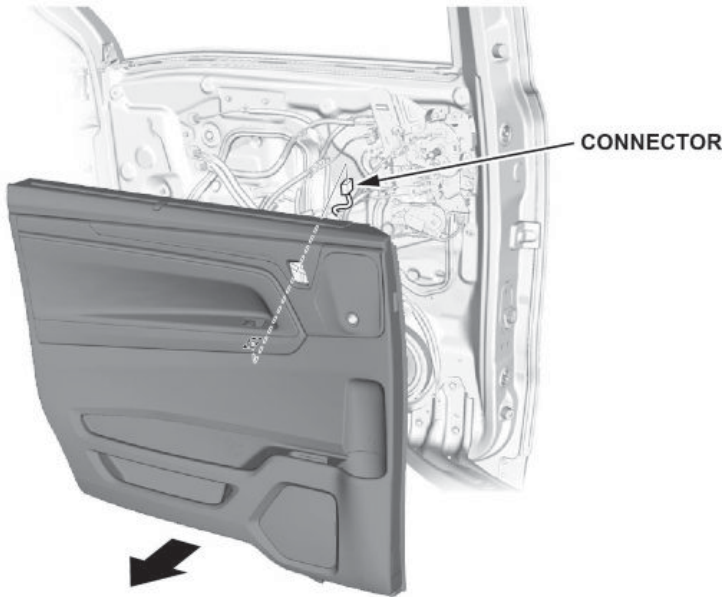
8. Starting at the rear, pull the door panel upward while making sure the clips from step 6 are free and not pulling on the lower door seal. Pull the door panel away from the inner handle shaft, and lift it upward.
9. While holding the sliding door panel away from the door, disconnect the connector. Then, remove the door panel.

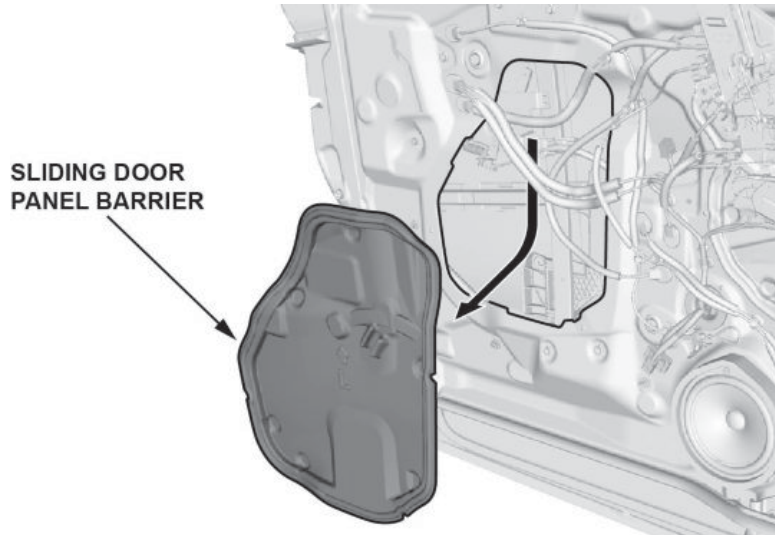
10. Remove the sliding door panel barrier.

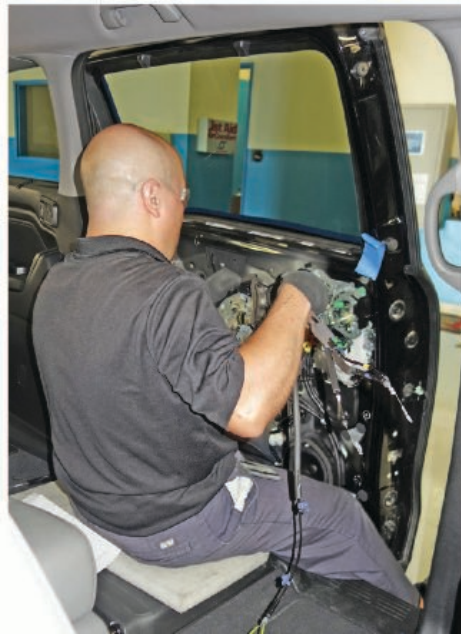
20. Sit in the open door with one leg on either side of the lower roller bracket, and pull the door forward to access the rear latch opening as shown.

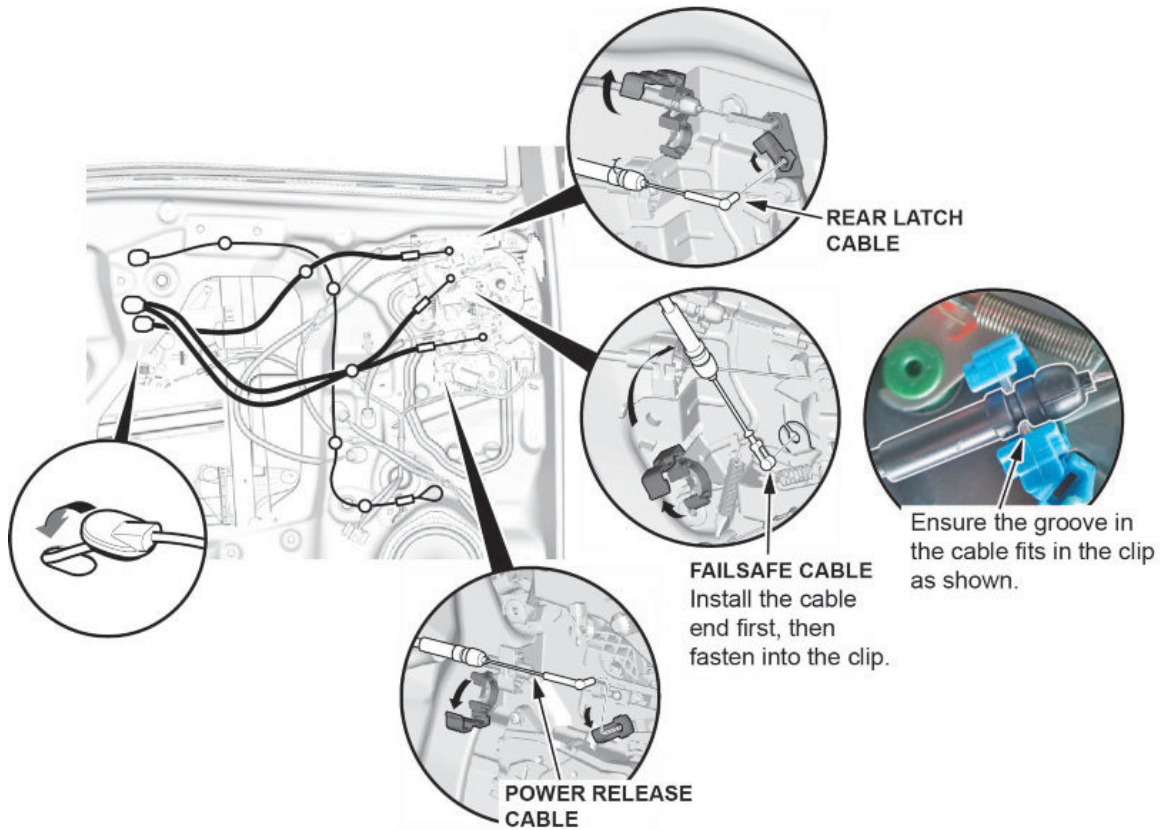
27. Install the cables.

27.1. Install the rear latch cable.

27.2. Install the failsafe cable. Make sure the cable is installed in groove and not between the front rib and the rubber boot.

- Install the end of the cable before installing the cable into the cable fastener.
- Make sure the cable is not kinked or bent.

27.3. Install the power release cable.

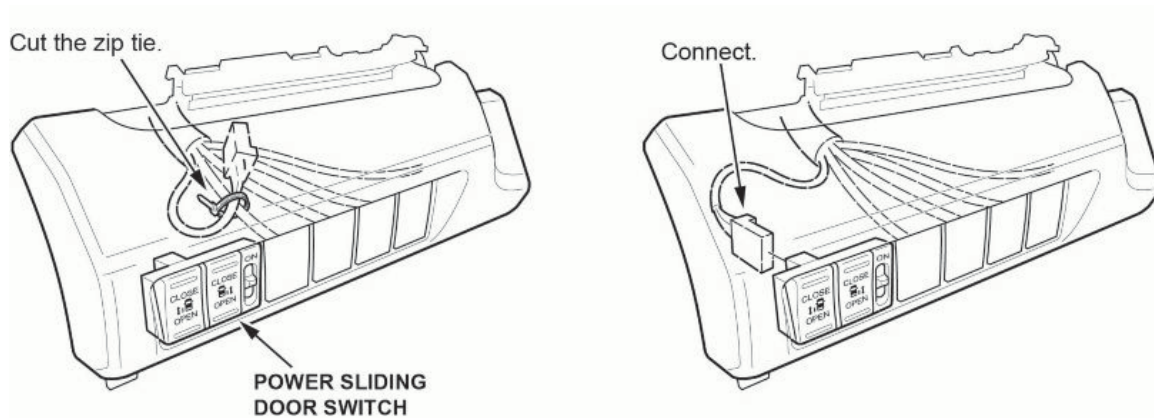
31.4. Cut the zip tie, and connect the power sliding door main switch connector.
