RECALL

Ambulance Bus Litter Support Clamp

**Models Affected: 2007 through 2019 Model Year
All American Buses with Ambulance Litters**

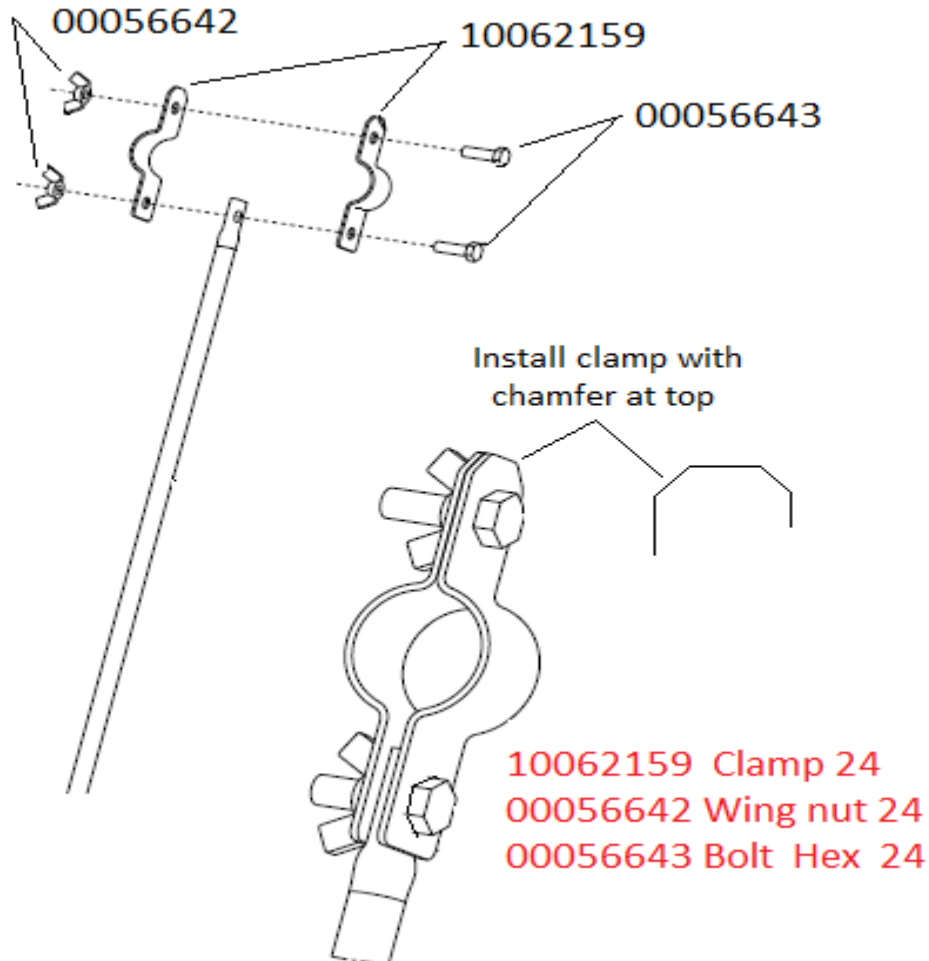
The top litter hanger support clamp may develop a crack and fail allowing litter to fall.

Remove the current clamps, 12 per unit and replace with the new clamps and fasteners.

1. Park bus on level surface, apply parking brake, turn of ignition key, and chock wheels.
2. Remove 5/16 wing nut and bolt from the upper loop clamp, remove current loop clamp.
3. Install the new support clamp assy. one at the front and one at the rear of each litter.
