Safety Recall

Code: 20BJ

| Subject | Fuel Pump Flange |
| Affected Vehicles | U.S.A. & CANADA: Certain 2007-2012 MY Audi Q7 and 2009-2012 Audi Q5 vehicles <i>Check Campaigns/Actions screen in Elsa on the day of repair to verify that a VIN qualifies for repair under this action. Elsa is the <u>only</u> valid campaign inquiry & verification source.</i> <ul style="list-style-type: none">✓ Campaign status must show "open."✓ If Elsa shows other open action(s), inform your customer so that the work can also be completed at the same time the vehicle is in the workshop for this campaign. |

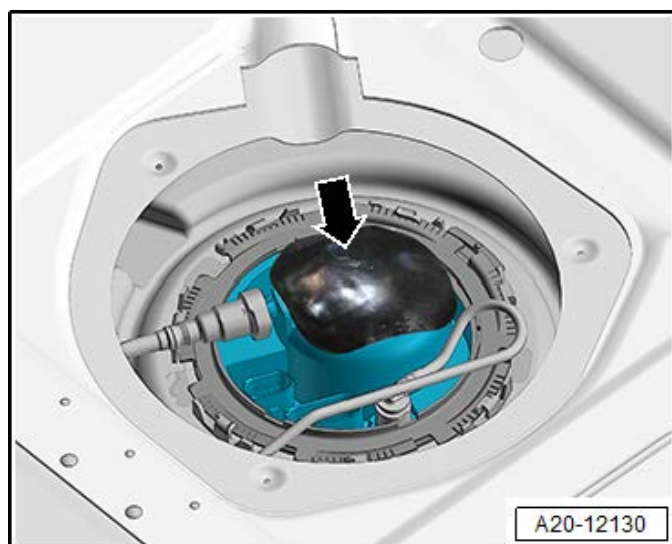
Repair Overview

- Replace Fuel Filter Flange and install Protective Film.

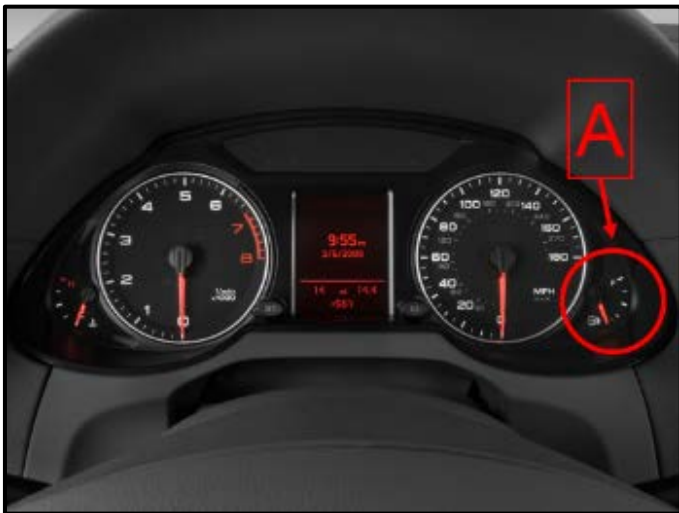
Verify fuel level:

- Check the vehicle fuel level displayed on the instrument cluster <A>.
- Record the vehicle fuel level on the repair order.

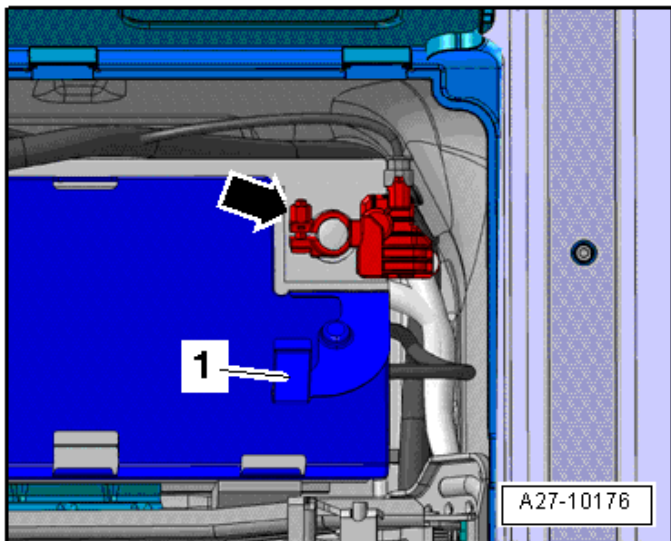
Disconnect battery ground cable:

- Access the battery.
- Open the cover <1> over the battery negative terminal.
- Loosen the nut several turns, remove and isolate the battery ground cable terminal <arrow> from the battery pole.

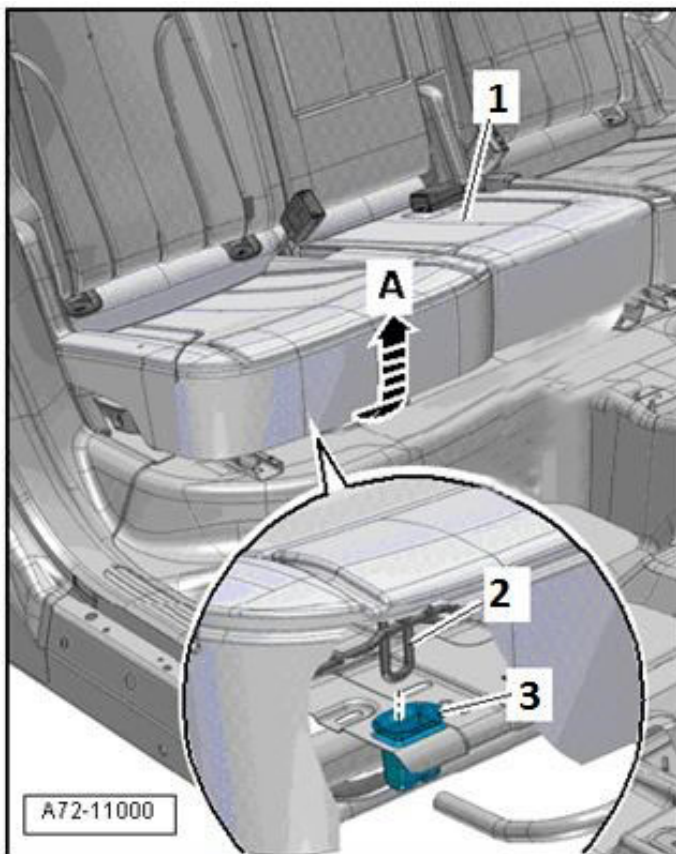
Remove right (passenger side) rear seat cushion and seat frame:

- Lift up on the seat cushion <A> until the cushion frame <2> releases from the grommets <3>.
- Disconnect the seat heating electrical connector (if equipped).

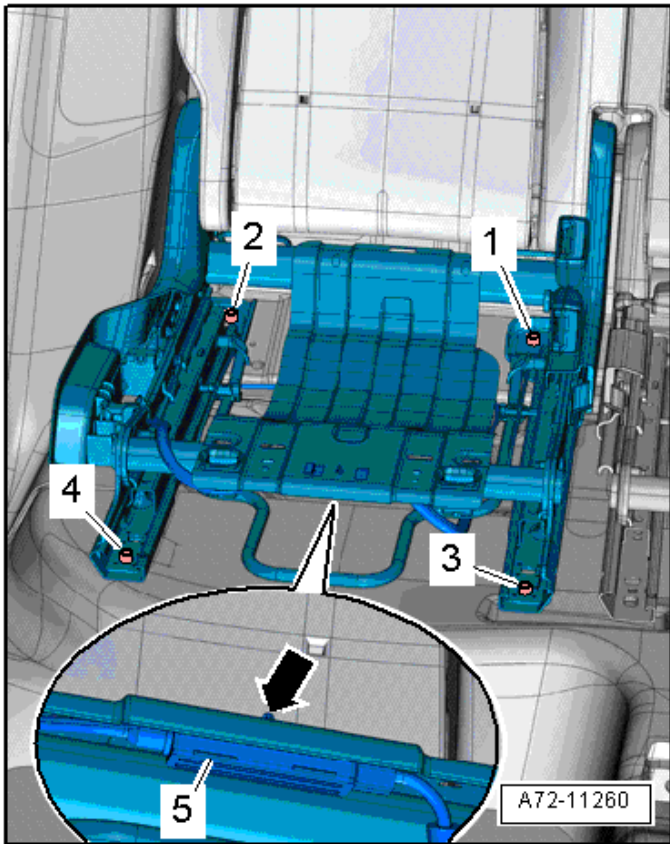
- Remove the four right rear seat frame bolts <1, 2, 3, and 4> using hand tools.

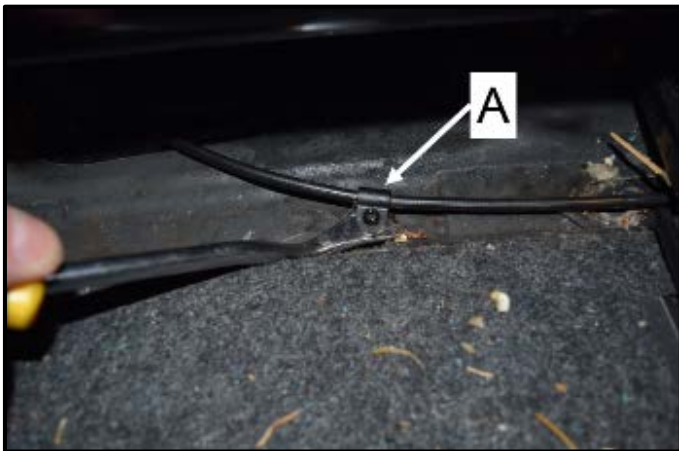
Disconnect seat adjustment cable (if equipped):

- Slide the seat frame forward and unclip the seat frame adjustment cable from the threaded tab <A>.

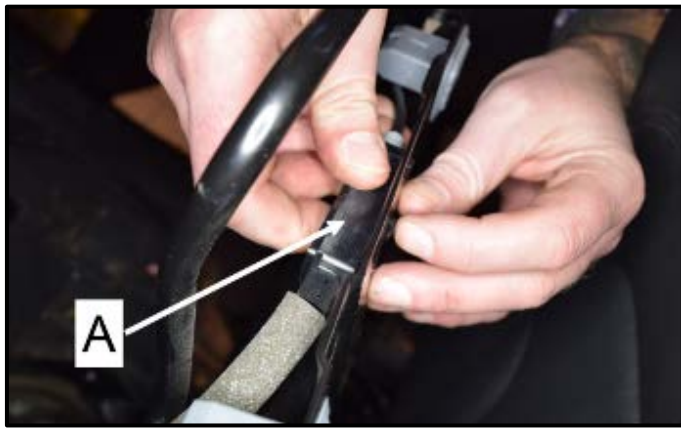
- Flip the seat frame up to gain access to the seat frame adjustment cable connector.
- Unclip the seat frame adjustment cable connector <A> from the seat frame.

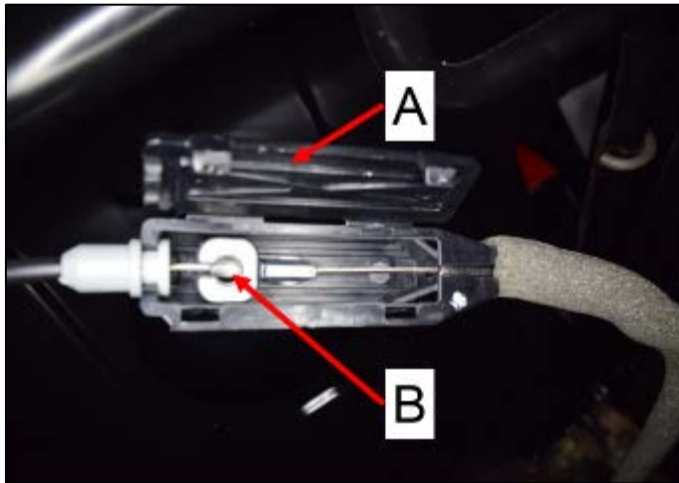
- Open the seat frame adjustment cable connector cover <A> using a small screwdriver or pick tool.
- Remove the cable from the adjustment cable cover and disconnect at the junction .

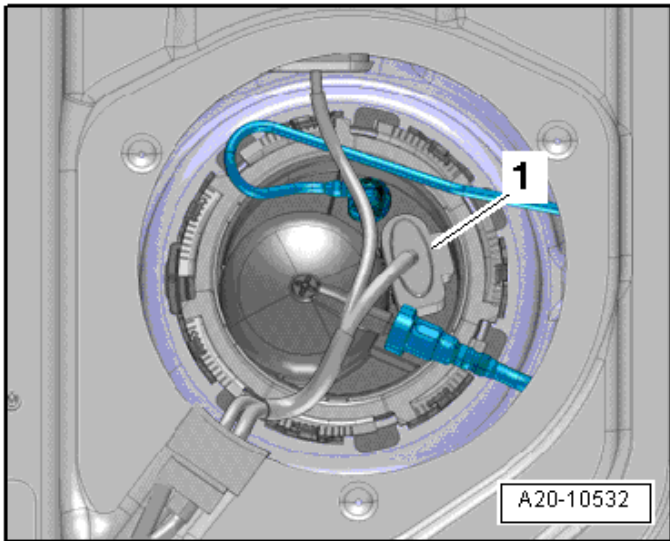
- Clean and/or vacuum the area around the fuel pump opening to ensure no debris falls into the fuel tank during the repair.
- Release the lock and disconnect the electrical connector <1>.

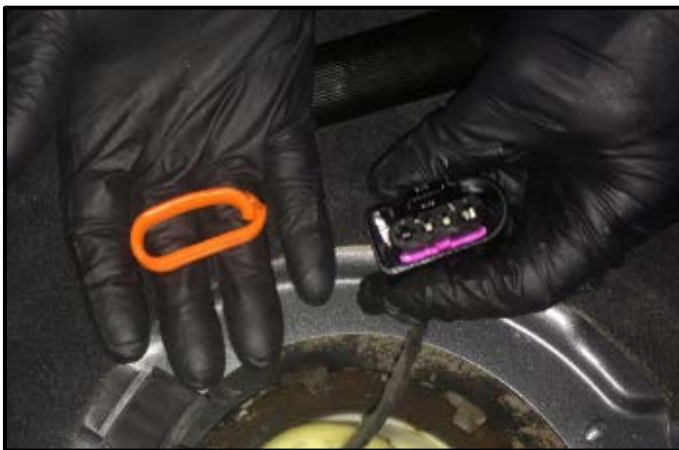
Due to clearance issues between the locking tab and the body of flange, a small pick tool can be used to aid in removal of the connector.

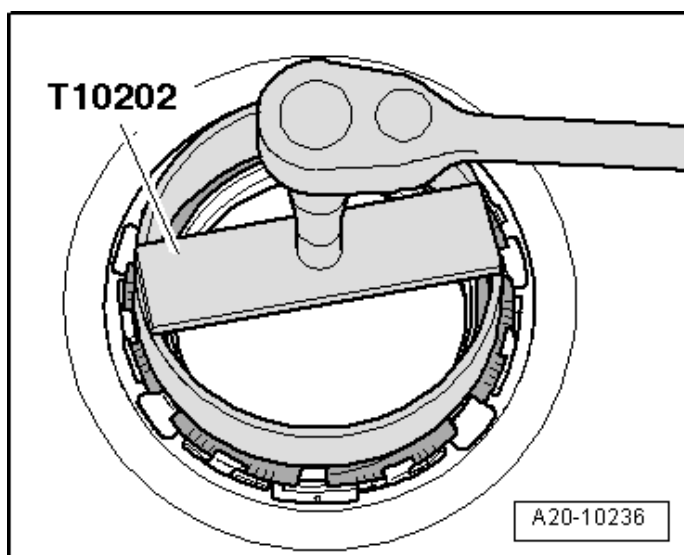
- Using special tool -T10202-, remove the fuel pump flange lock ring by turning counterclockwise.

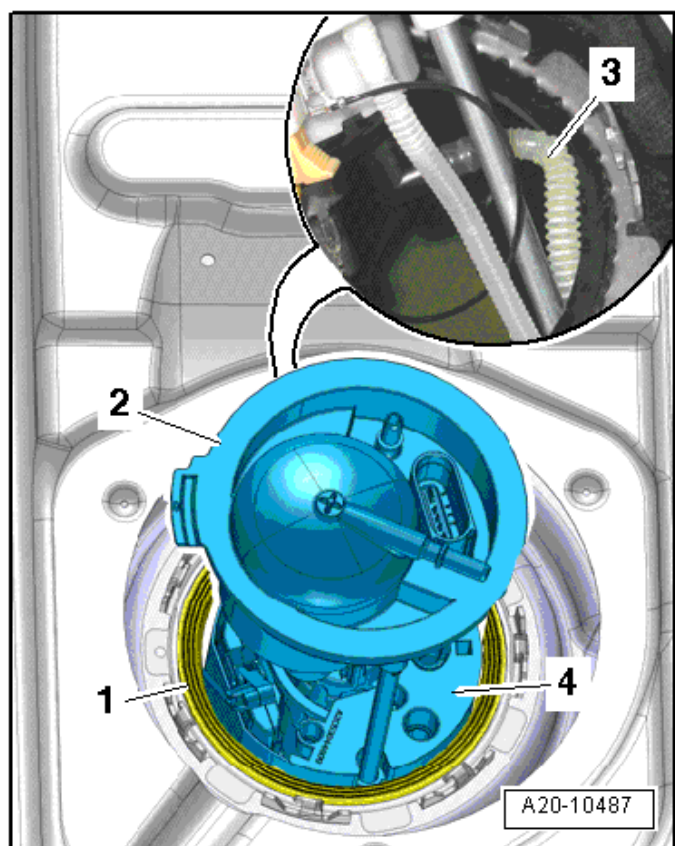
- Pull the fuel filter flange <2> out of the fuel tank slightly and remove the seal <1>.
- Move the fuel filter flange toward the right side of the vehicle, reach into the fuel tank through the gap between the flange and the opening and carefully guide the fuel line <3> out of the fuel tank.
- Remove the fuel filter flange <2> from the opening in the fuel tank and set it to the side with the lines still connected.

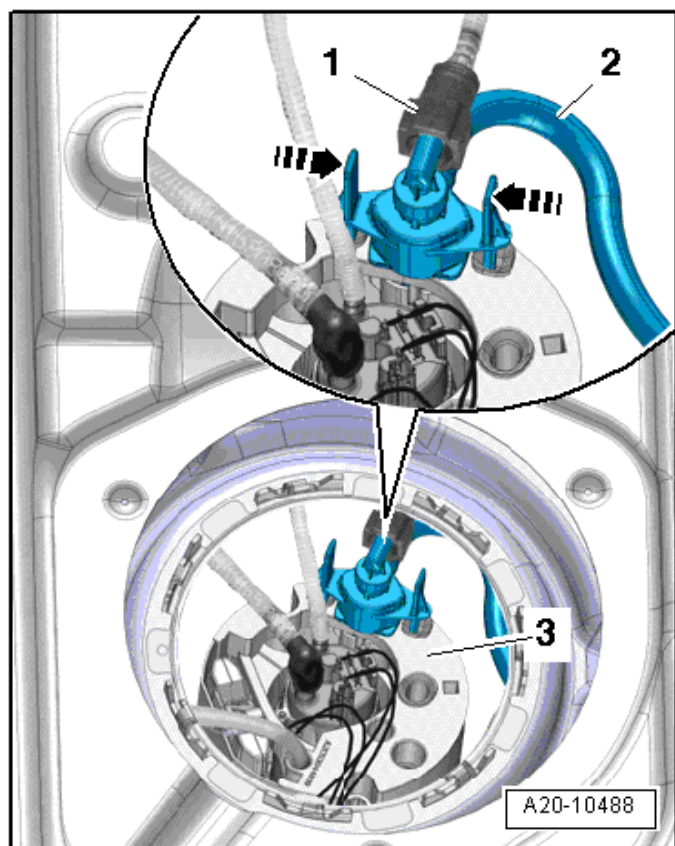
- Reach through the opening in the fuel tank and unlock the suction jet pump <arrows>.
- Pull suction jet pump <2> carefully upward with suction jet pipe <1> still connected.
- Disconnect suction jet pipe <1> from suction jet pump by pressing release button between the finger and thumb, pushing in on the connector, and then pulling off. Do not use pliers or other tools to disengage the connector or damage to the connector can occur.
- Remove the suction jet pump.
- Reach through the opening in the fuel tank and carefully remove the fuel delivery unit <3> being careful not to damage or bend the fuel sending unit floater arm.

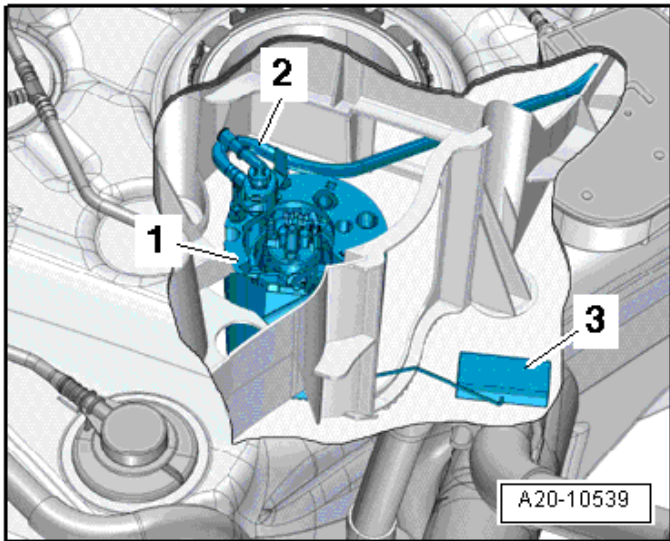
Be careful not to bend the floater arm on the Fuel Level Sensor <3> when removing the fuel delivery unit <1>.

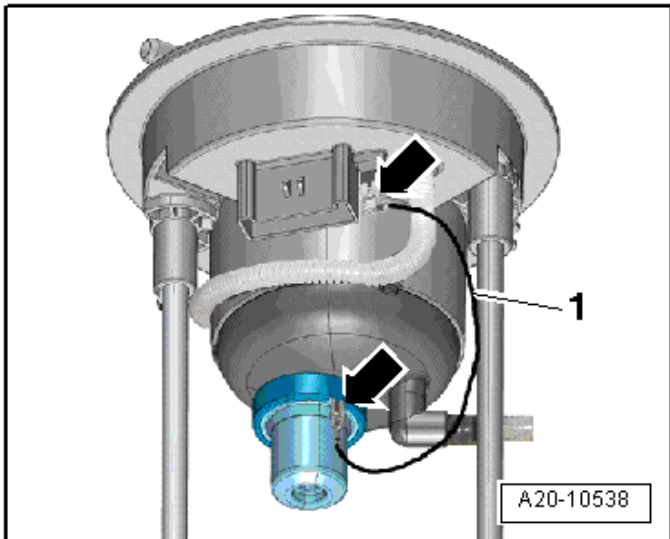
- Prepare the new fuel filter flange assembly for installation onto the fuel delivery unit.
- Remove the fuel filter flange assembly from the top of the fuel delivery unit, and install the new fuel filter flange.

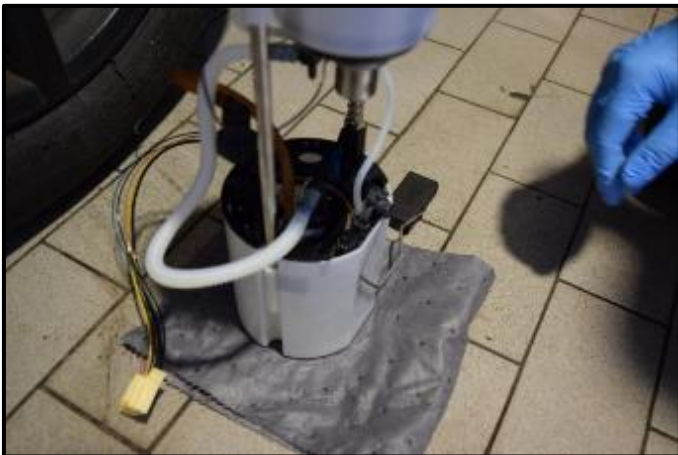
Be sure to connect the ground wire <1> to the fuel delivery unit <arrows> before continuing. Take care that during installation of the new fuel delivery unit assembly that the ground wire <1> is not damaged.

- Make sure the fuel hoses and wires are routed correctly as shown in the illustration.
- The fuel supply line must be routed in front of the guide pipe.
- The suction jet pipe must be routed behind the guide pipe.
- Insert the guide tube and the sealing flange into the guide holes of the fuel delivery unit.

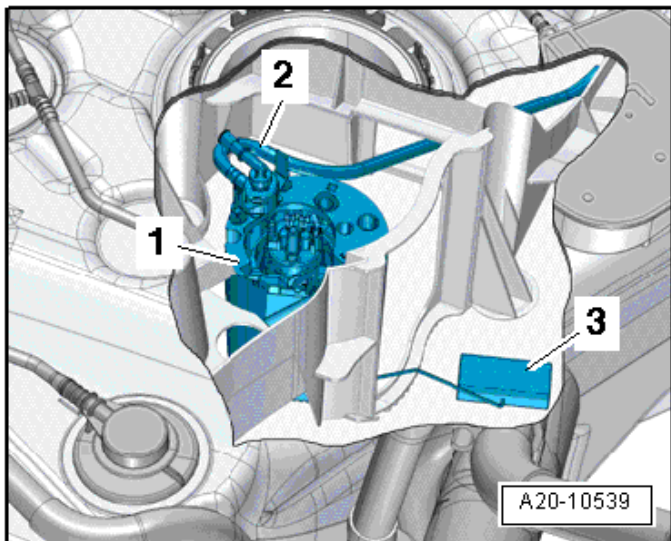
- Carefully reinsert the fuel delivery unit <1> into the fuel tank.
- Reach through the opening in the fuel tank and properly align the suction jet pump <2>.

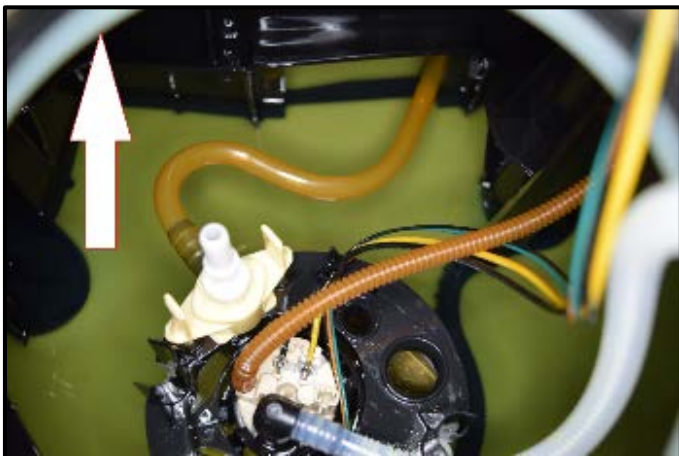
- Arrow denotes the front of the vehicle.
- Attach the suction jet pump to the fuel delivery unit. To do this, reach into the fuel tank through the opening and press down until you hear an audible click.
- Suction jet pump must engage audibly.
- Make sure the suction jet pipe and the suction jet pump are securely locked in place.

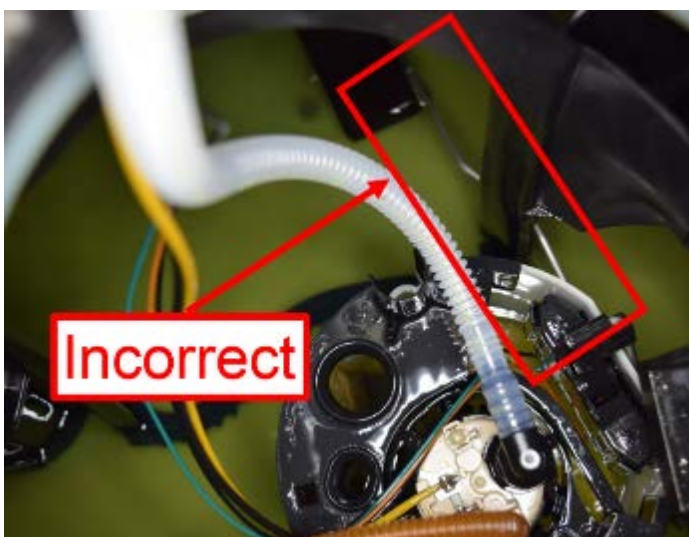
- Pay attention to the installation position of the Fuel Level Sensor Float.

The floater arm of the Fuel Level Sensor must point toward the right side of the vehicle through the opening in the fuel tank baffle.

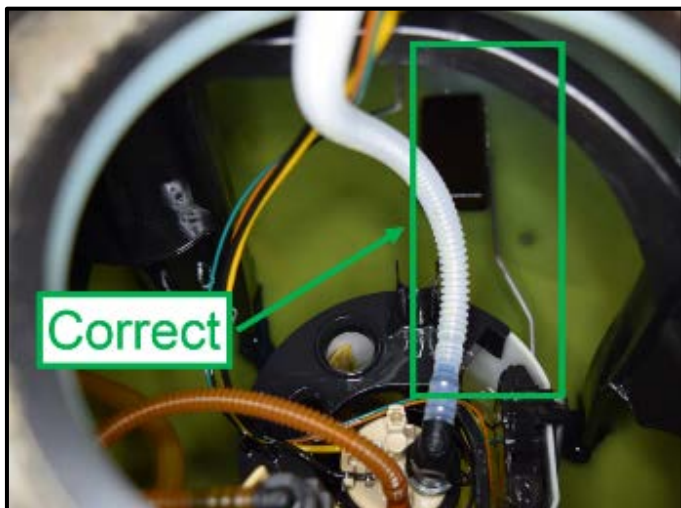
- Note the correct positioning of the fuel level sensor float.

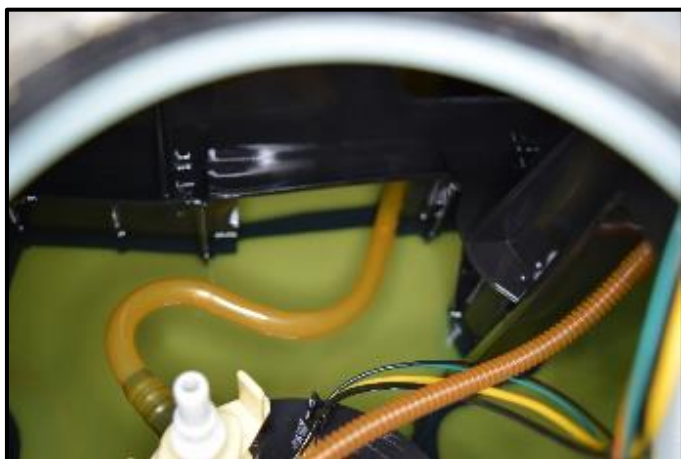
- Note the proper routing of the suction jet pipe. The suction jet pipe should be directed forward through the opening in the fuel tank baffle.

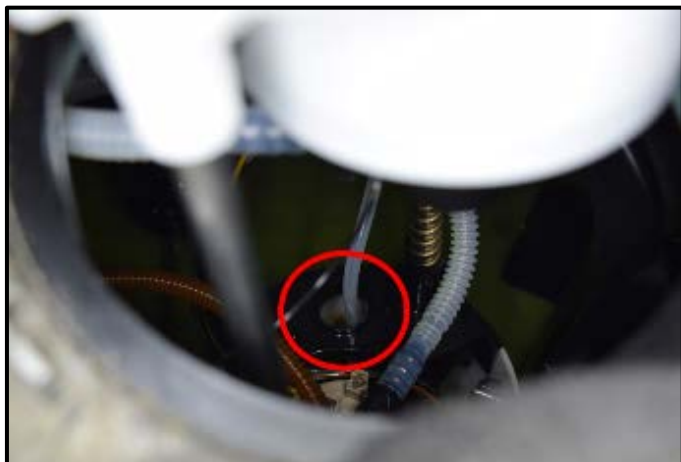
- Note the proper routing of the vent pipe <circle>.

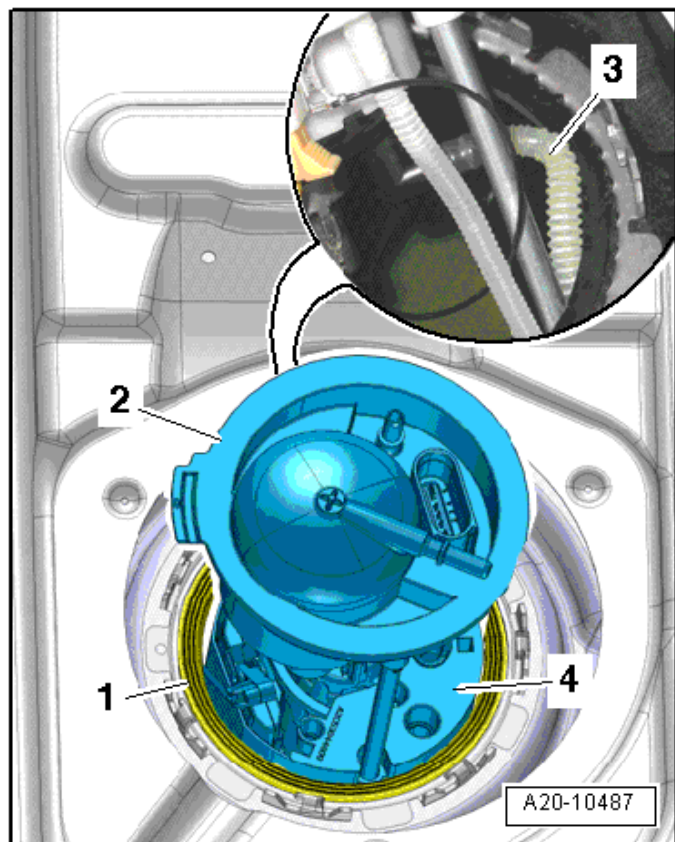
- Move the fuel filter flange <2> toward the center of the vehicle and insert the fuel filter flange <2> and fuel line <3> into the fuel tank.
- Carefully install the fuel line <3>.
- Install the new filter flange seal dry <1>. Do not lubricate the seal.

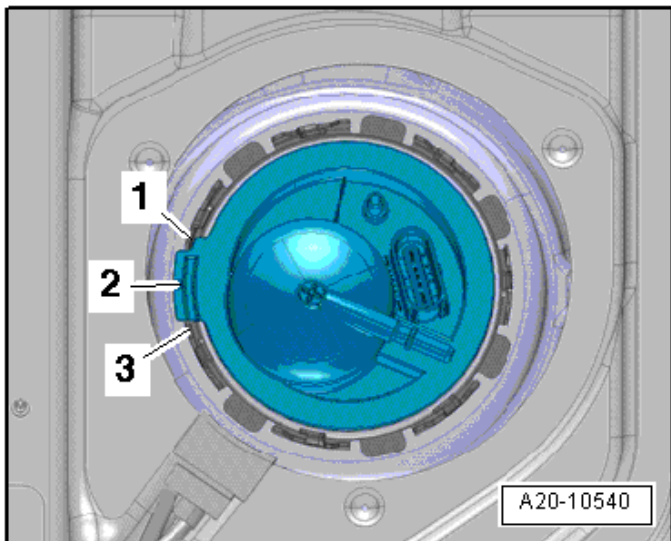
- Move the fuel pump flange into the installation position.

The tab <2> on the sealing flange faces toward the rear of the vehicle and must be between the tabs <1> and <3> on the fuel tank.

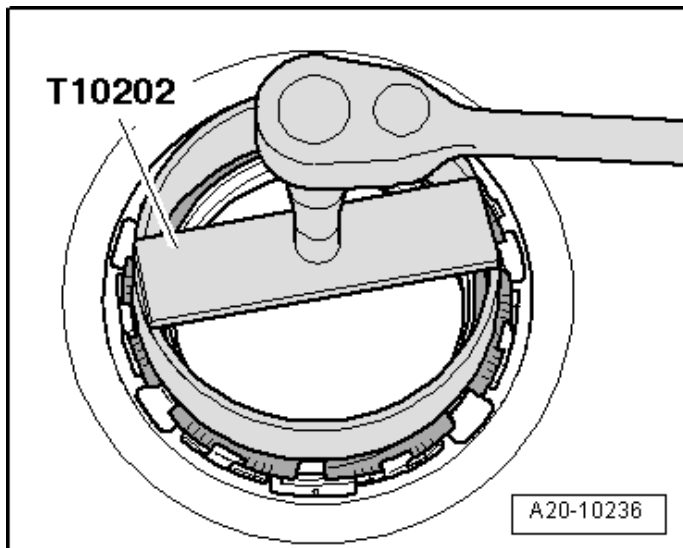
- Tighten the locking ring using the Fuel Sending Unit Wrench -T10202-. Torque the locking flange to 110 Nm.

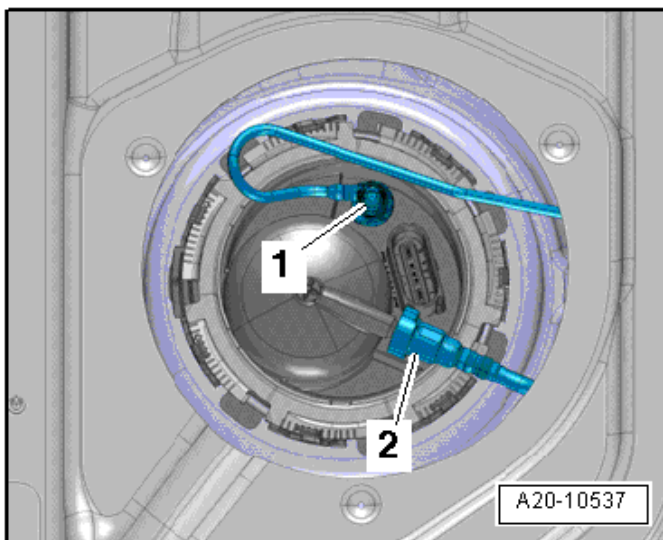
- Connect the fuel line <2>.
- Install new quick coupling piece cap onto connection <1>.

The fuel heater line is not applicable on most vehicles. You must install the quick coupling piece cap onto the nipple located at the fuel heater line connection <1> if the fuel heating line is not applicable, or you will develop a fuel leak.

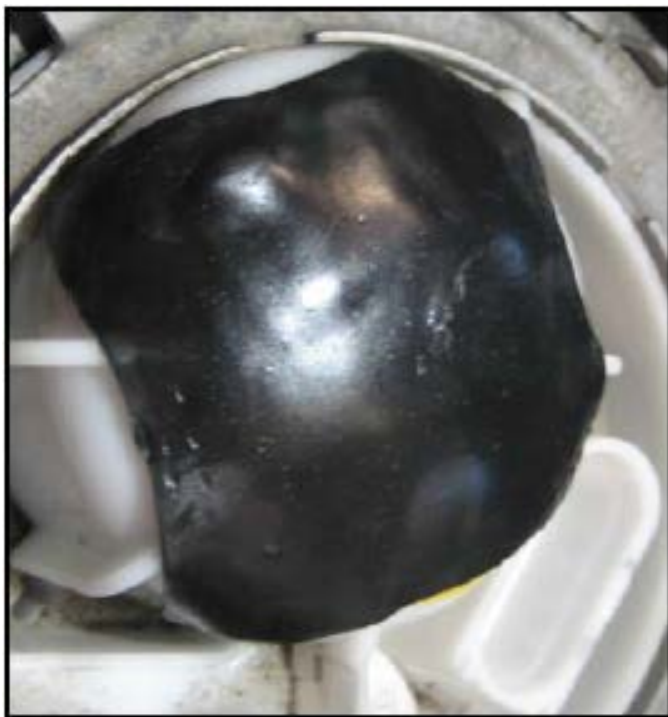
- Apply protective film as shown. Start application from the center and work the protective film towards the outside edges of the fuel filter flange taking care to eliminate air gaps or bubbles under the film.
- Use care when applying protective film so that no dust or dirt comes in contact with the adhesion side of the film.

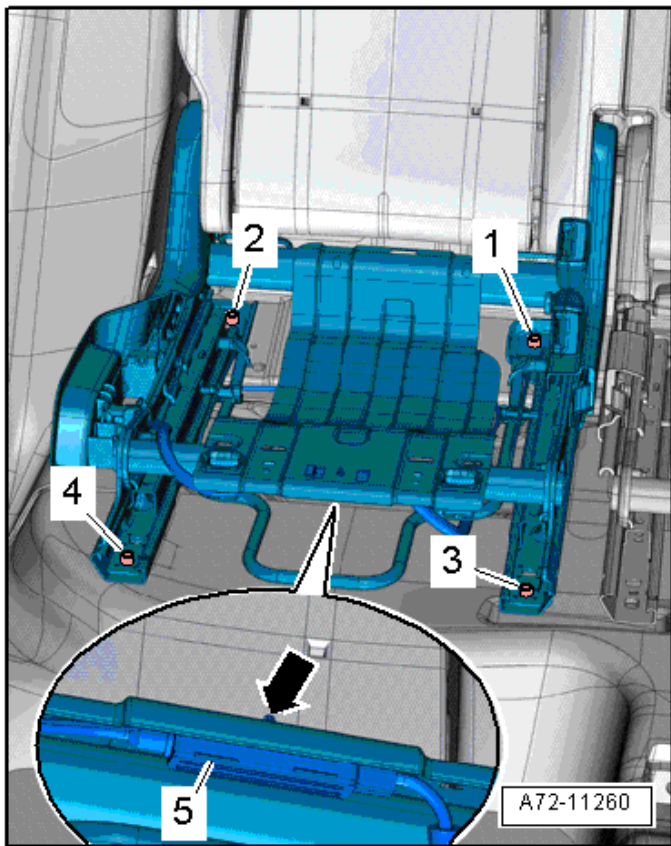
Reinstall seat frame and seat bench:

- Start bolt <1> by hand first.
- The bolt holes in the seat frame for the other three bolts are elongated. Bolt hole <1> is not elongated. This will reduce any chance of cross threading a bolt.
- Torque the seat frame mounting bolts <1, 2, 3, and 4> to 50 Nm.

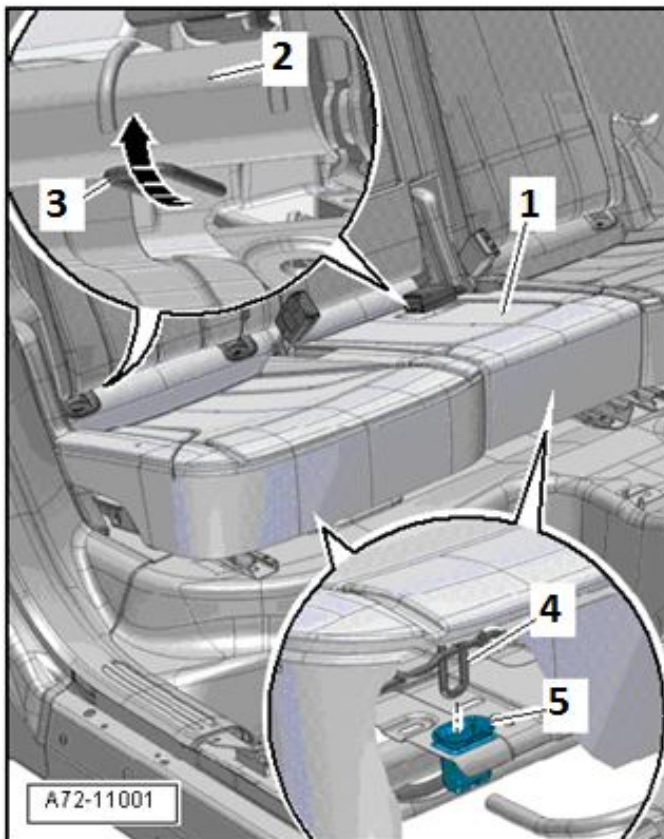
Replace the mounting grommets <5> each time the bench seat is removed. Do not reuse the grommets.

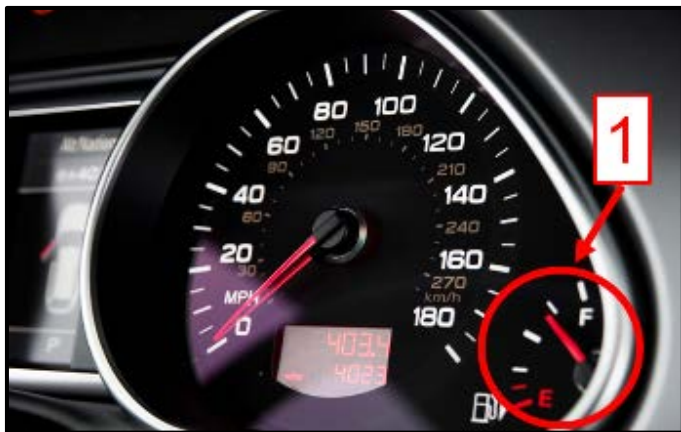
- Check the vehicle fuel level displayed on the instrument cluster <1>.
- Record the vehicle fuel level on the repair order.

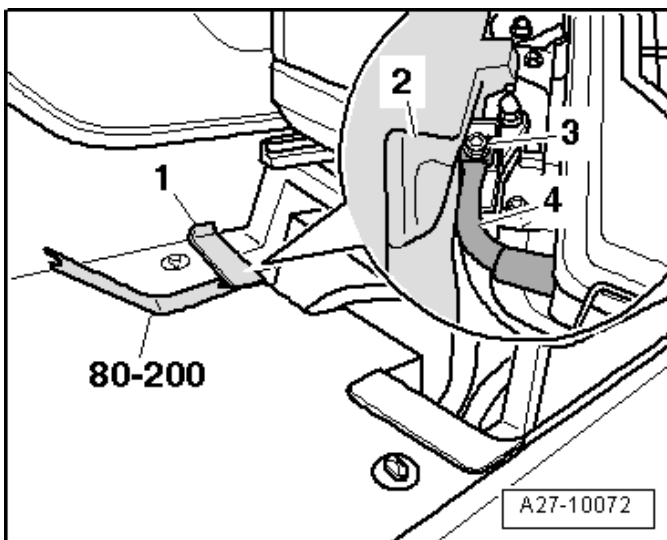
- Pry cover <1> with Pry Lever -80-200- (or equivalent) from floor covering.
- Raise floor covering <2> slightly in ground wire area.
- Remove nut <3>, remove and isolate ground wire <4> from ground point.

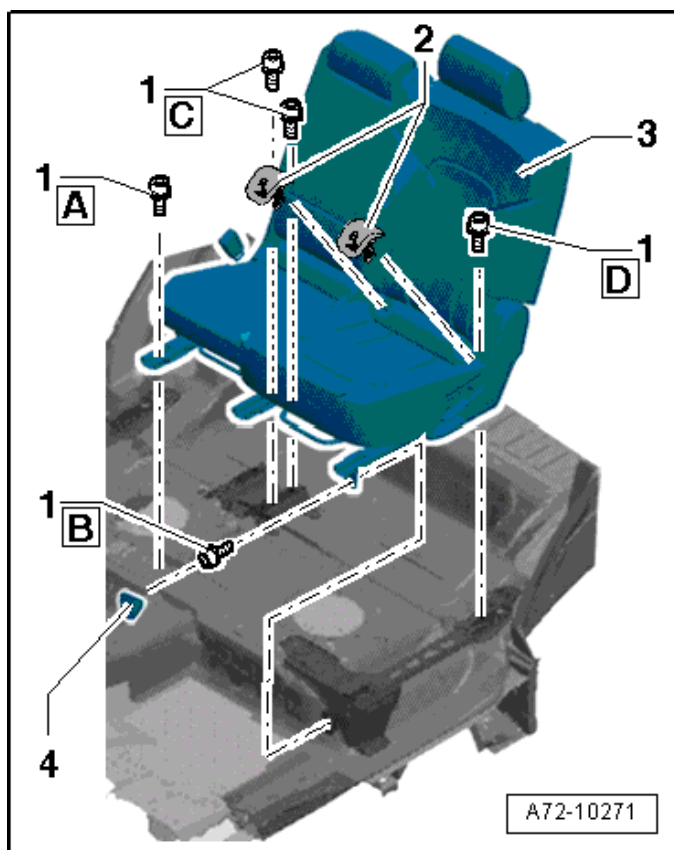
- Remove the second row front seat frame bolts <1A, 1B>.
- Slide the seat frame forward using the third row entry assist handle (if equipped), or slide the seat forward beyond the seat rail stop bolts to gain clear access to and remove the rear seat frame bolts <1C (x2) and 1D>.
- Lift seat frame assembly <3> out of the vehicle.

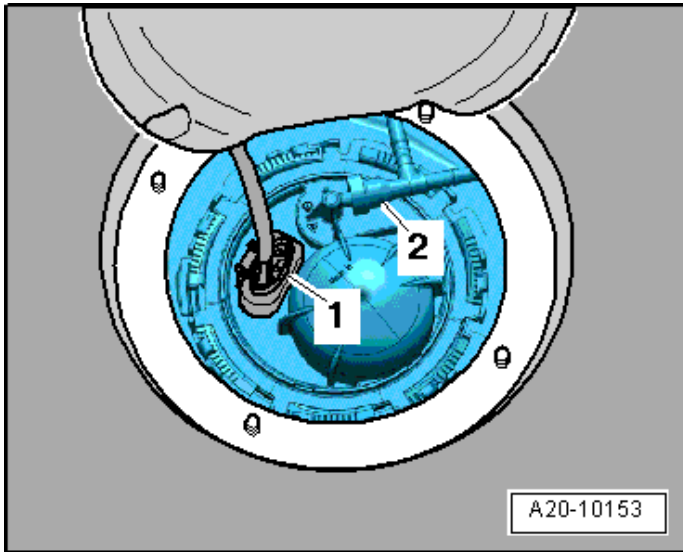
- Disconnect filter flange electrical connector <1>.
- Remove the fuel tank vent line connector <2> from the filter flange by squeezing the release tab between the finger and thumb, pushing in on the connector, and then pulling off.

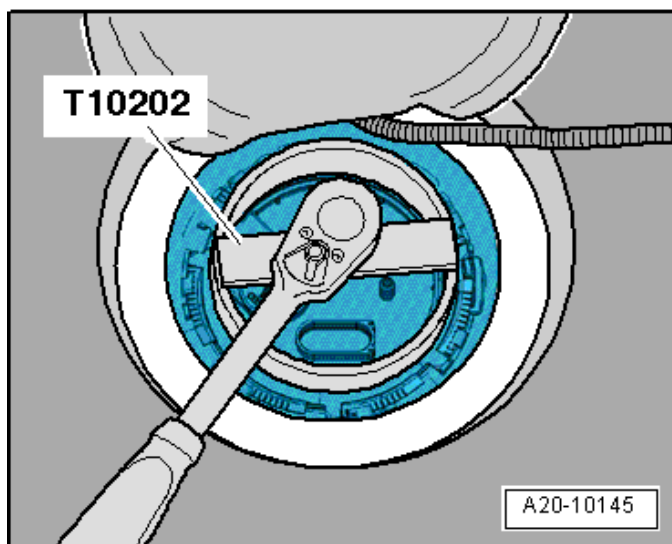
- Using Fuel Sending Unit wrench -T10202-, remove the locking ring from the fuel filter flange by turning counterclockwise.

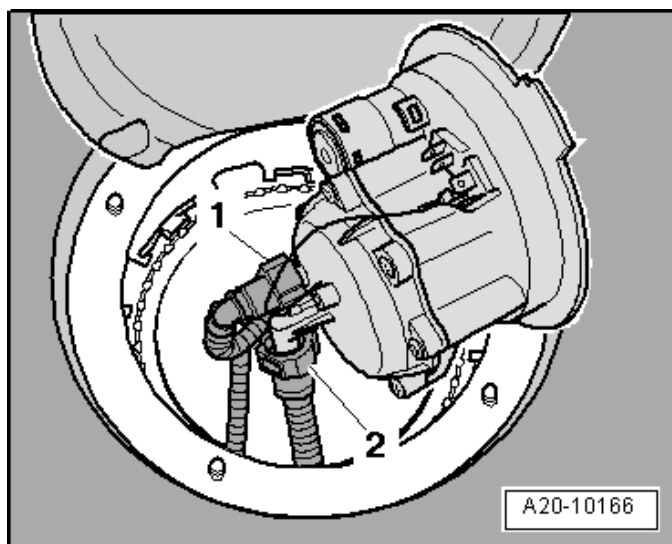
- Disconnect fuel lines <1> and <2> from fuel filter flange by squeezing the release tab between the finger and thumb, pushing IN on the connector, then pulling OFF.
- Disconnect electrical connector.
- Remove left locking flange with fuel filter housing and seal.

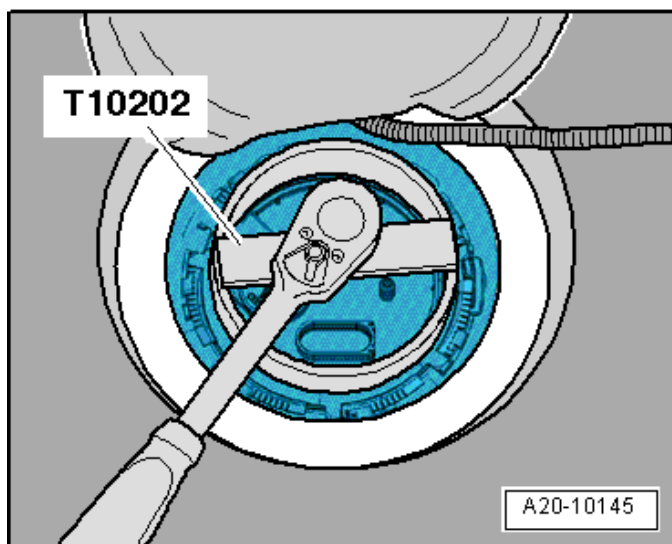
- Reinstall the fuel filter flange locking ring by turning clockwise. Torque the locking flange to 110 Nm.

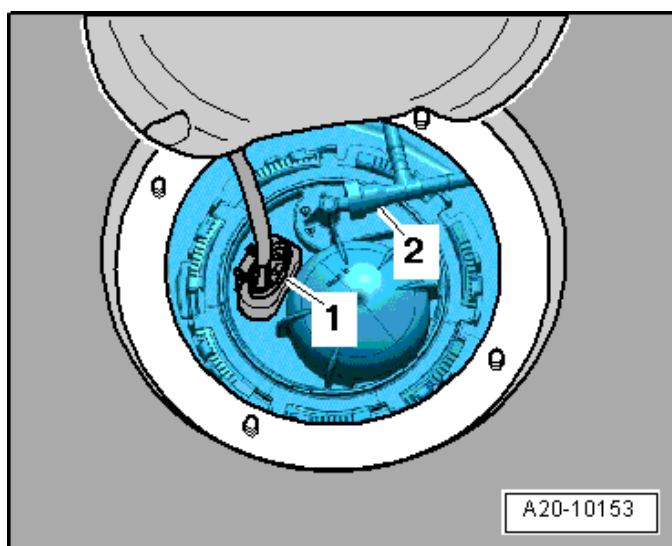
- Reconnect the fuel filter flange electrical connector <1> and push into place until you feel and hear the audible click.
- Reconnect the fuel tank vent line connector <2> and push into place until you feel and hear the audible click.

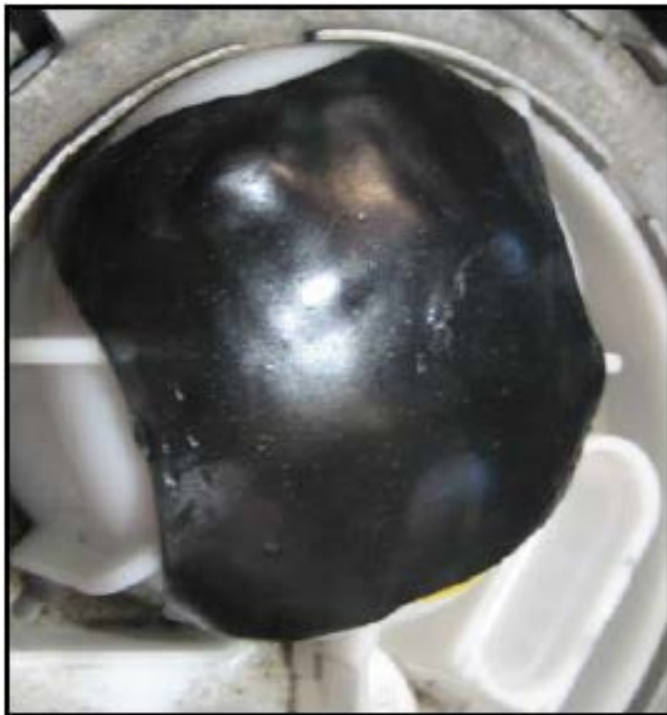
- Apply protective film as shown. Start application from the center and work the protective film towards the outside edges of the fuel pump flange taking care to eliminate air gaps or bubbles under the film.
- Use care when applying protective film so that no dust or dirt comes in contact with the adhesion side of the film.

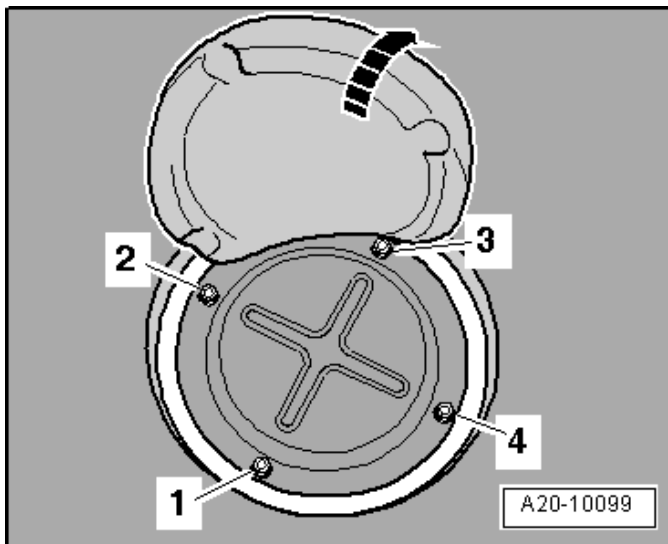
- Reinstall left locking flange cover and reinstall screws <1> through <4>.
- Fold the floor covering carpet closed to conceal the locking flange cover.
