December 2018

Dealer Service Instructions for:

## **Safety Recall UB7 / NHTSA 18V-822 Seat Track Position Sensor**

**2019 (DT) RAM 1500 Pickup**

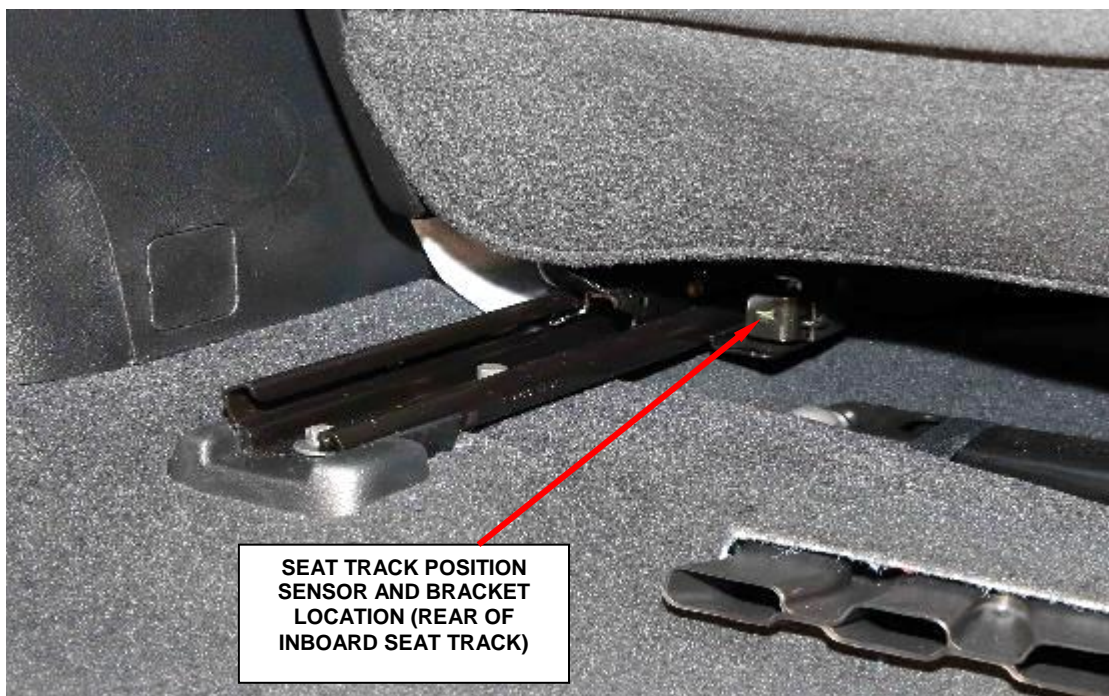
**Figure 1 – Inspect Seat Track Bracket**

1. Open the right rear door.
2. Locate the passenger seat track position sensor bracket located under the seat on the rearmost section of the inboard track (Figure 1).
3. Grab the bracket and **gently** try to wiggle it forwards and backwards, up and down.

**NOTE: The bracket on a GOOD seat frame WILL NOT feel loose and wiggle. The bracket on a BAD seat frame WILL feel loose and wiggle.**

- If the seat track position sensor bracket feels loose or wiggles, continue with section **B. Replace Front Seat Cushion Frame**.
- If the seat track position sensor bracket **does not** feel loose or wiggle, no further action required. Return the vehicle to the customer.

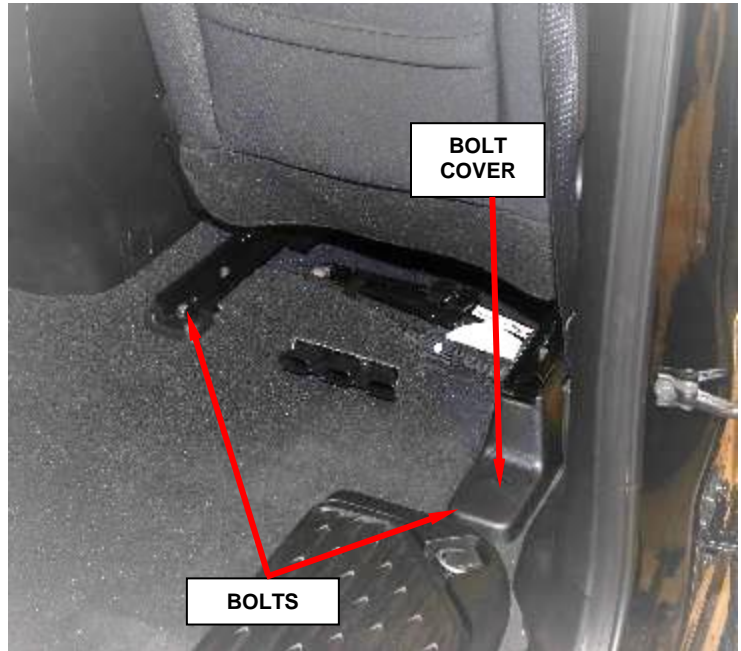
**Figure 2 – Rear Seat Mounting Bolts**

3. Remove and save the bolt cover and both seat bolts at the rear of the seat (Figure 2).

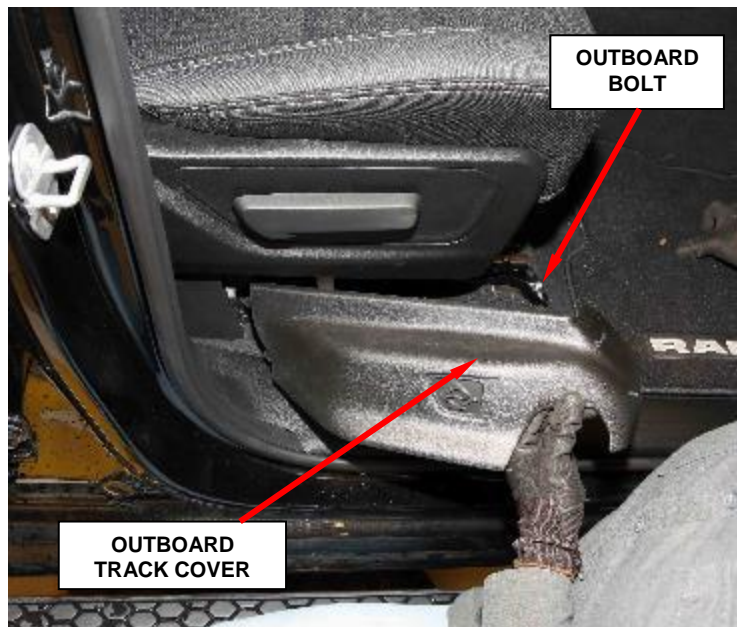
**Figure 3 – Outboard Seat Bolt**

5. Using a trim tool pry outward to unclip the front of the outboard track cover then slide forward to remove (Figure 3).

6. Remove and save the outboard seat bolt (Figure 3).

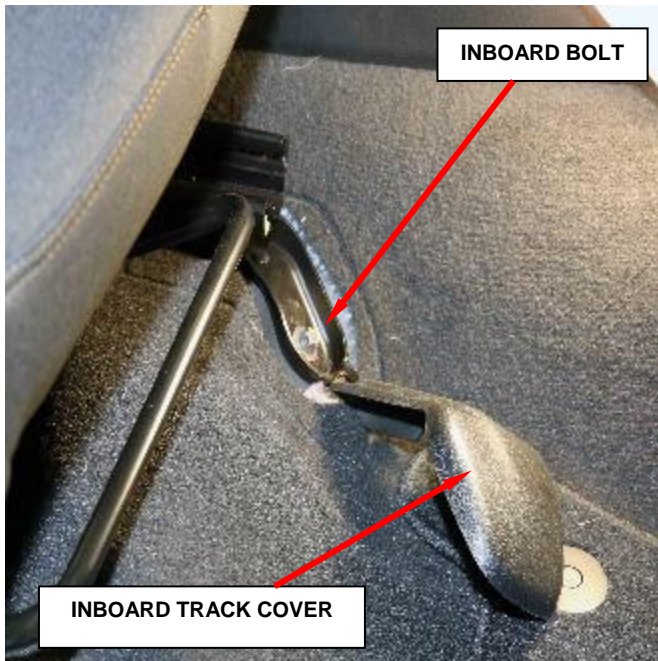
**Figure 4 – Inboard Seat Bolt**

7. Using a trim tool, release the clip then slide the inboard track cover forward to remove (Figure 4).

8. Remove and save the inboard seat bolt (Figure 4).

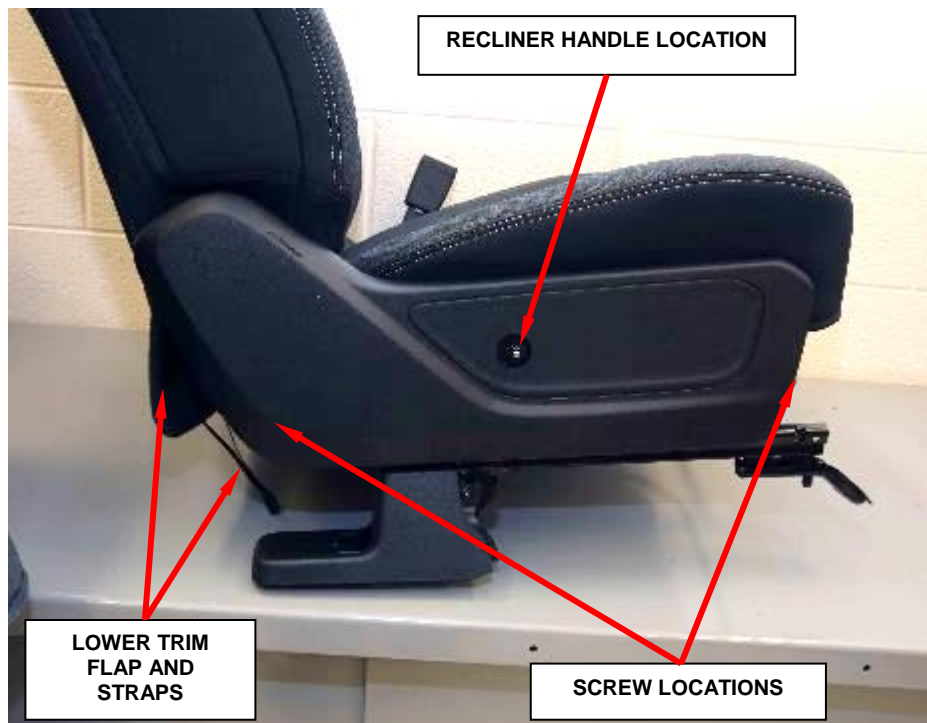
**Figure 5 – Outboard Side Shield**

10. Remove the recliner handle (Figure 5).

11. Release the lower trim straps and lift the flap (Figure 5 and 6).

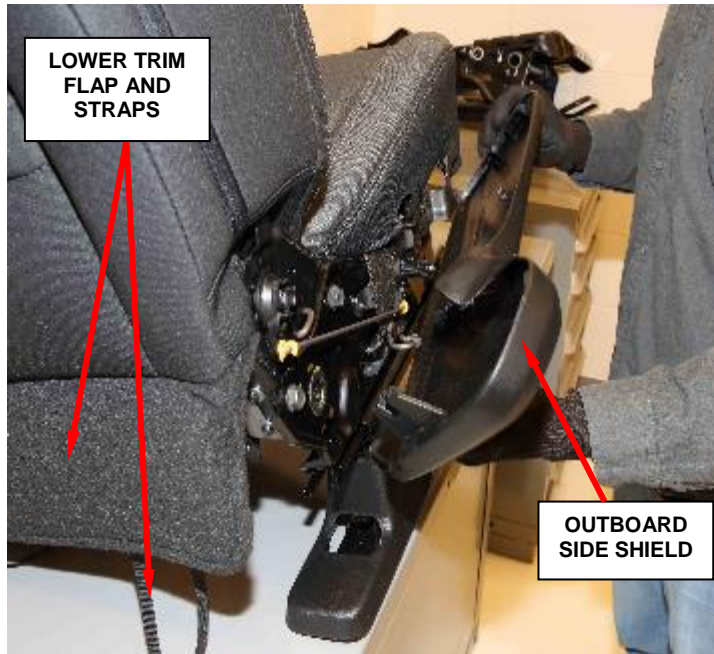
**Figure 6 – Outboard Side Shield**

13. Pull outward at the bottom to release the clip, then lift at the rear to release the hook retainers, then slide forward to remove the outboard side shield (Figure 6).

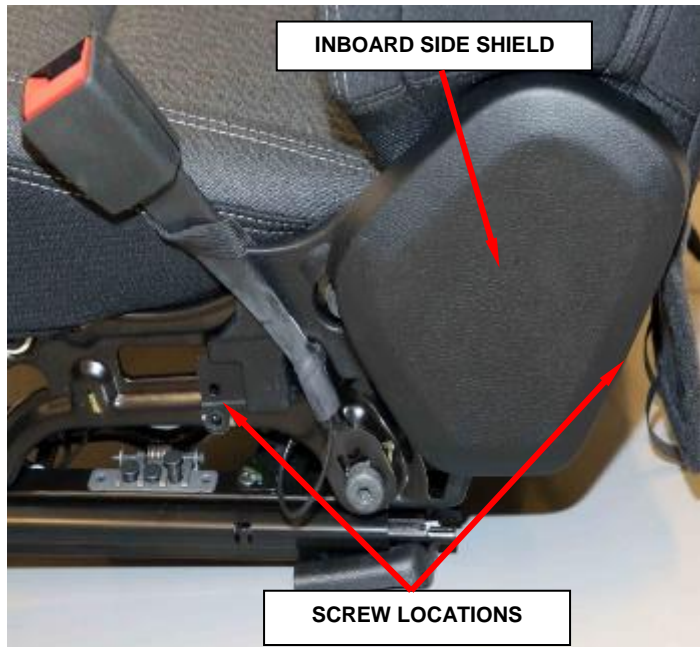
**Figure 7 – Inboard Side Shield**

14. Remove the screws at the front and rear of the inboard side shield (Figure 7).
15. Lift upward and forward to release the hooking feature and remove

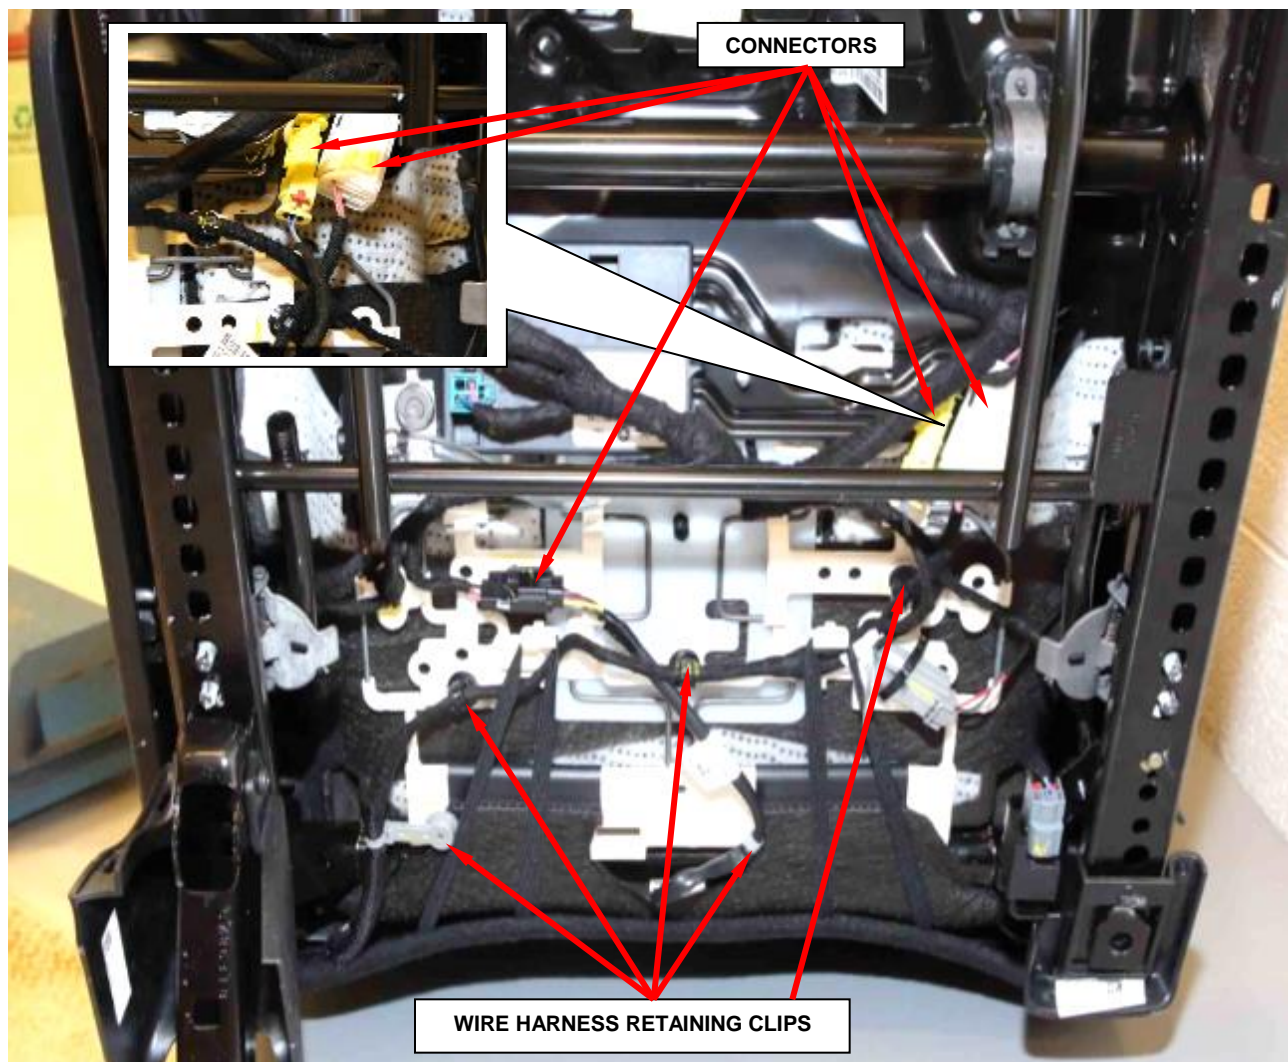
**Figure 8 – Wire Harness Connectors and Retaining Clips**

17. Unclip the wire harness retaining clips and disconnect the three wire harness connectors (Figure 8).

54. Clip the wire harnesses and connect the three wire harness connectors (Figure 8).
55. Close the seat trim flap and hook the lower trim cover straps.

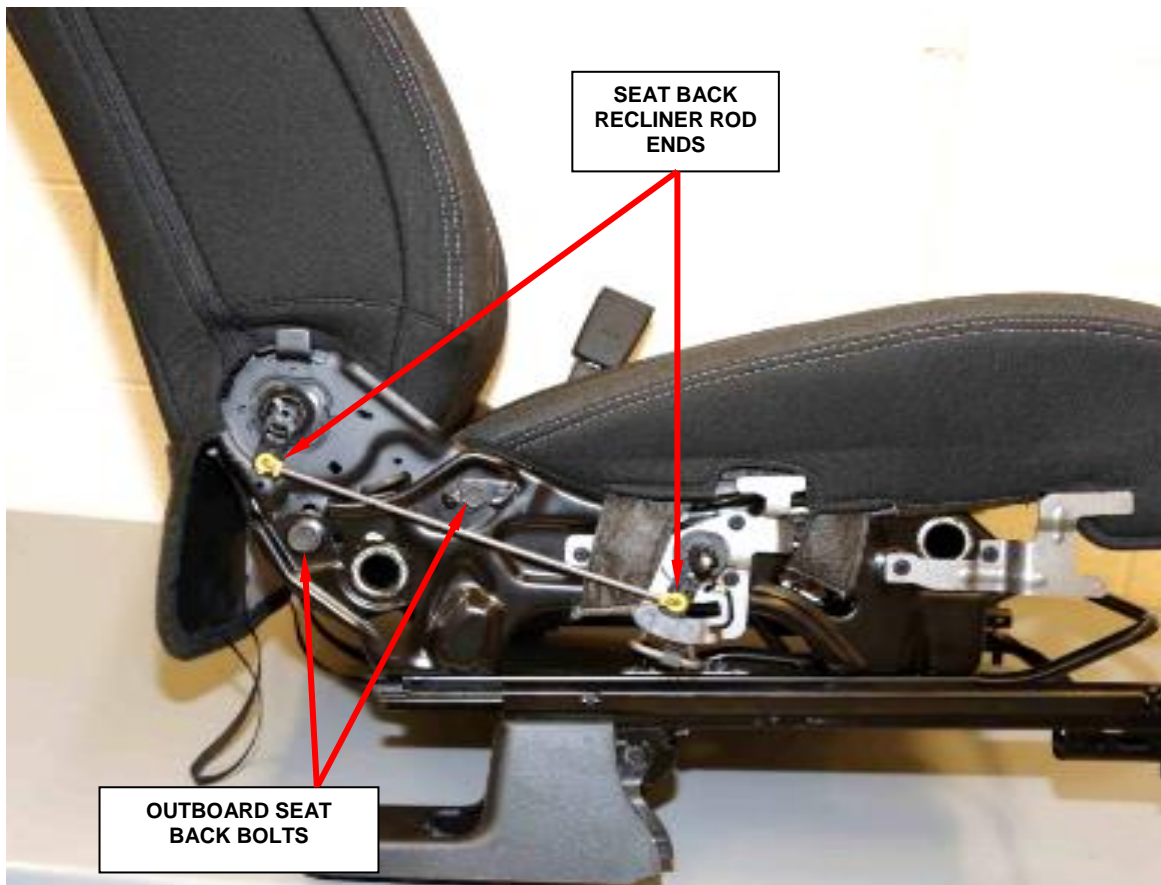
**Figure 9 – Seat Back Bolts and Recliner Rod**

18. Remove and save the seat back recliner rod from the seat back and seat back recliner handle spindle (Figure 9).

19. Remove and save the bolts on both sides of the seat back, and remove the seat back (Figure 9).

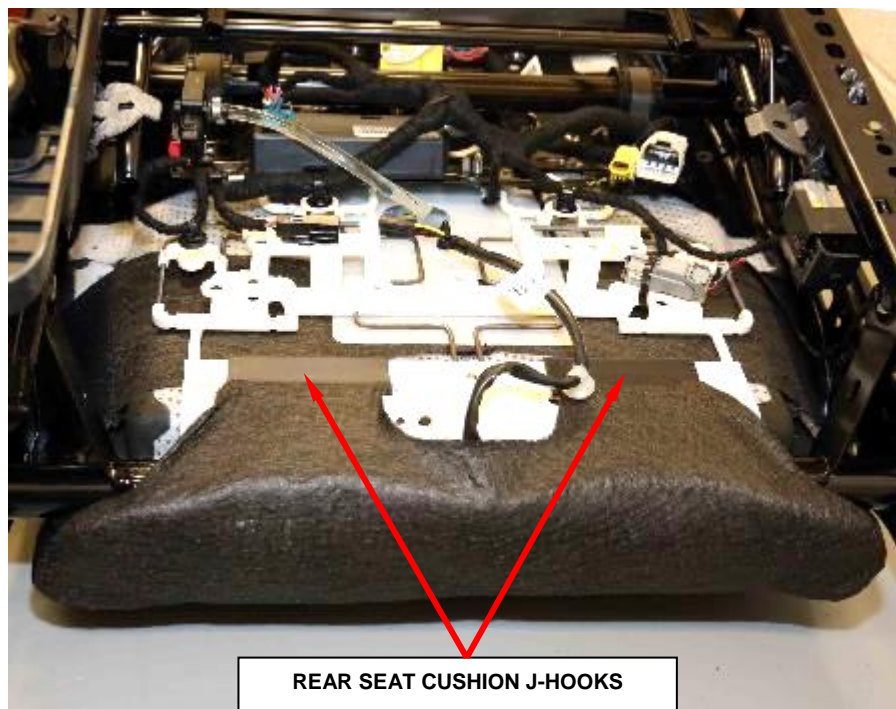
**Figure 10 – Seat Cushion J-Hooks**

20. Release the J-hooks at the rear of the cushion (Figure 10).

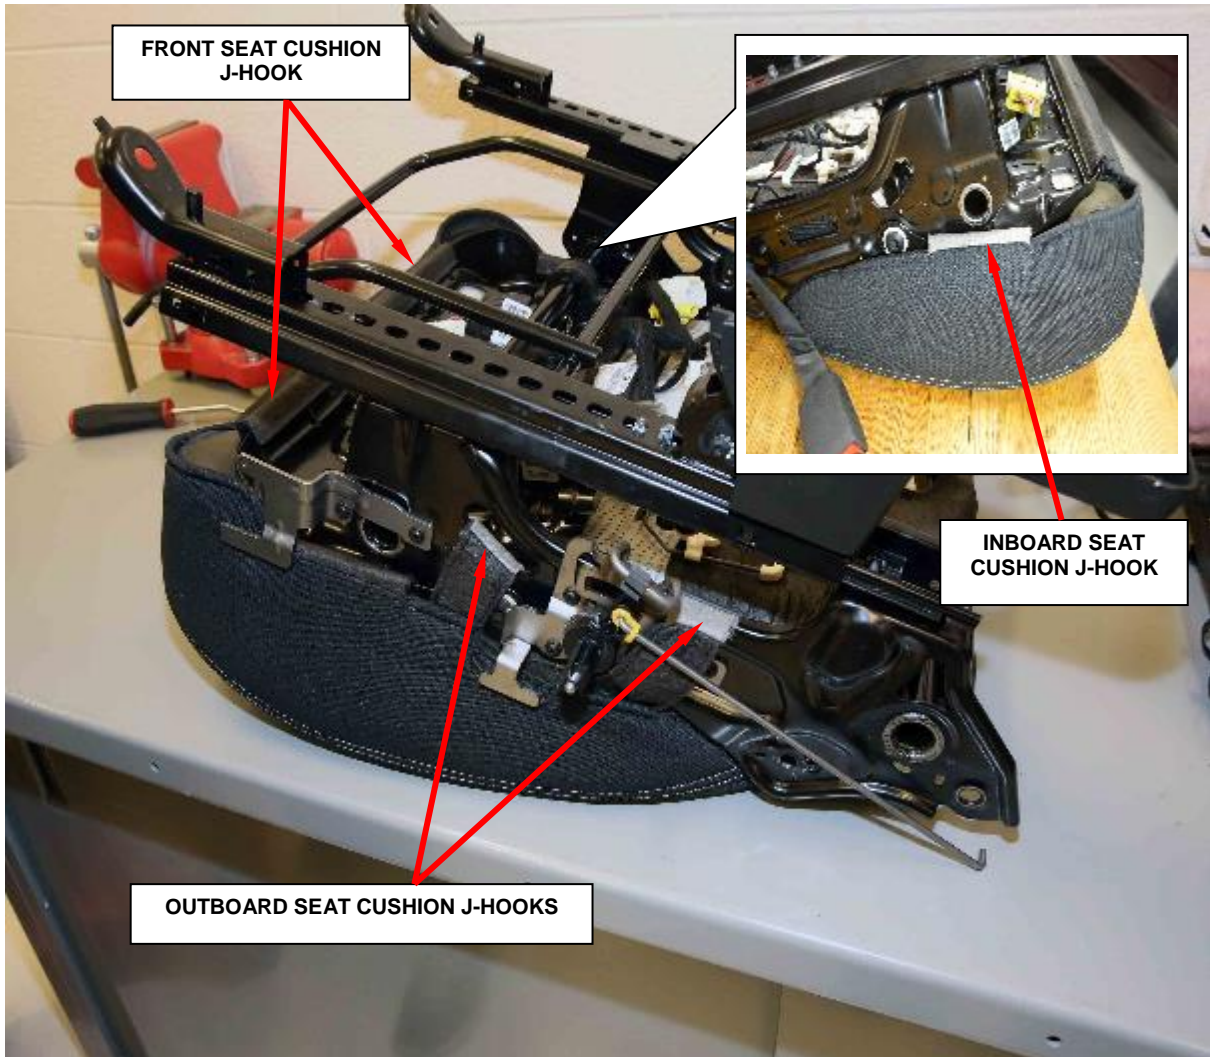
**Figure 11 – Seat Cushion J-Hooks**

21. Release the cover J-hooks at the front and sides of the seat (Figure 11).

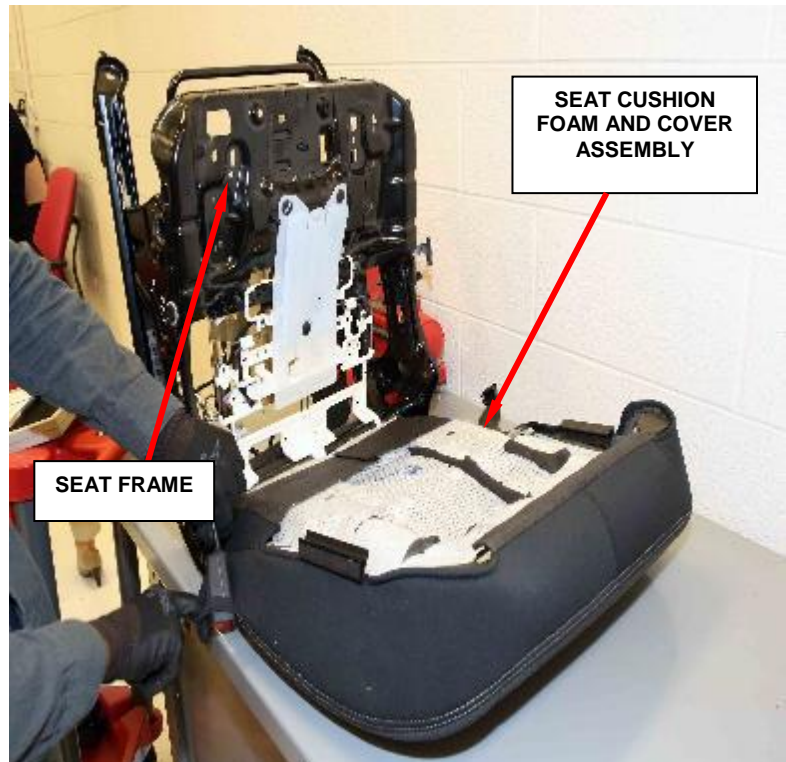
**Figure 12 – Seat Cushion**

- 22. Remove the seat cushion foam and seat cushion cover as an assembly, from the seat frame (Figure 12).

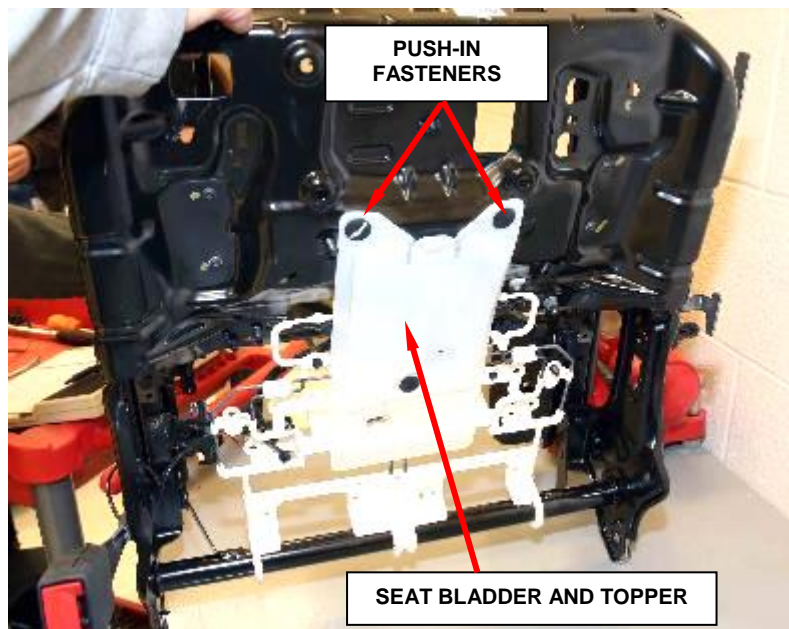
**Figure 13 – Seat Bladder**

- 23. Remove the two push-in plastic fasteners that secure the seat bladder and the plastic toppers to the seat cushion pan (Figure 13).

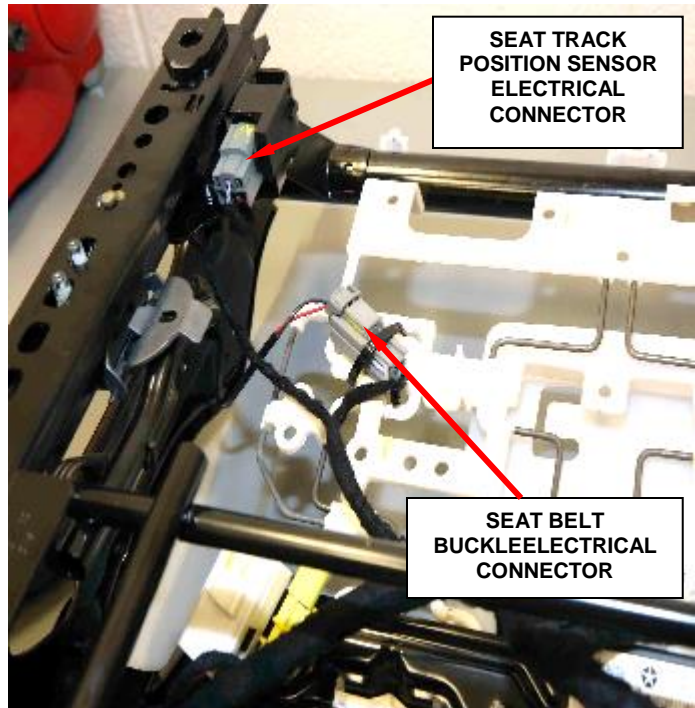
**Figure 14 – Electrical Connectors**

- 24. Disconnect the seat belt buckle electrical connector (Figure 14).

- 25. Disconnect the seat track position sensor electrical connector and release the harness from the bracket (Figure 14).

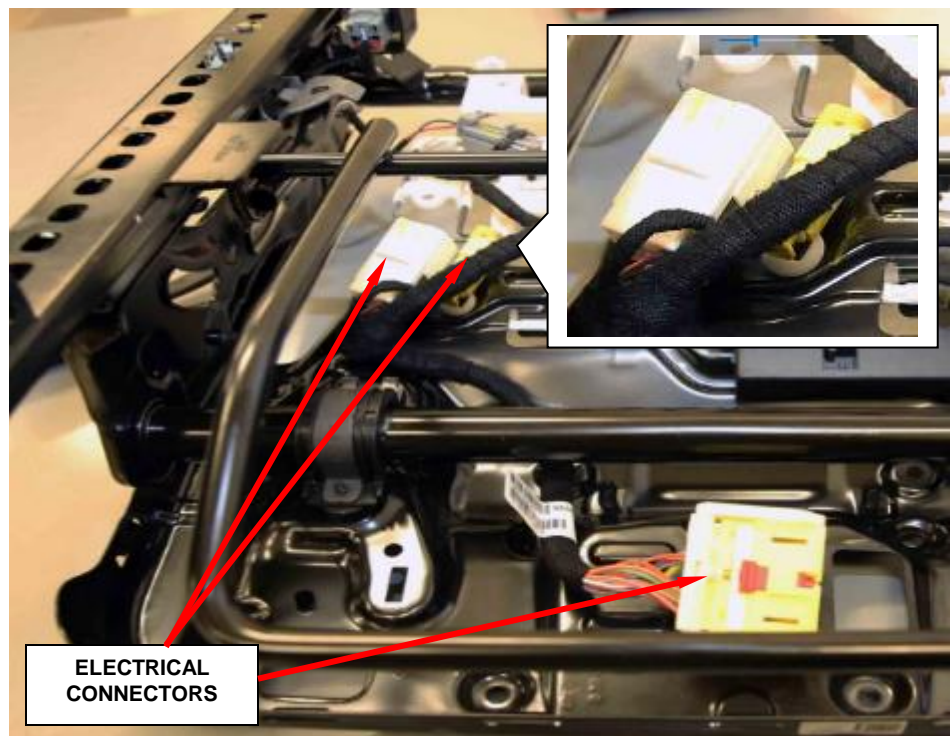
**Figure 15 - Electrical Connectors**

- 26. Release the three electrical connectors from the seat frame (Figure 15).

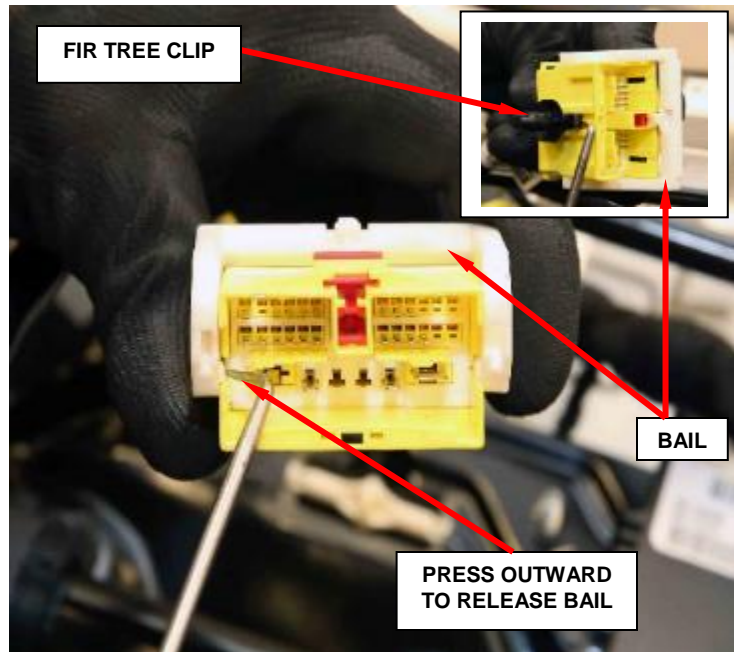
**Figure 16 – Seat Harness Connector**

27. Remove and save the fir tree clip from the seat harness connector (Figure 16).

28. Release the seat harness connector bail and rotate to the locked position to assist routing the connector under the structural support (Figure 16).

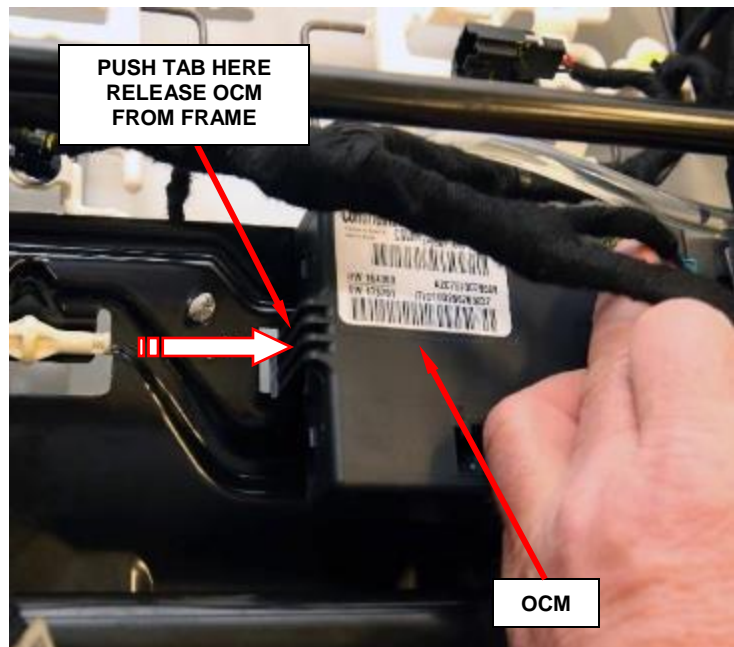
**Figure 17 - OCM**

29. Push the tab and release the OCM from the seat frame (Figure 17).

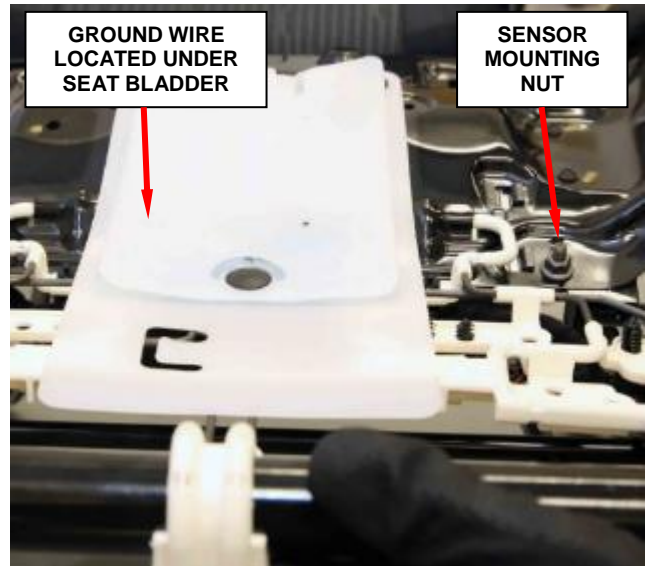
**Figure 19 – Ground Wire and Sensor Mounting Nut**

30. Remove the ground wire from the seat frame. (Figure 18).
31. Remove and save the OCM sensor mounting nut (Figure 18).
32. Remove the wire harness, seat bladder, the plastic toppers, the pressure hose and the OCM with integral electronic pressure sensor from above the front seat cushion as a unit (Figure 19).

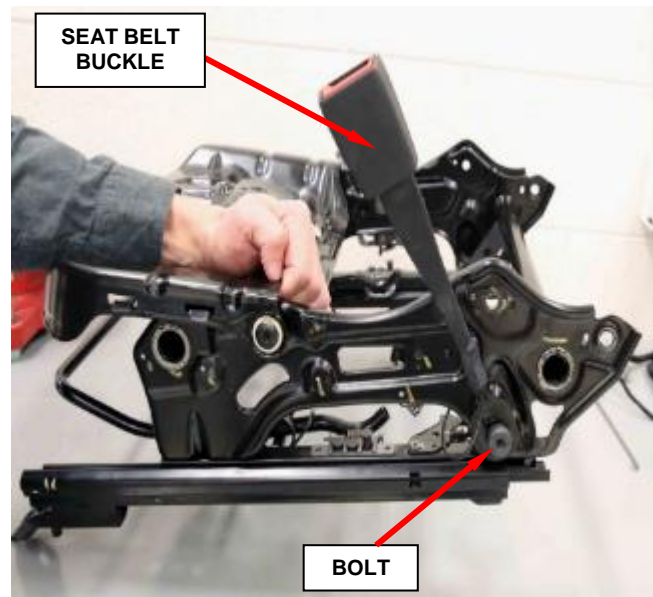
**Figure 20 – Transfer Seat Belt Buckle**

33. Remove the seat belt buckle and transfer to the **NEW** seat frame assembly. Tighten the bolt to 40 N·m (30 ft. lbs.). (Figure 20).

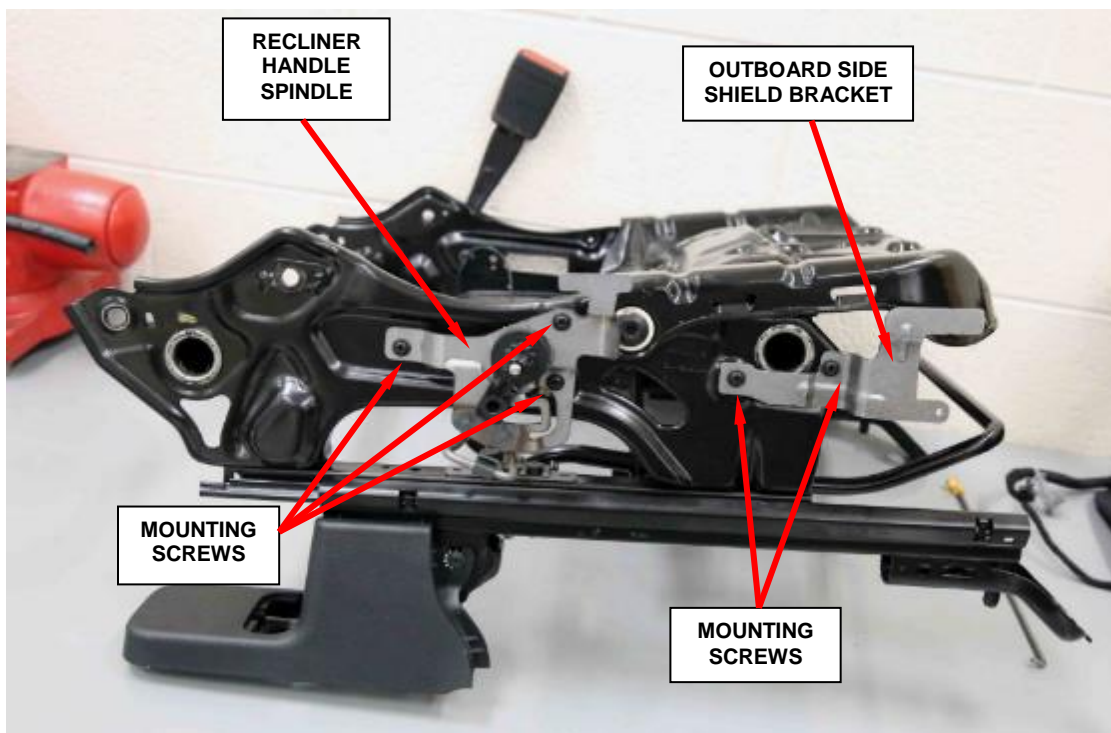
**Figure 21 – Transfer Spindle and Side Shield Bracket**

34. Remove the seat back recliner handle spindle and transfer to the **NEW** seat frame assembly. Tighten the screws securely. (Figure 21).

35. Remove the outboard side shield bracket and transfer to the **NEW** seat frame assembly. Tighten the screws securely. (Figure 21).

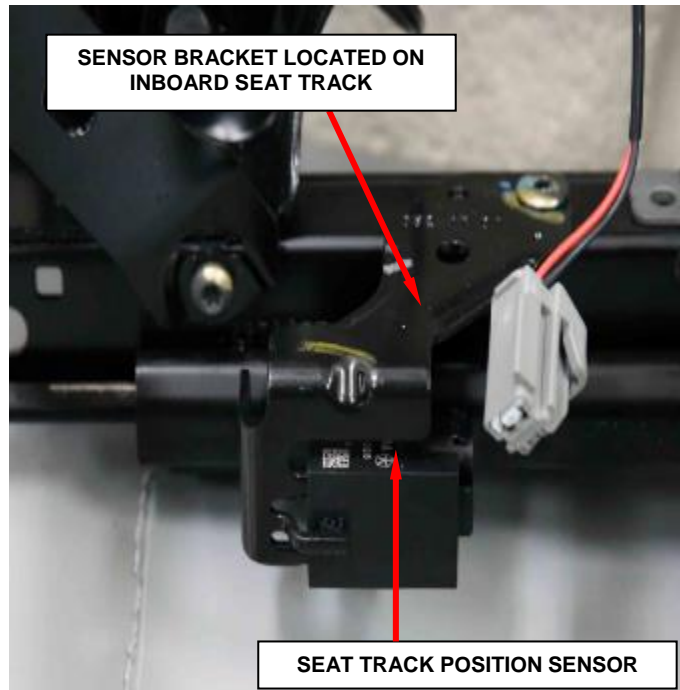
**Figure 22 – Transfer Seat Track Position Sensor**

- 36. Remove the seat track position sensor and transfer to the **NEW** seat frame assembly (Figure 22).

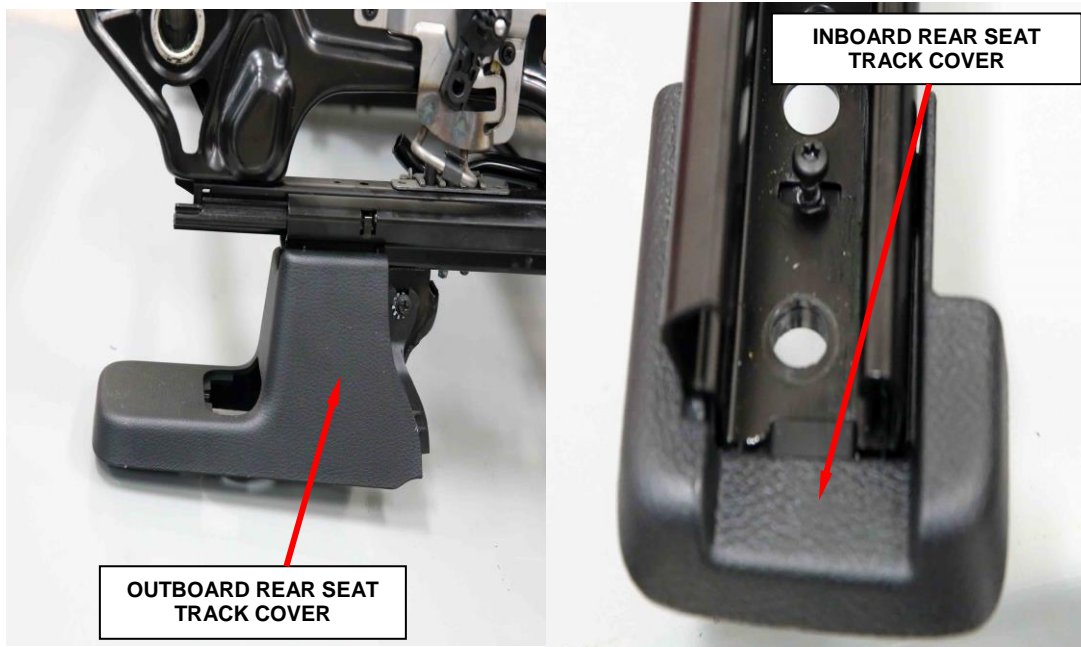
**Figure 23 – Rear Seat Track Covers**

- 37. Remove the rear inboard and outboard seat track covers and transfer to the **NEW** seat frame assembly. Tighten the screws securely. (Figure 23).
