CR167 – Oil Cooler Replacement

Panigale V4 - Panigale V4 S - Panigale V4 Speciale
Safety Recall Campaign SRV-RCL-18-006

Date: December 13, 2018
To: All required parties in descending order, Dealer Principal, General Manager, Service Manager, North American Dealer Network
From: Richard Kenton, Technical Director
Matthew Feinstein, Regulatory Compliance Manager

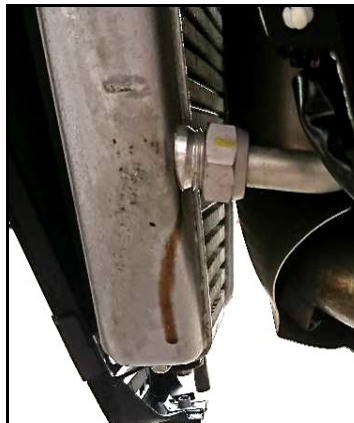
Continuous quality testing on the product pointed out a potential failure of the oil cooler at the delivery hose fitting (vehicle LH side) resulting in oil leakage. This phenomenon may occur under high performance use of the vehicle such as track riding.

The solution developed is to upgrade all affected bikes of this campaign and replace the oil cooler. The new part no. 54811364A is characterized by two reinforcement plates at the fitting points of the oil delivery and return hoses as shown in the figure.

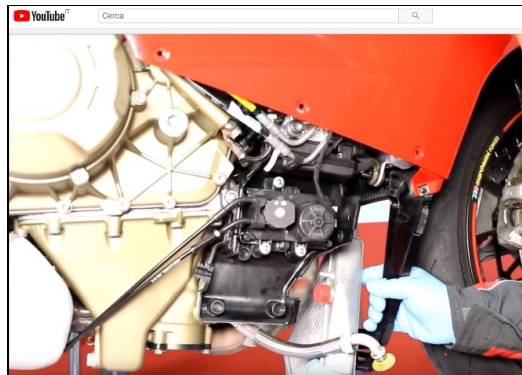
To tighten the nuts retaining oil delivery and return hoses to cooler you must use a torque wrench with 24 mm fork socket as shown.

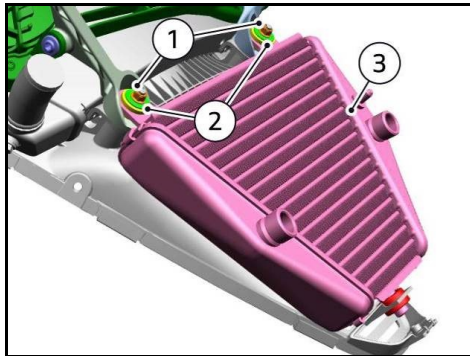
1. Position the bike on the rear paddock stand
2. Remove the lower half-fairings, on LH and RH sides of the bike (See Sec.5: "Fairing installation - Fairing" of the Workshop Manual)
3. Remove the **2 nuts (1)** and the relevant **spacers with collar (2)** retaining the **oil cooler (3)** to the Radiator Duct

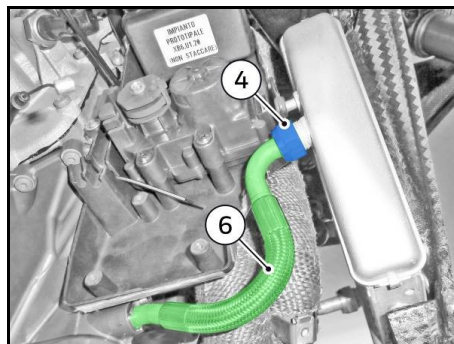
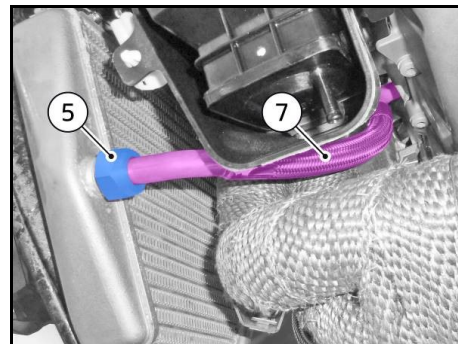
4. Remove the **nut (4)** and **nut (5)** retaining the **return hose (6)** and the **delivery hose (7)** of the oil cooler

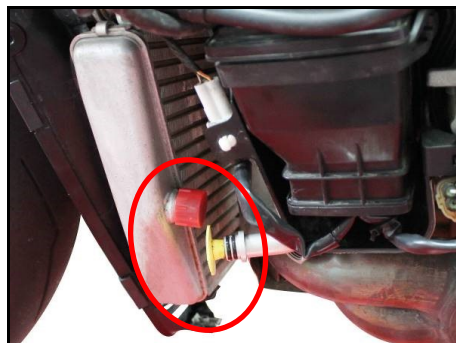
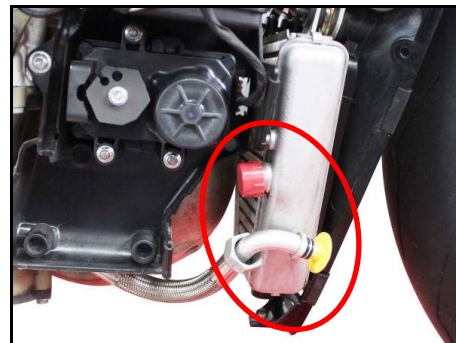
Prevent oil from leaking out of the cooler and delivery and return hoses using service caps (or equivalent) as shown in the figure

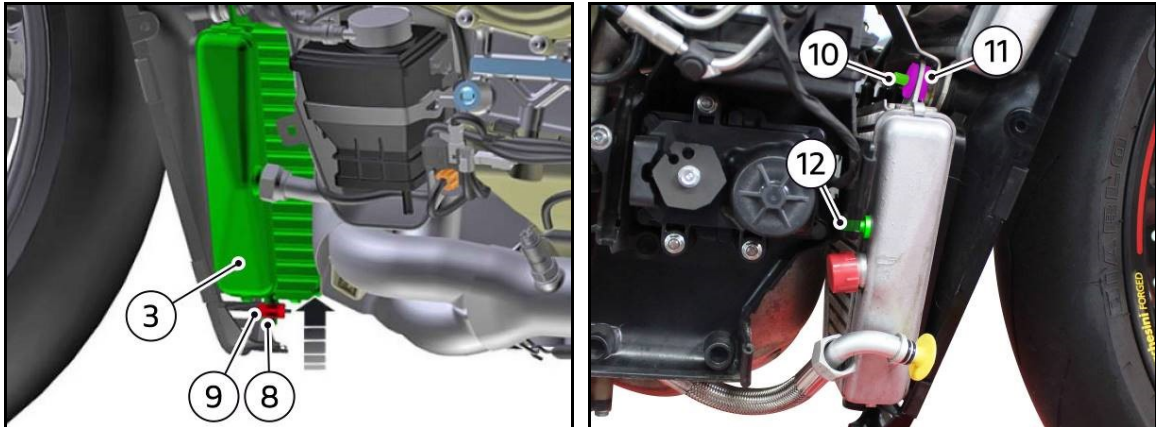
5. Remove the oil cooler (3):

- 5.1 Slide out pin (8) from the vibration damper (9) present on the Radiator Duct
- 5.2 Slide out the 2 stud bolts (10), on RH and LH side of the Rad-Duct, from the vibration dampers (11) present on the oil cooler
- 5.3 Slide pin (12) out of the exhaust butterfly valve motor support (motorcycle RH side)

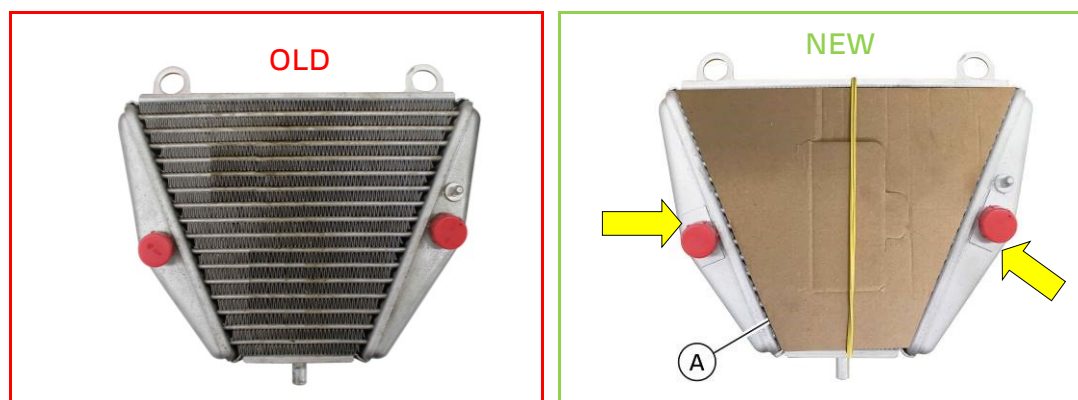
- 6.1 Take the new oil cooler (A) part no. 54811364A, characterized by two reinforcement plates installed at the fitting points of the oil delivery and return pipes as shown

Do not remove the two front and rear protections present on the oil cooler. This packaging is to protect the oil cooler fins and avoid damage during assembly

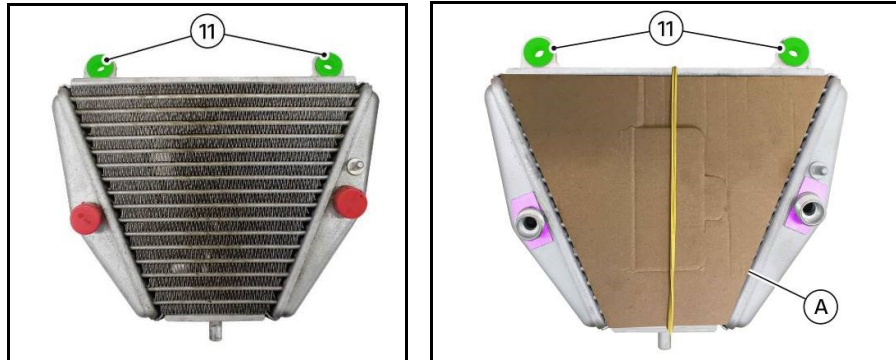
6.2 Remove the 2 vibration dampers (11) from the old oil cooler and install them to the new oil cooler (A)

6.3 Remove the service caps from the new oil cooler

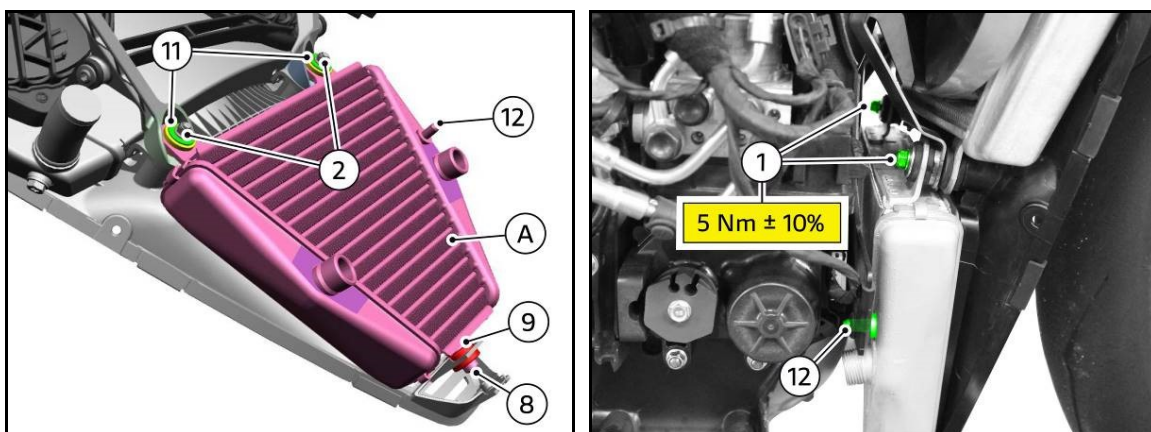
7. Install the new oil cooler (A) to the bike as follows:

7.1 Slide the oil cooler into place in relation to the radiator duct

7.2 Insert the pin (8) on the vibration damper (9) present on the Radiator Duct

7.3 Install the 2 vibration dampers (11) in the threaded stud bolts of the Radiator Duct

7.4 Insert the pin (12) into its vibration damper present on exhaust butterfly valve motor support (motorcycle RH side)

7.5 Install the 2 spacers with collar (2) on the 2 vibration dampers (11)

8. Start the 2 nuts (1) and tighten them to **5 Nm ± 10%**

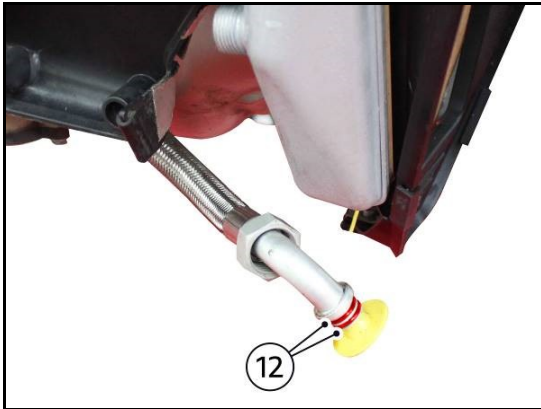
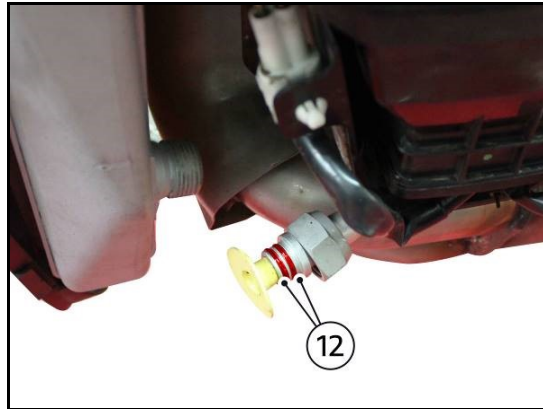
Before installing the oil cooler delivery and return hoses, apply engine oil to the 4 O-Rings (12) so as to avoid any damage during assembly.

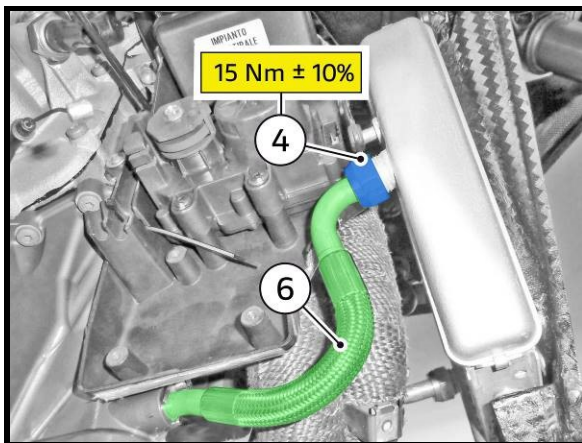
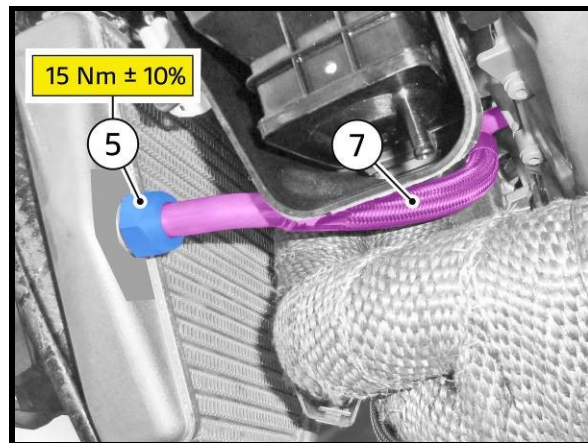
9. Remove the service caps from the oil cooler hoses

10. Install the oil cooler return hose (6) and delivery hose (7) tightening the nuts (4) and (5) to **15 Nm \pm 10%**

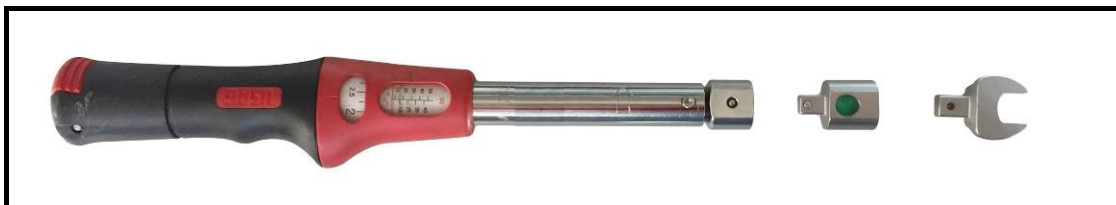
When tightening to the specified torque, if you use an adapter for the 24 mm fork insert make sure to adjust the torque value according to the torque wrench in use.

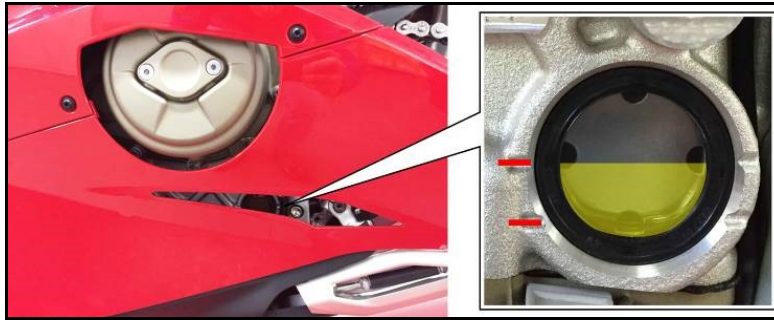
11. Remove the 2 front and rear protections from the oil cooler and clean any oil residues from the motorcycle
12. Restore the proper oil level in the engine
