Keystone RV Company

SAFETY ADVISORY # 19-340

Dexter Axle Inner Bearing Insufficient Grease

TITLE: Bearing Inspection and Replacement or Repacking		
AFFECTED SITE(s): VARIOUS		DEPARTMENT(s): Quality
Written By: Tim Cart / Sarah Riley	Approved By: John Jurek	Revision Date: 10/31/18

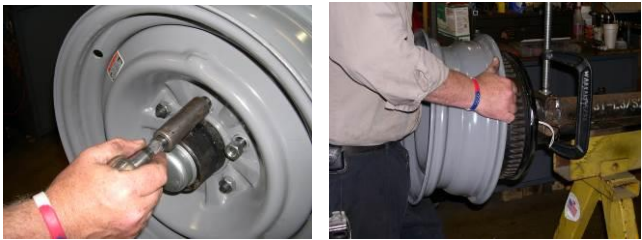
Bearing Inspection and Replacement or Repacking	
<p>Safety Note:</p> <p>Secure the trailer/axle according to the Dexter Light Duty 600-8K Complete Service Manual (LIT-001-00) instructions.</p> <p style="color: red;">Do not jack the trailer up on the axle tube.</p>	
1. Identify unit(s) needing to be inspected based on production dates provided by Dexter.	No photo
2. Raise and support the trailer (or loose axle). <u>NOTE:</u> Elevate and support the trailer unit per manufacturers' instructions.	No photo
3. Remove the wheel nuts with an impact gun or breaker bar and socket, and remove the tire and wheel.

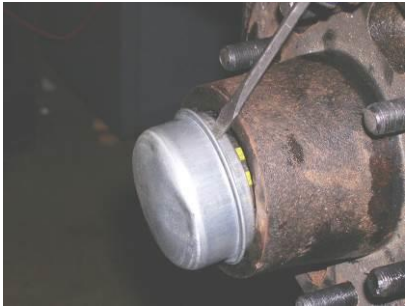
<p>4. Remove the grease cap using a cap remover or a hammer with a flat head screwdriver.</p>

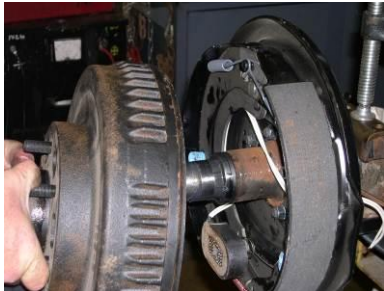
<p>5. Remove the hub (or hub & drum) from the spindle by hand.</p> <ul style="list-style-type: none"> (i) Remove spindle nut retainer. (ii) Unscrew spindle nut counterclockwise. (iii) Remove spindle washer. (iv) Remove hub from spindle being careful not to drop outer bearing cone <p>NOTE: It may be helpful to use the cap to catch the bearings as they come off the spindle.</p>

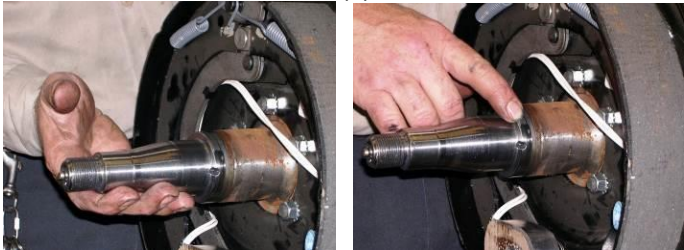
<p>6. Inspect the magnets, shoes, and linings for contamination.</p> <p>Caution: Brake linings or magnets must be replaced if covered with grease or oil. Do not try to clean contaminated parts.</p>	<p>No photo</p>
<p>7. Inspect spindle for damage.</p> <ul style="list-style-type: none"> (i) Clean the spindle with a towel. (ii) Feel for any spindle or seal journal damage by hand. <p>NOTE: If the seal journal or spindle is damaged, the axle must be replaced.</p>	<p>(i)</p>

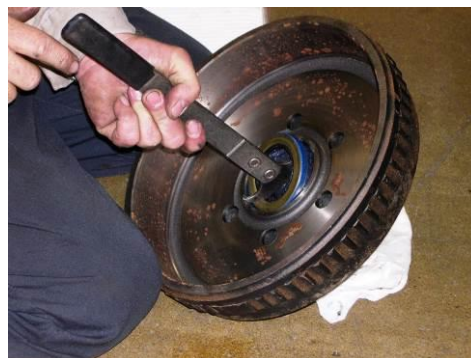
8. Remove the seal from the drum using a seal puller. Ensure seal journal is not damaged during seal removal, and discard seal.

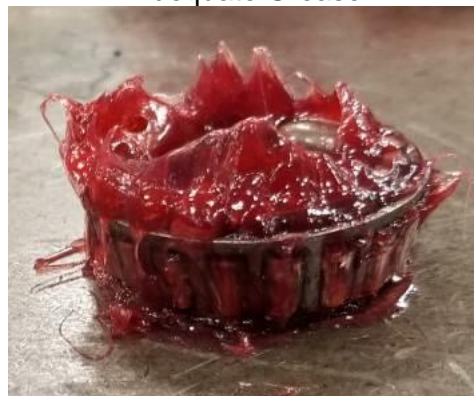
Adequate Grease

Adequate grease:

- A. Grease must be between rollers
- B. A 1/4" bead of grease must be visible opposite the filling side
- C. Exterior of rollers coated with grease

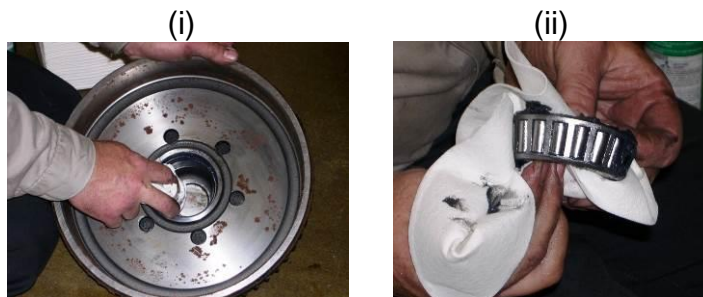
10. Inspect bearings for damage or discoloration.

(i) Clean bearing cone and the inside of the hub and drum with a towel and suitable solvent.
NOTE: Bearing should be as clean as possible to prevent contaminating new grease.

(ii) Inspect both bearing cups and cones for any damage such as pitting, spalling, or corrosion (see Appendix C for example photos).
NOTE: If damage is observed, contact your Original Equipment Manufacturer of the camper or Dexter Service and Warranty for replacement hub and bearing cones. Please have axle serial number available during communication.

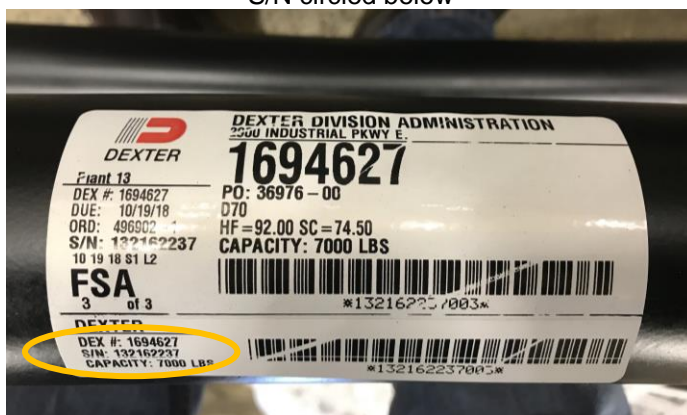
Serial Number (S/N) found on center of axle beam, S/N circled below

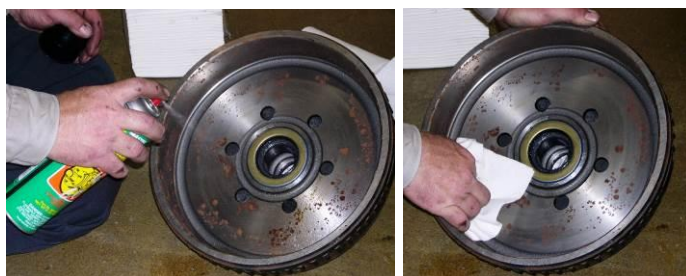
11. Clean the brake drum using a brake cleaner and a towel.

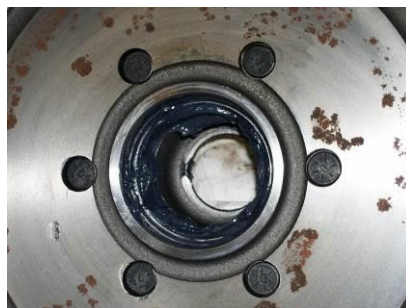
12. Re-install inner bearing.

NOTE: Ensure outer bearing is adequately greased per step 9.

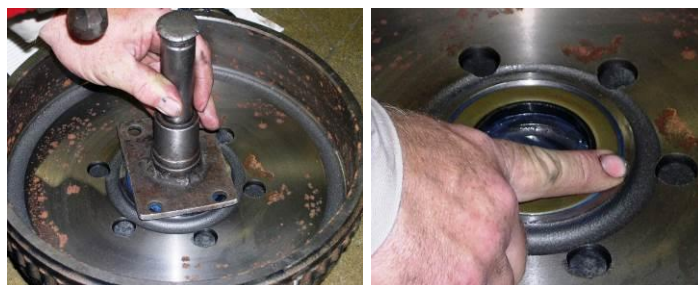
13. Install a new seal using a hammer and a block of wood or flat piece of steel set on top of the seal (installation instructions in Appendix E).

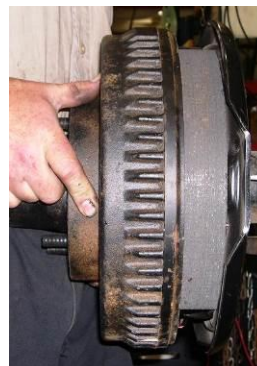
14. Carefully remount the hub (or hub & drum) onto the spindle by hand.

Caution: Do not force the hub or hub and drum onto the spindle. When hub and drum are properly aligned with spindle, it will install with minimal resistance.

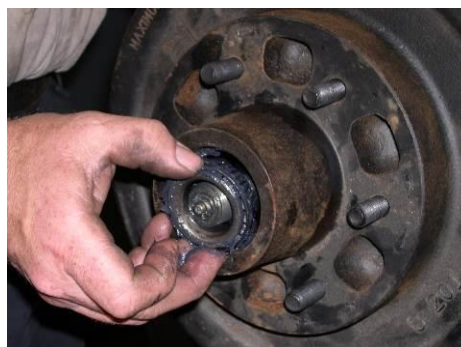
15. Install greased outer bearing cone.

NOTE: Ensure outer bearing is adequately greased per step 9.

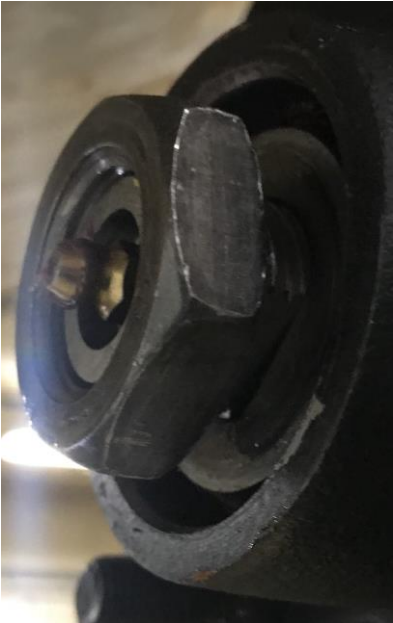
<p>16. Install the D-washer and spindle nut.</p>

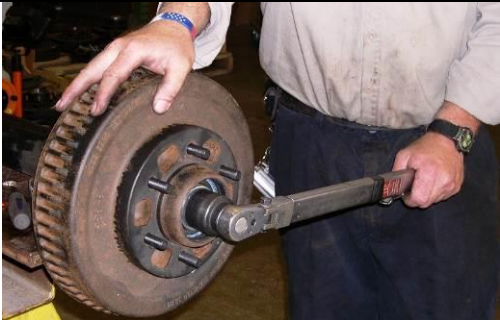
<p>17. Slowly turn the hub on the spindle while tightening the spindle nut to 50 ft-lbs with a torque wrench.</p> <p>NOTE: Spinning the hub will seat and properly align the bearing cups.</p>

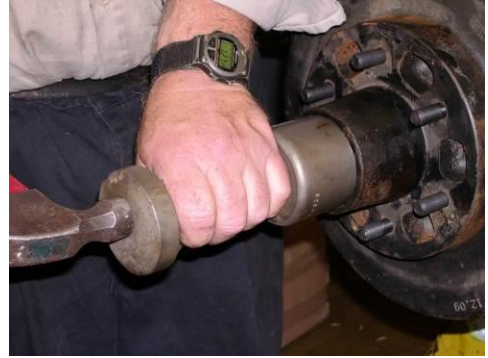
21. Install the grease cap using a cap driver and a hammer or mallet.

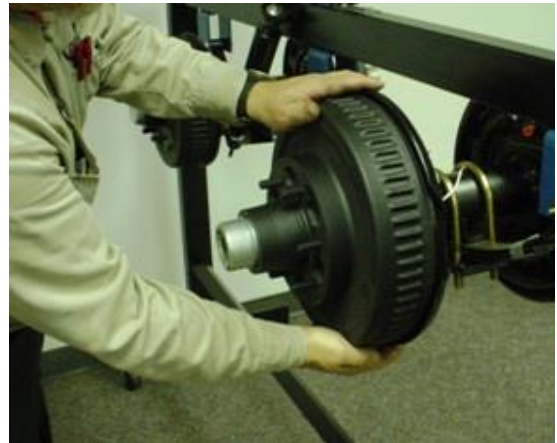
22. Pull and push the hub assembly towards and away from you to check for excessive end play.

NOTE: Slight wheel end play is acceptable. Any excessive end play may be corrected by re-torquing the spindle nut (steps 17-19).

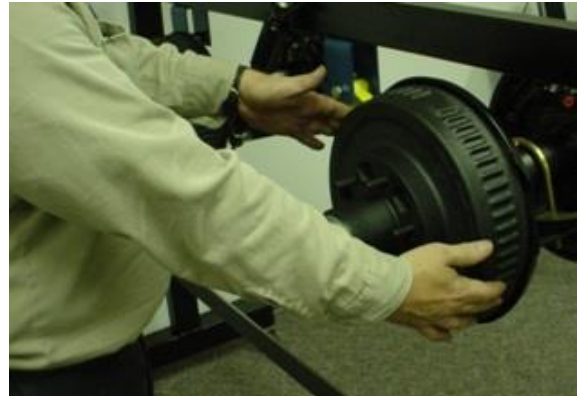
23. Rotate hub slowly forwards and backwards. The wheel assembly should turn freely and smoothly.

NOTE: Readjusting the brake may correct any dragging.

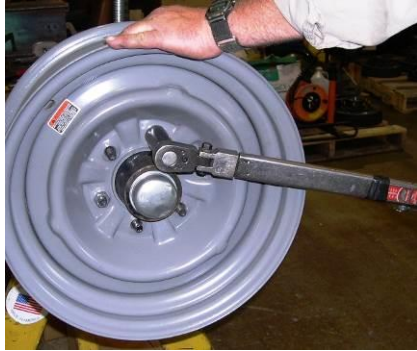
<p>24. Remount the tire and wheel by tightening the wheel nuts with a torque wrench and socket to manufacturer's recommended specifications.</p>

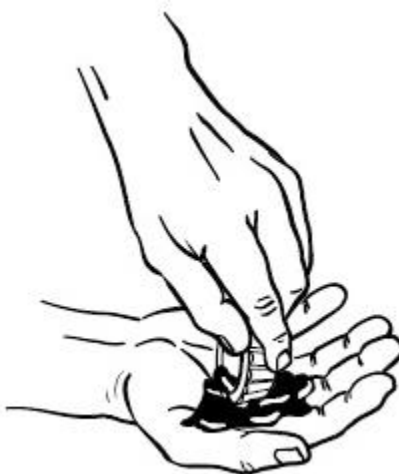
1. Place a quantity of grease into the palm of your hand.
2. Press a section of the widest end of the bearing into the outer edge of the grease pile closest to the thumb forcing grease into the interior of the bearing.
3. Repeat this while rotating the bearing from roller to roller.
4. Continue this process until you have the entire bearing completely filled with grease.

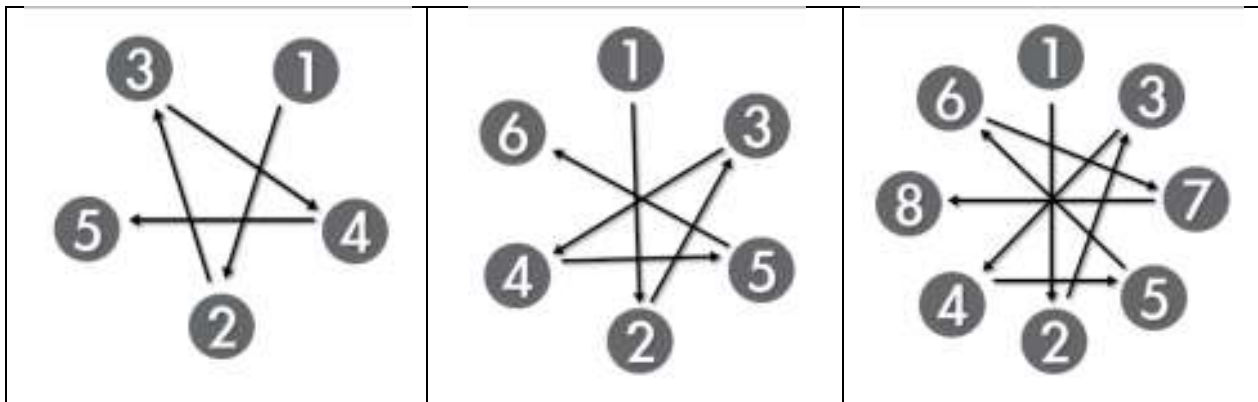
Fig. 1

Step 3 You must use the star pattern and torque wrench when tightening the lug nuts to the wheel. This sequencing pattern shows how to progressively tighten the lug nuts to best achieve the proper torques and clamp load. See Figure 1.

Step 4 Using the star pattern outlined in Figure 1, tighten the lug nuts until the 1st stage torque (20-25 ft/lbs) outlined in Figure 2 is achieved. Verify the lug nuts are properly positioned in the tapered seats of the wheel.

Step 5 Using the star pattern outlined in Figure 1, tighten the lug nuts until the 2nd stage torque (50-60 ft/lbs) outlined in Figure 2 is achieved.

Step 7 Using the star pattern outlined in Figure 1, tighten the lug nuts until the 3rd and final stage (110-120 ft/lbs) is achieved. See Figure 2.
