December 1, 2018

Safety Recall: B-Pillar Trim Clip Mounting Hole

AFFECTED VEHICLES

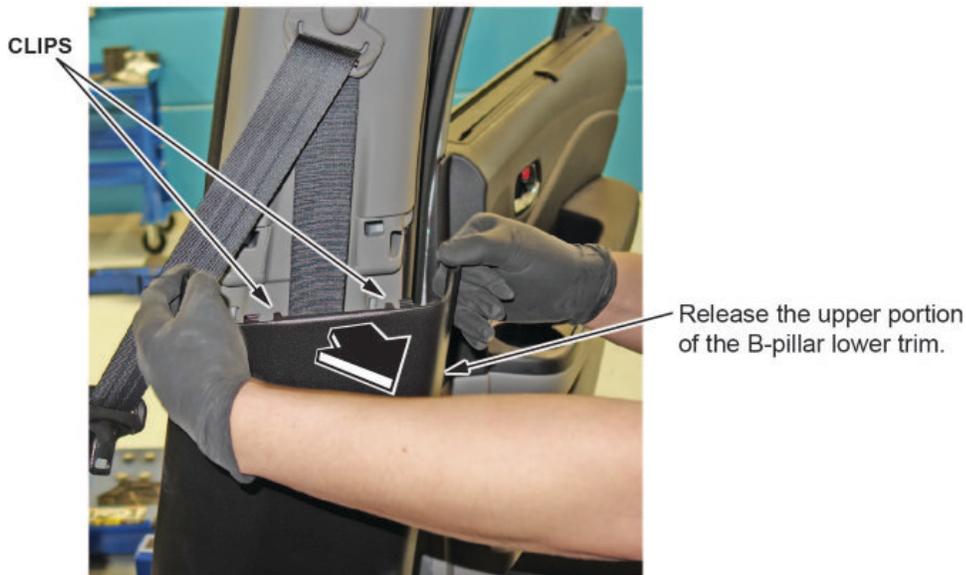
1. Move the front passenger's seat all the way forward, and fold the seat-back fully forward.
2. Do the battery terminal disconnection procedure, and wait at least 3 minutes before starting work.
3. Pull back the top part of the B-pillar lower trim.

The B-pillar lower trim does not have to be completely removed; only remove enough to access the B-pillar upper trim.

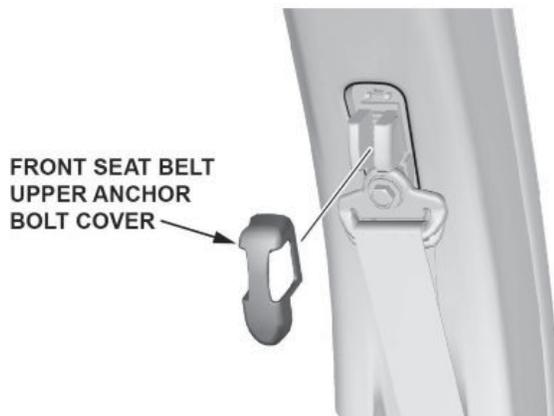
4. Remove the front seat belt upper anchor bolt cover.

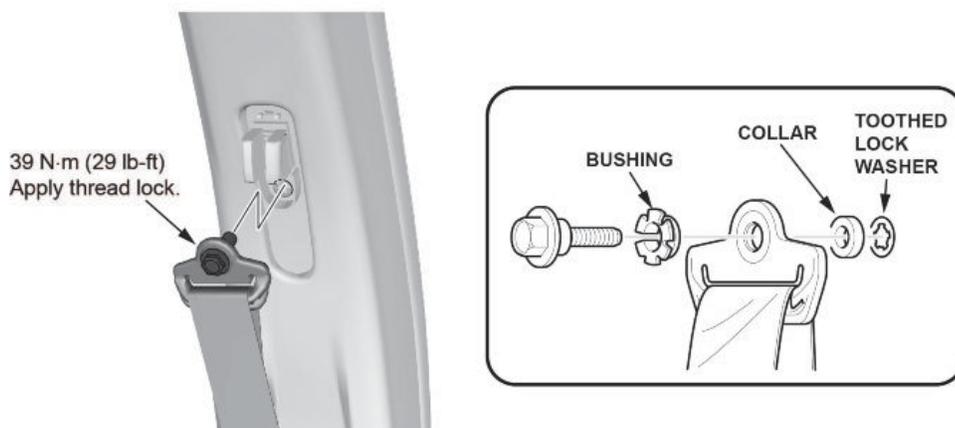
5. Remove the front seat upper anchor.

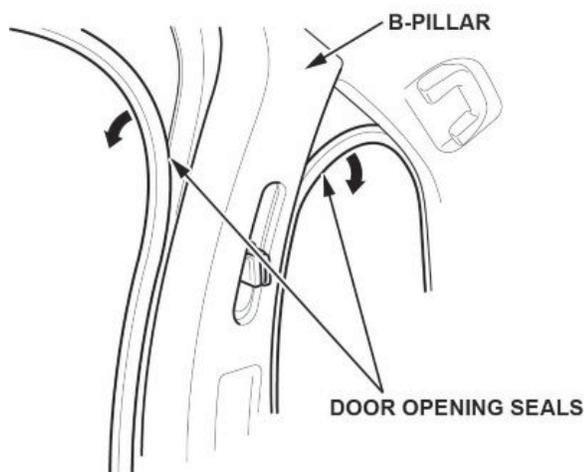
6. Pull back enough of the door opening seals to access the B-pillar upper trim.

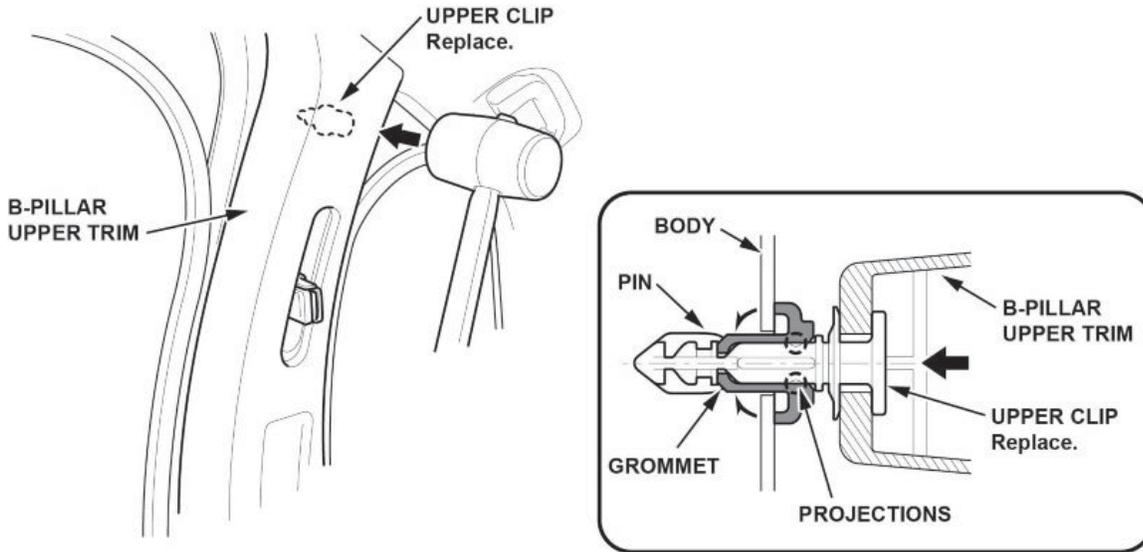
7. Using a rubber mallet, hit the upper clip in the B-pillar upper trim to break it, which allows you to remove it.

Place a clean shop towel over the B-pillar upper trim to avoid marring it.

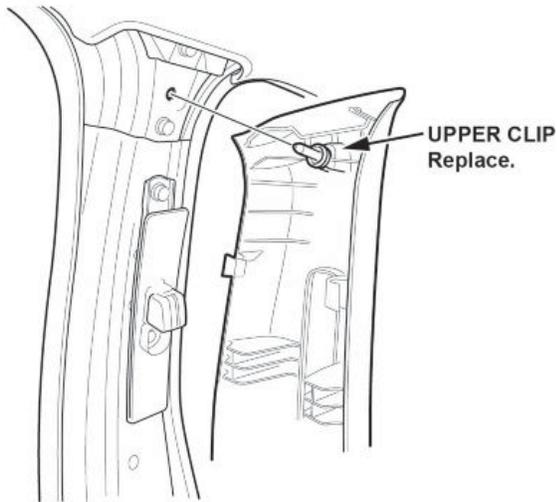
8. Pull back the top of the B-pillar upper trim to remove the upper clip from the body, then remove the trim.

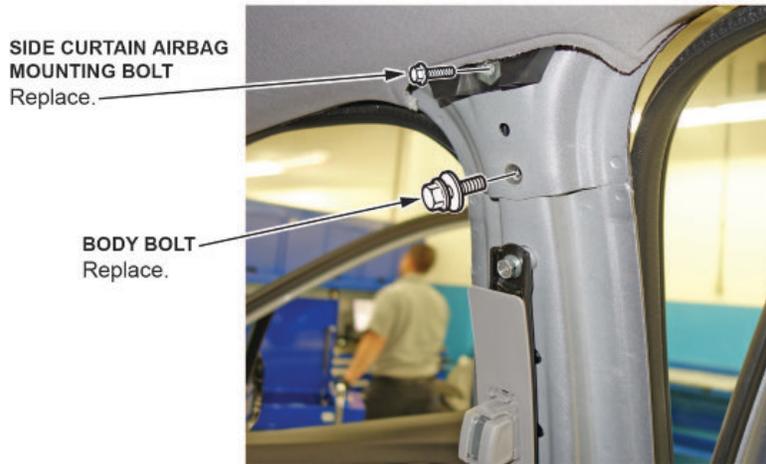
9. Install the B-pillar bracket.

9.1. Remove the side curtain airbag mounting bolt.

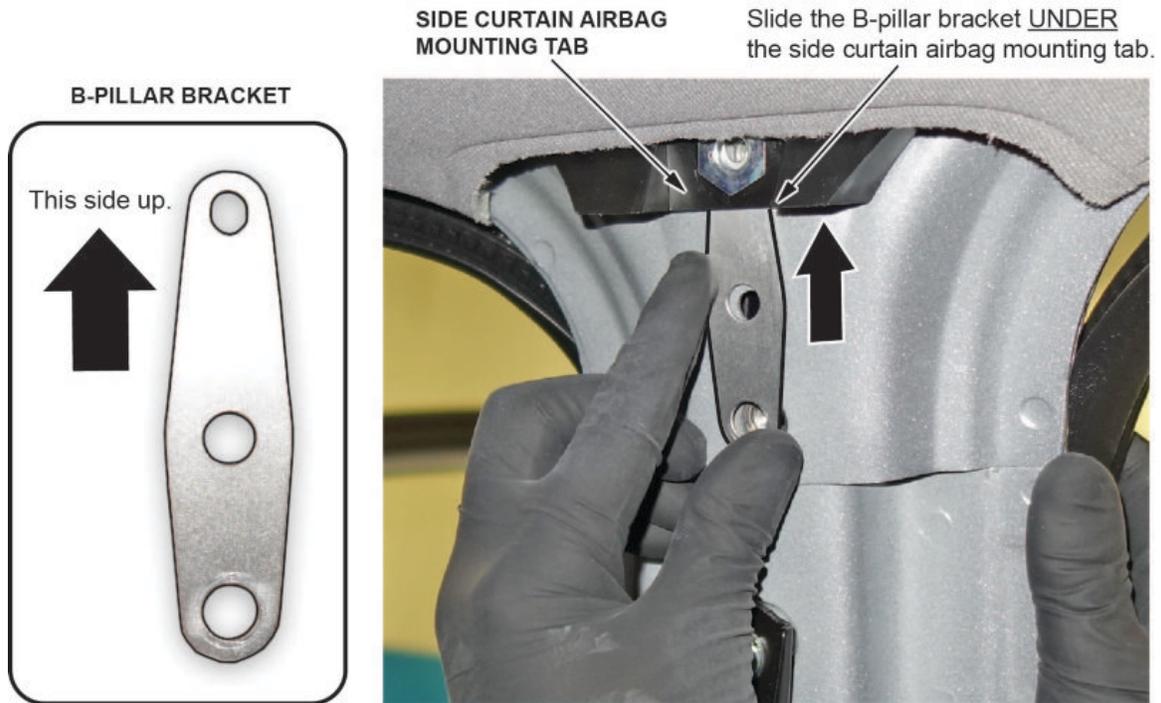
9.2. Remove the body bolt as shown.

9.3. Position the B-pillar bracket under the side curtain airbag mounting tab.

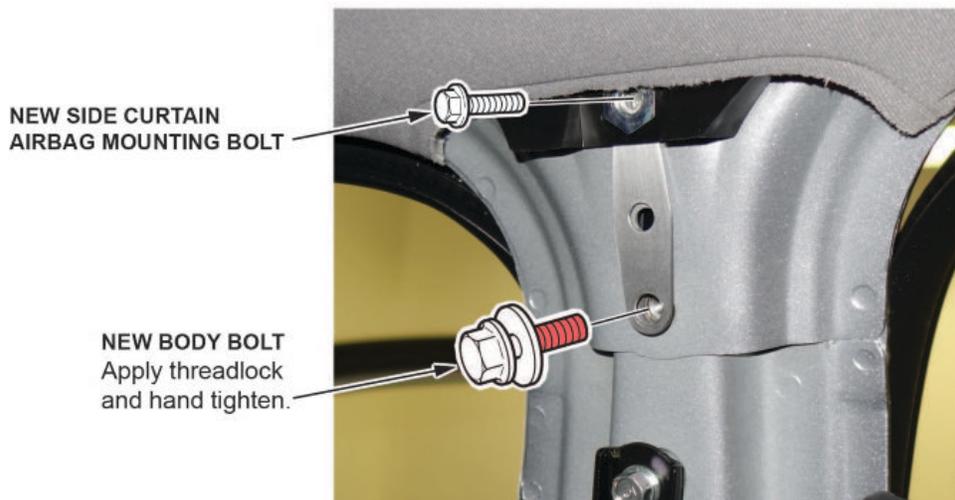
9.4. Install the new side curtain airbag mounting bolt, finger tight.

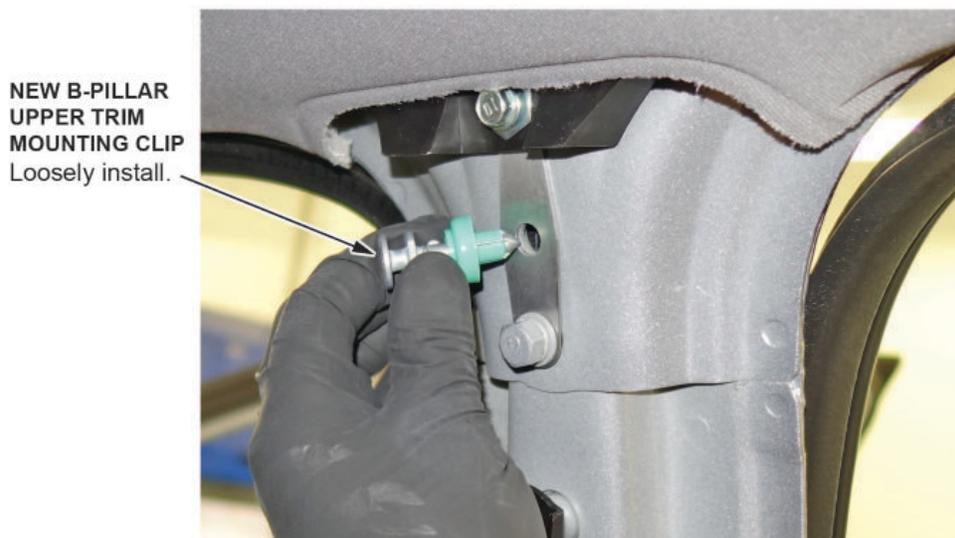
9.5. Apply Hondaloc3 threadlock to the new body bolt, and install it finger tight.

9.6. Align the bracket hole with the original clip hole by inserting the new B-pillar upper trim mounting clip into the bracket hole.

Use the clip as a guide. Do not push it in all the way or set it because you'll have to break it to remove it.

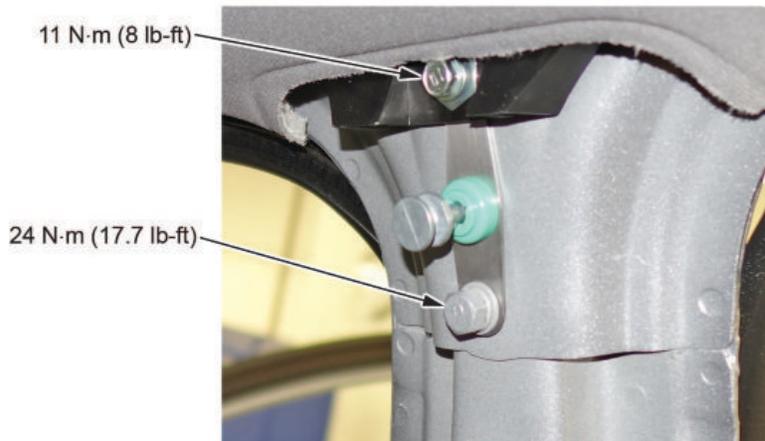
9.7. With the clip in the hole, torque the two bolts to the following specifications:

- Side curtain air bag mounting bolt: **11 N·m (8 lb-ft)**.
- Body Bolt: **24 N·m (17.7 lb-ft)**

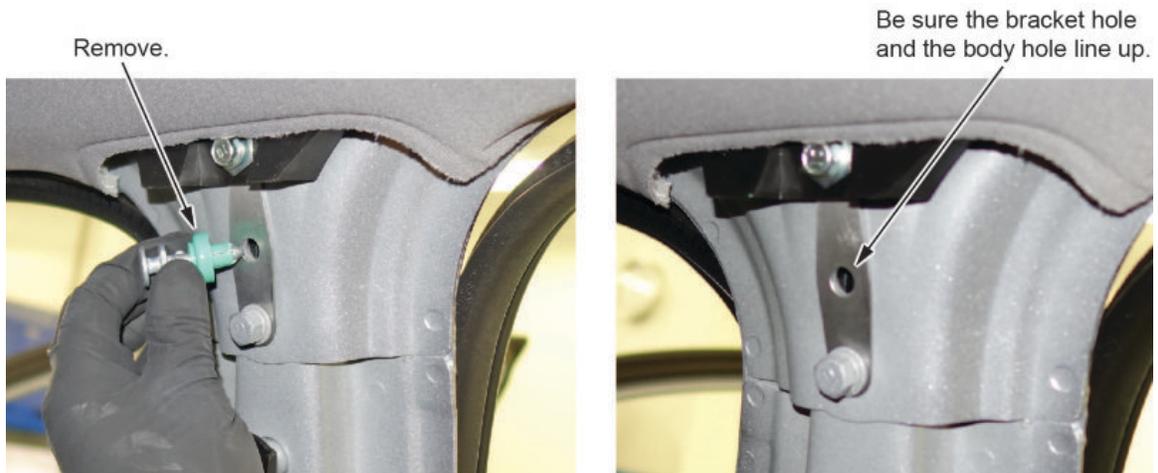
9.8. Remove the clip, and confirm the bracket hole is aligned with the original hole.

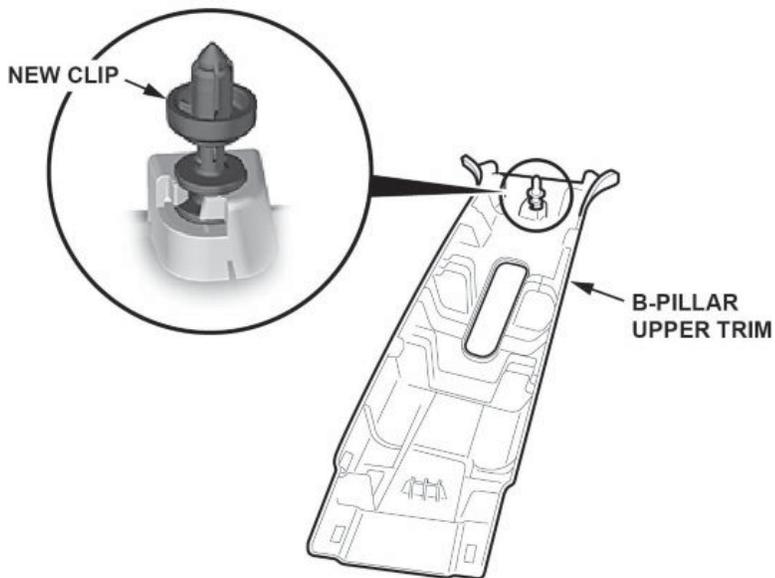
10. Install the new clip in the B-pillar upper trim, then install the trim.
