TITLE: REAR BRAKE HOSE & SENSOR WIRE INSPECTION**RECALL**

2018 Z900, 900 ABS & Z900 RS REAR BRAKE HOSE & SENSOR WIRE INSPECTION

NHTSA RECALL NO. 18V-866

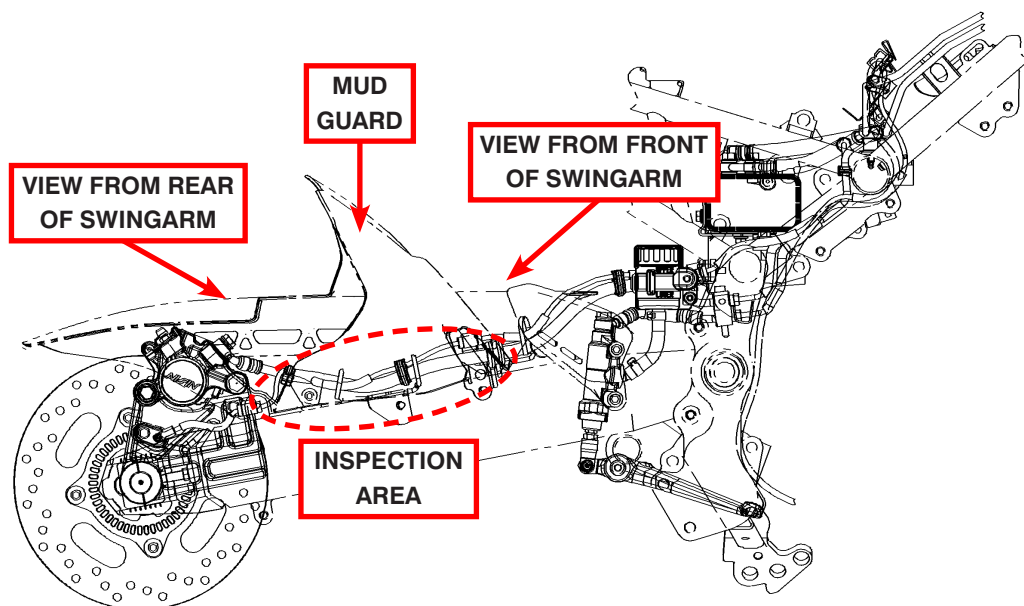
View the mud guard on the right hand side of the swing arm from the front and rear as shown below.

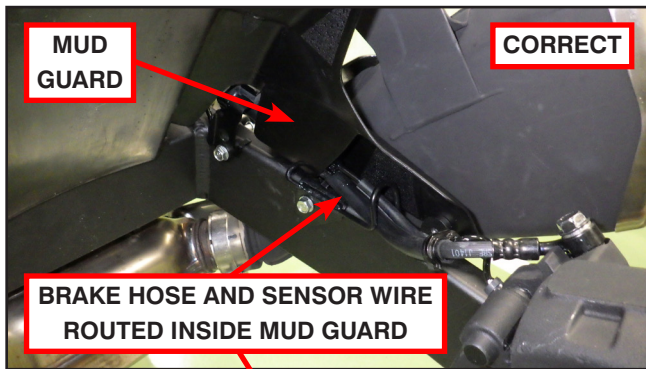
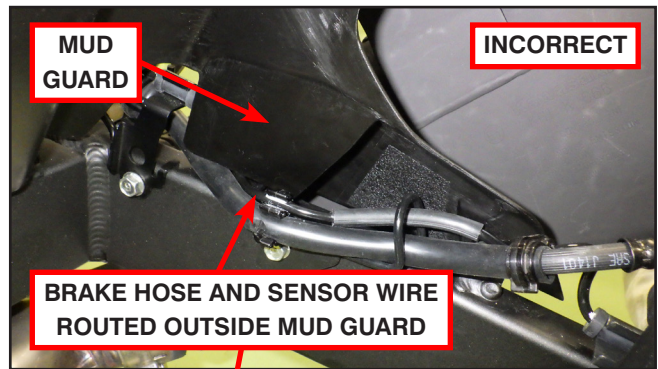
VIEW FROM REAR OF SWINGARM

- ★ If the rear brake hose and rear wheel rotation sensor wire are both inside the mud guard as shown in the “**CORRECT ROUTING**” images below, the routing is correct. No further action is required. Proceed to the “Warranty Information” section of this bulletin.
- ★ If the rear brake hose and/or rear wheel rotation sensor wire are outside the mud guard as shown in the “**INCORRECT ROUTING**” images below, check the brake hose and the rear wheel rotation sensor wire and the clamp for damage.
 - If the hose AND wire have NOT been damaged, proceed to the “Reroute” section of this bulletin.
 - If the hose or the wire have been damaged, proceed to the “Replace” section of this bulletin.

If the rear brake hose and rear wheel rotation sensor wire are NOT inside the mud guard, refer to the appropriate chapters in the service manual and disassemble the mud guard, correct the routing, then reassemble the mud guard

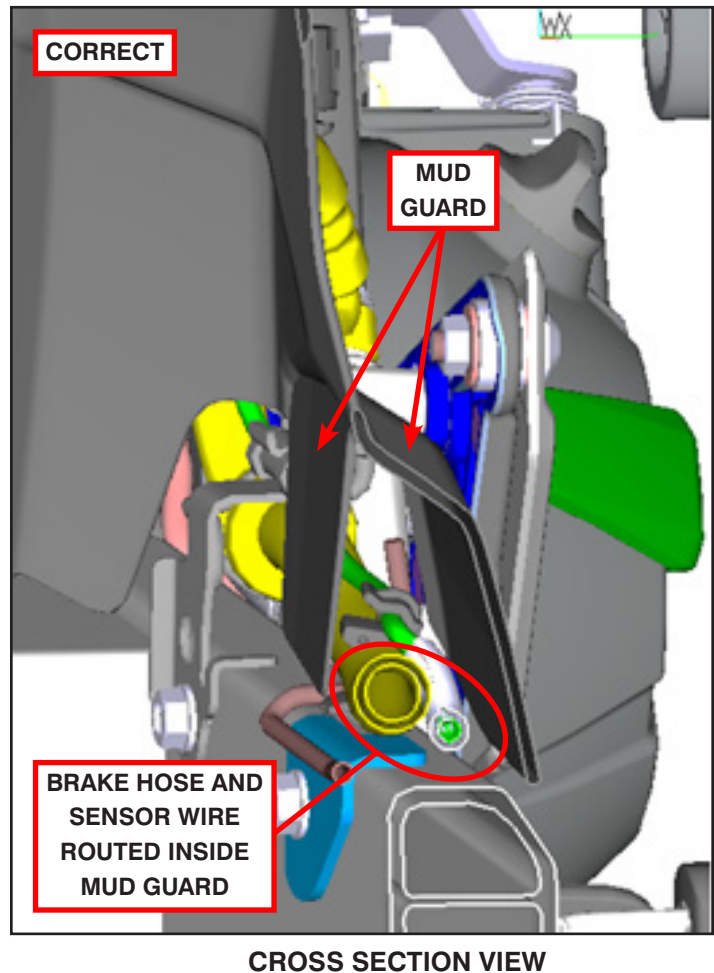
- o During reassembly, be sure to route the rear brake hose and rear wheel rotation sensor wire **INSIDE THE MUD GUARD** as shown in the image to the right.

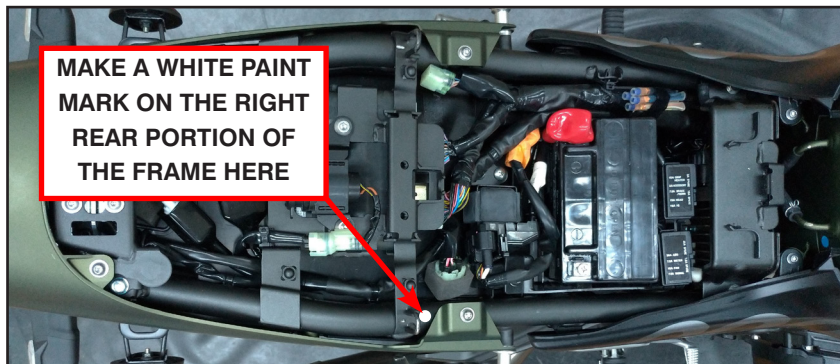
Make a white paint mark on the right/rear portion of the frame under the seat as shown below to serve as repair verification.
