# Recall Campaign

FL801AB

## Subject: TBB Saf-T-Liner C2 Roof Header Adhesive

**Models Affected: Specific Model Year 2017-2019 Thomas Built Buses Saf-T-Liner C2 buses manufactured July 1, 2016, through June 8, 2018.**

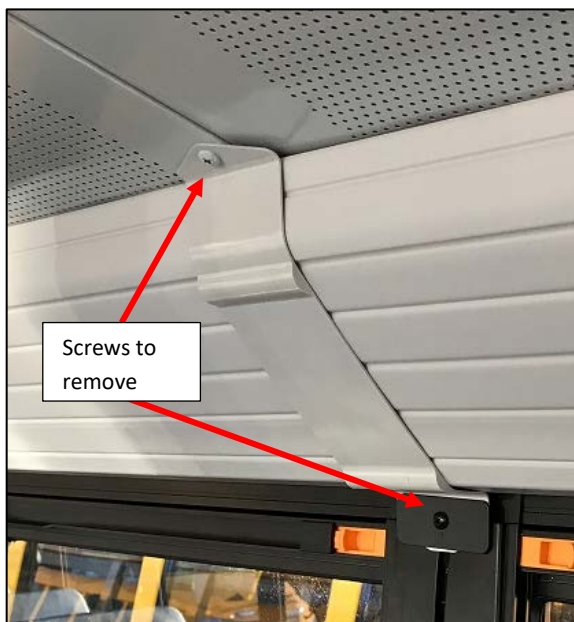
Figure 1: Header Cover Screw Location

1. Park the vehicle on a level surface, turn the key completely off, put the bus in Park, and set the parking brake. Chock the tires.
2. Starting at the back of the bus, remove the header covers by removing the screws shown in **Figure 1**, the cover supports, and the black clip between windows. The covers will pull off the bottom ridge. Retain the supports and screws for reinstallation.

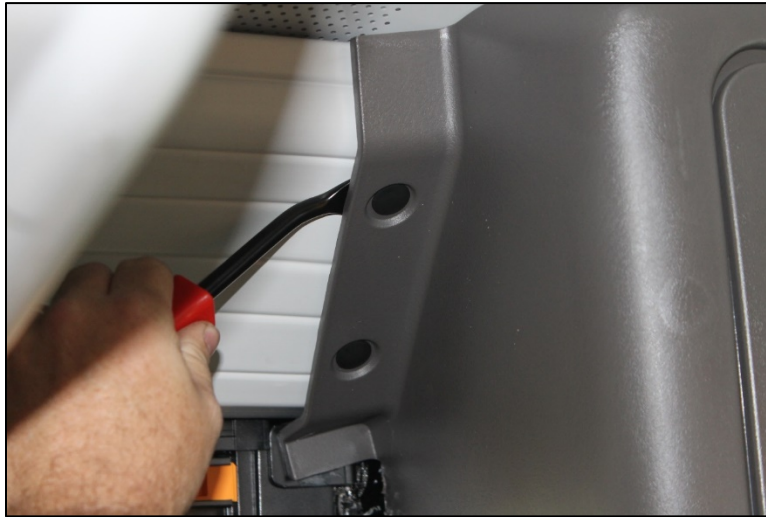
**Figure 2: Removing "Christmas Trees" (Driver's Side Shown)**

3. Remove the two "Christmas trees" on the entrance door cover at the front passenger side of the bus and the two "Christmas trees" on the 2-10 box above the front driver's side. Retain for reinstallation. See **Figure 2**.

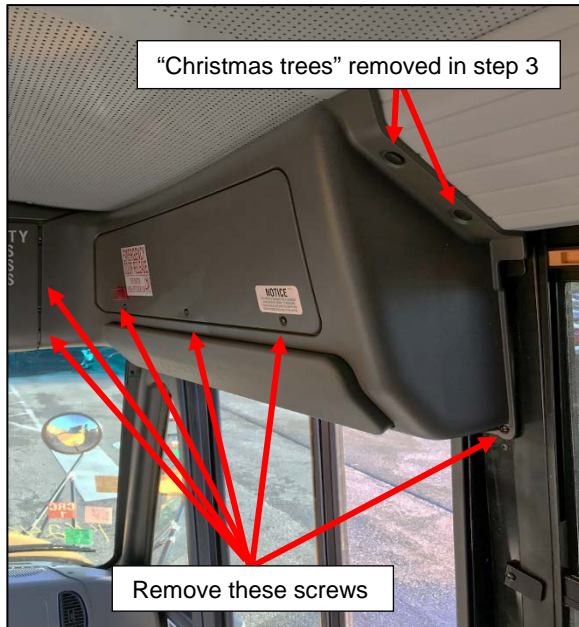
Figure 3: Entrance Door Cover & Screw Locations

4. Remove screws from the cover above the entrance door (required to add the additional screws at the front rafter). Retain for reinstallation. See **Figure 3**.
5. Remove the two screws behind and the one screw underneath the front entrance door cover. Retain for reinstallation. See **Figure 4**.
6. After verifying all of the screws have been removed, carefully take off the cover and set aside for reinstallation.
7. Remove the screws at the top of the interior. Retain for reinstallation. See **Figure 5**.
8. On the driver's side, remove the 2-10 box. (This is very similar to the removal of the entrance door cover.)
9. Remove the two "Christmas trees" at the back of the box. Retain for reinstallation.

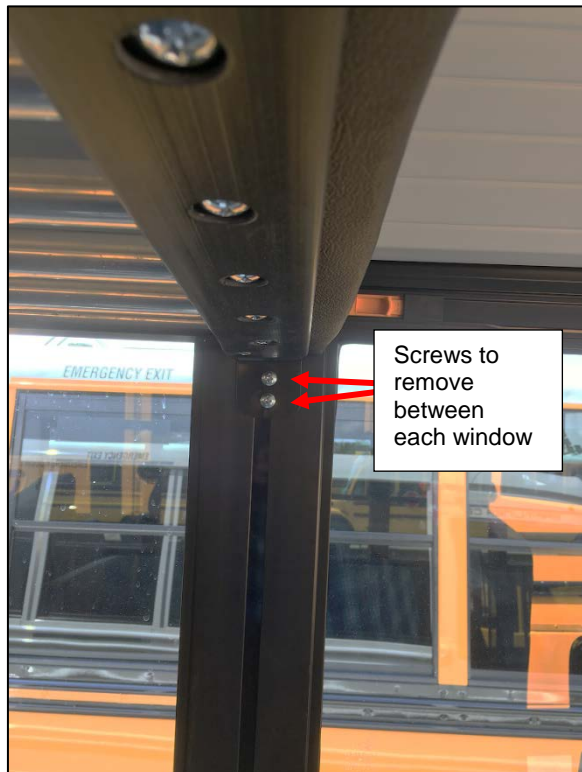
Figure 9: Removing the screws on rack at windows

2. Starting at the back of the bus, remove the screws holding the luggage rack to the sidewall, between the windows. Retain for reinstallation. See **Figure 9** and **Figure 10**.

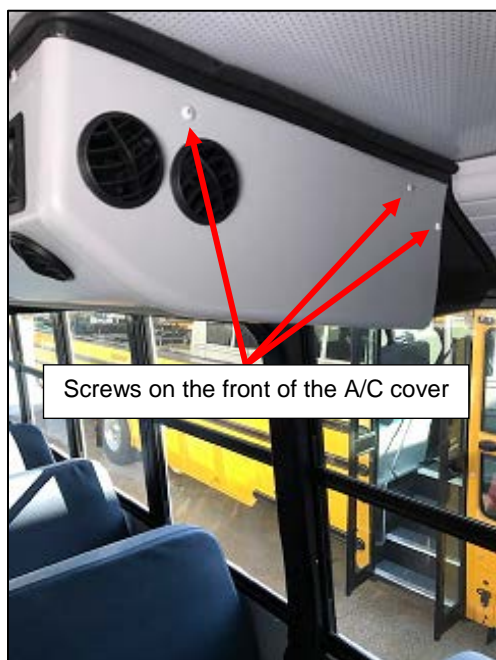
Figure 11: A/C Cover Screw Locations (Front and Sides)

1. Remove the A/C cover by removing screws on the front, sides, and underneath. Retain for reinstallation. See **Figure 11** and **Figure 12** for screw locations.

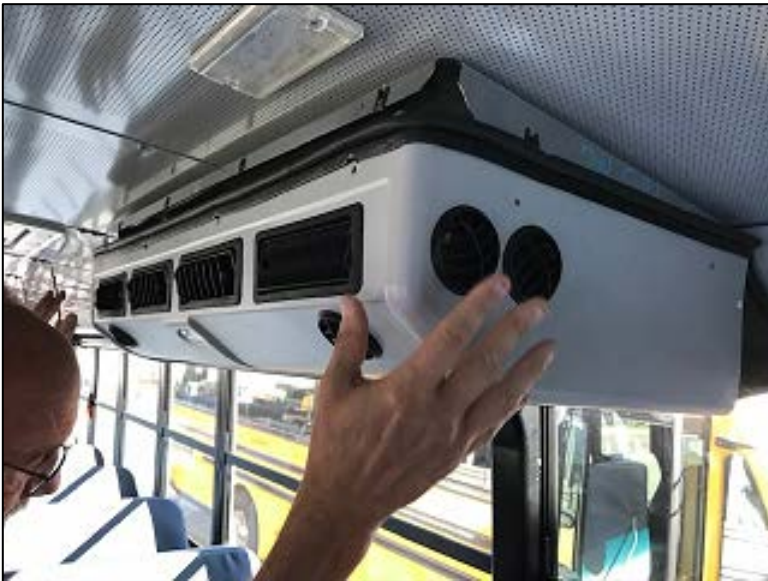
**Figure 13: Remove A/C Cover**

2. Gently remove cover. See **Figure 13**.
3. At the back, underside of the A/C unit and above the plastic cover for wiring and hoses coming from the floor, install two screws. See **Figure 14**.
