**TECHNICAL INSTRUCTIONS
FOR
SAFETY RECALL JLI/JLJ/JLK
FRONT PASSENGER AIRBAG INFLATOR REPLACEMENT
CERTAIN 2007 – 2012 MY ES 350**

Update 02/20/2020

- **Inspection added for all repairs. Please see page 12 for details**

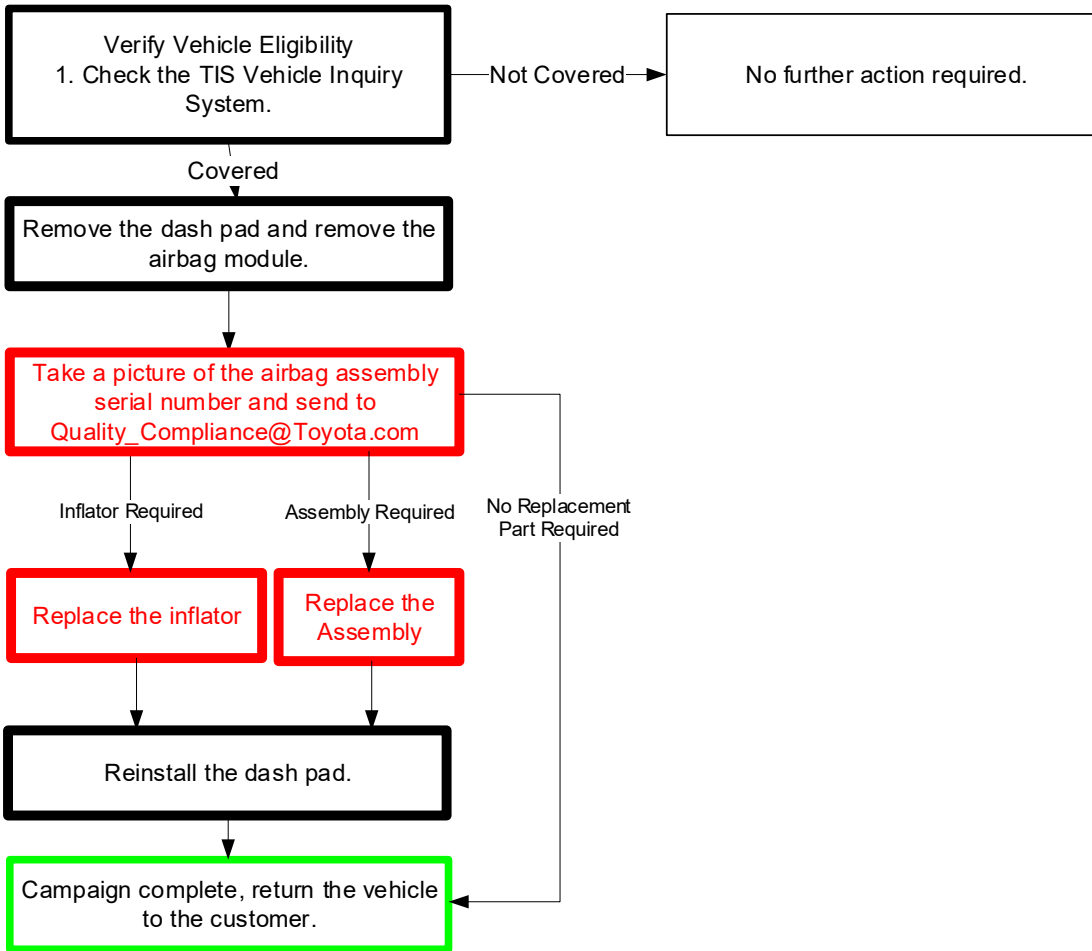
I. OPERATION FLOW CHART

The flow chart is for reference only. **DO NOT** use it in place of the full technical instructions. Follow **ALL** steps as outlined in the full technical instructions to confirm the campaign is completed correctly.

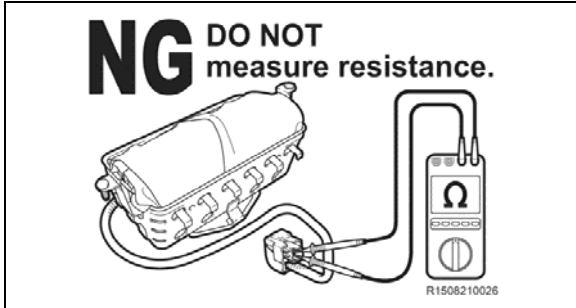
2. DO NOT MEASURE RESISTANCE

- a) **NEVER** measure the resistance of an airbag, this may cause accidental activation.

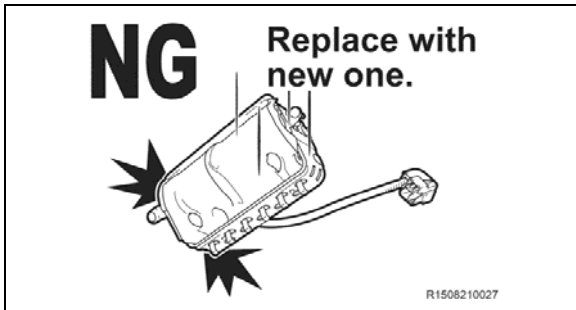
3. HANDLE THE AIRBAG CAREFULLY

- a) If the airbag is dropped, replace it with a **NEW** one.

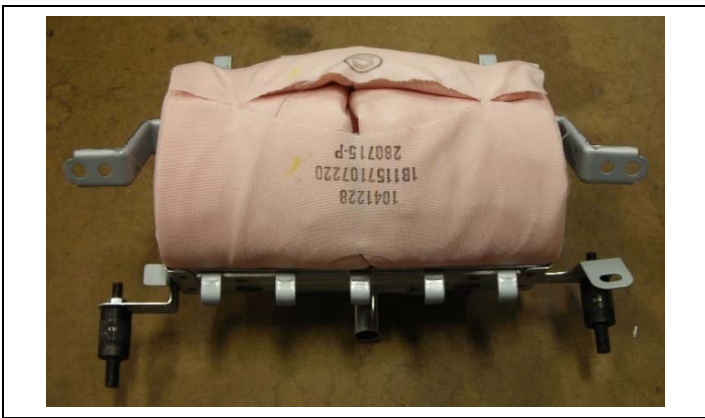
e) Mount the adaptors (579943-3R3) to the airbag as shown.

NOTE: The 6mm stud mounts to the airbag.

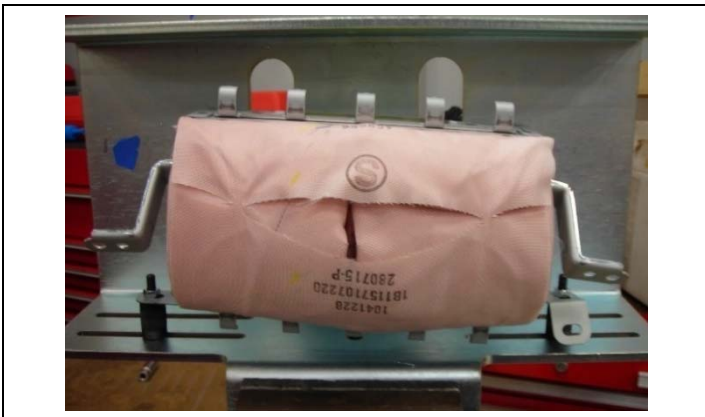
f) Mount the airbag to the mounting bracket as shown.

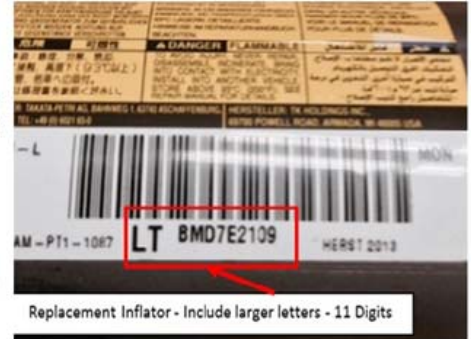
The first two characters of the Replacement Inflator Serial code will be either 'LT' or 'LR'.

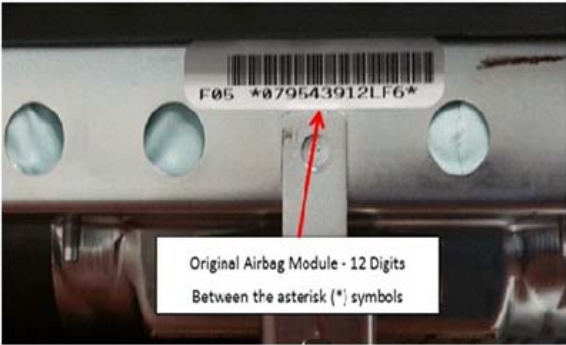
Original Airbag Module - 12 Digits
Between the asterisk (*) symbols

The Airbag module Assembly serial number is a **12 digit code**. It can be found along with a bar code on opening the Airbag assembly unit. To manually enter these details into the application, the technician has to identify the 12 digit code between two Asterisks (*) inside the Airbag assembly unit. The first seven characters of this 12 digit code are numbers and the 10th digit is either 'K' or 'L' always.

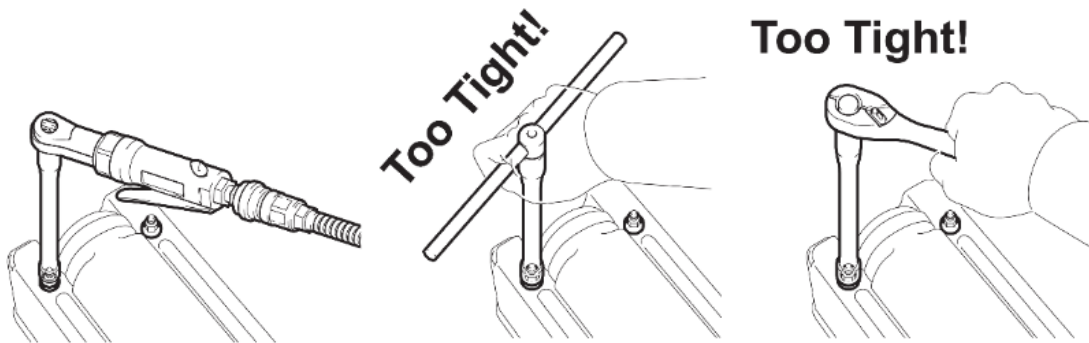
R1701260011Z01

OK

These tools cause overtightening !
