TECHNICAL INSTRUCTIONS
FOR
SAFETY RECALL J0A/J0B/J0C
FRONT PASSENGER AIRBAG INFLATOR MODULE
CERTAIN 2002 –2007 MODEL YEAR SEQUOIA

Updated 01-14-2021

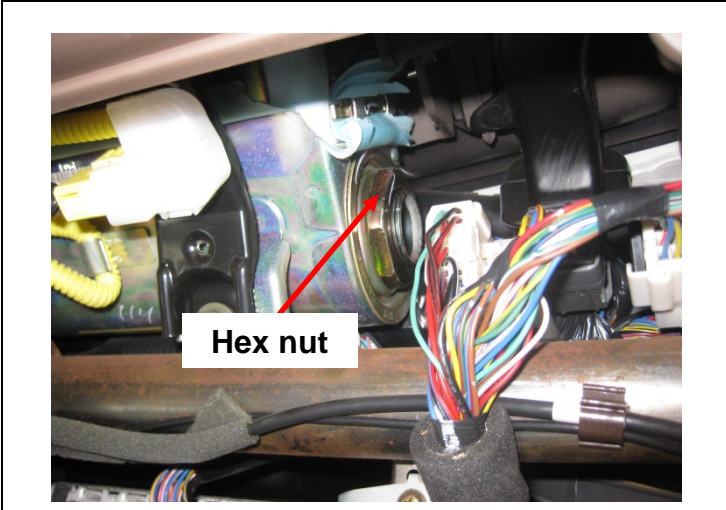
2. INSPECT INFLATOR TYPE
 - a) Inspect the inflator to determine if it has a large nut on the right side as shown.

NO: Proceed to section VIII.

YES: The vehicle is **NOT INVOLVED** in the Safety Recall.

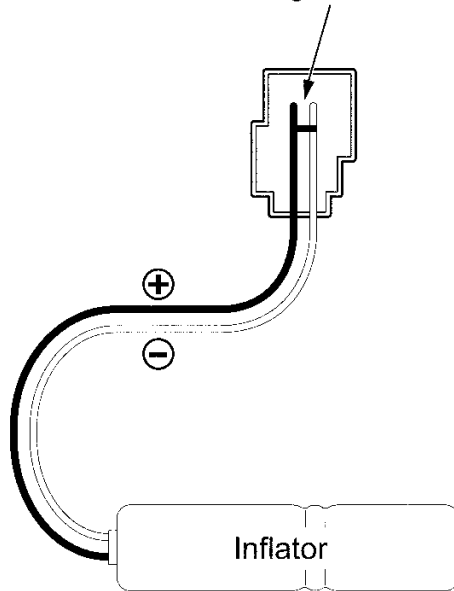
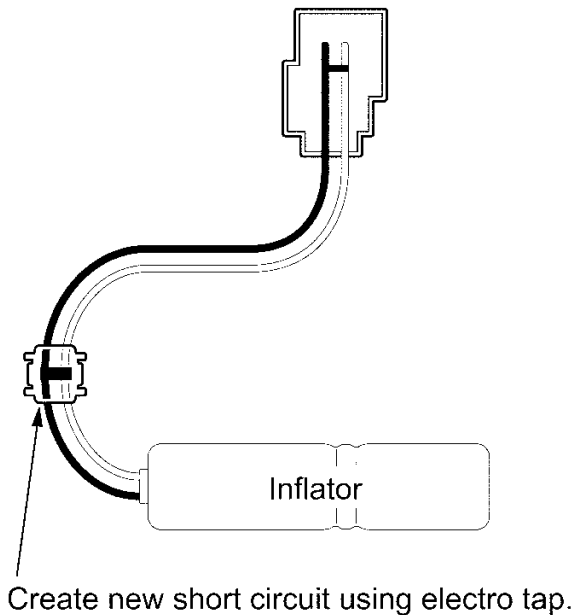
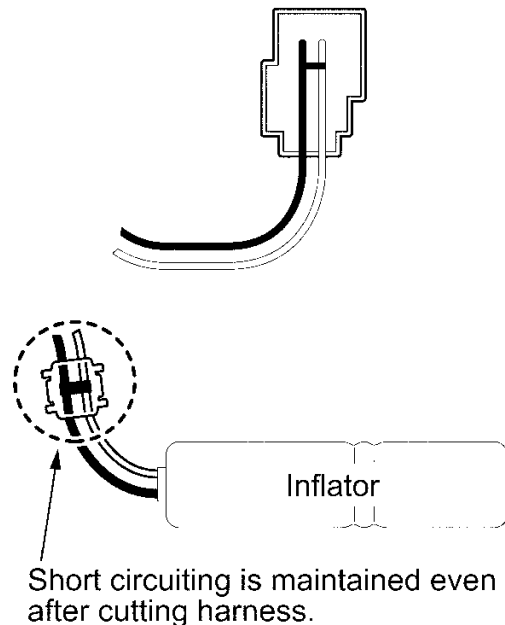
The connector of the inflator module contains a short circuiting mechanism to eliminate voltage variances when the connector(1) is disconnected. To allow for the replacement of the inflator module, a new short circuit(2) *MUST* be created before cutting the wires(3) and removing the inflator. The following steps *MUST* be followed exactly as described to ensure the work is completed correctly and safely.

Short circuiting on both sides.

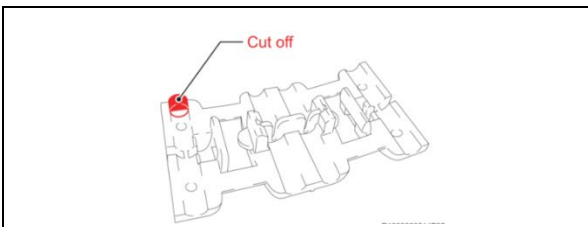
- a) Cut the yellow corrugated tube on the harness approximately 4 inches (10 cm) using nippers.

- **DO NOT** damage the wires in the tube.
- **DO NOT** use a knife or razor blade to cut the tube to avoid damaging the wires.
- This may be performed on either end of the inflator.

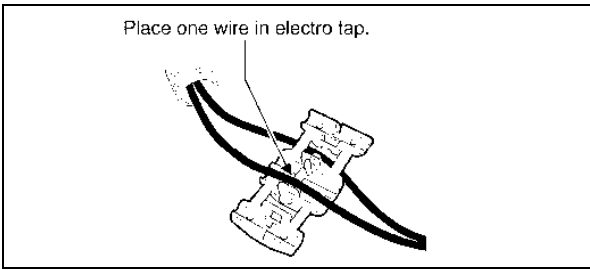
- b) Cut off the tab of the electro tap shown in the illustration.

This tab *MUST* be removed to ensure a good short.

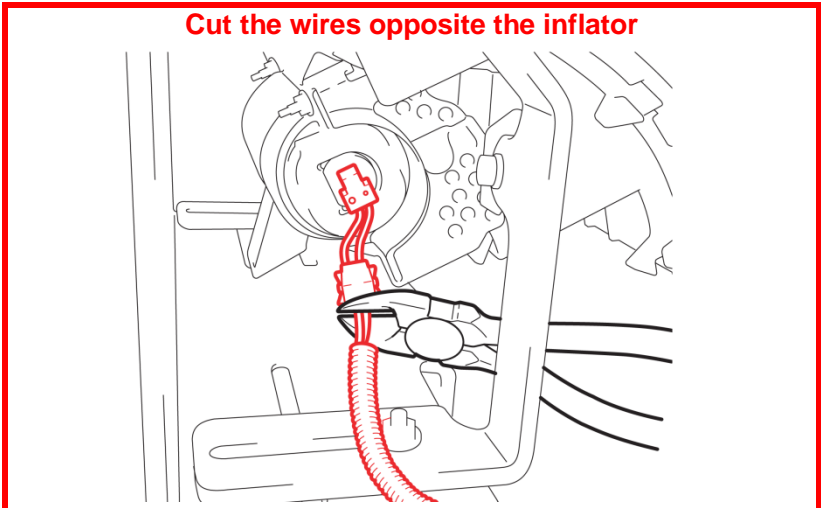
a) Cut the 2 wires at the side of the electro tap that is farthest away from the inflator.

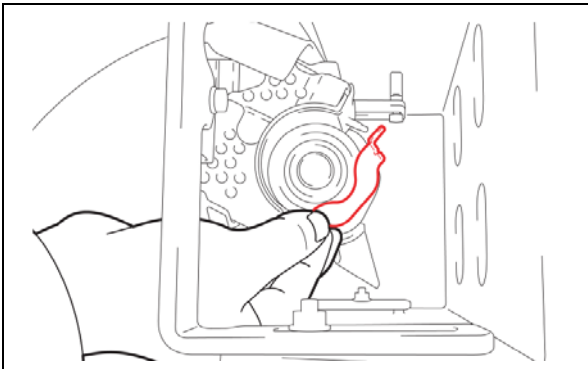
- b) Remove the stopper plate and place in a secure location because it will be reused.

STOP DO NOT discard the Stopper Plate, it will be reused.

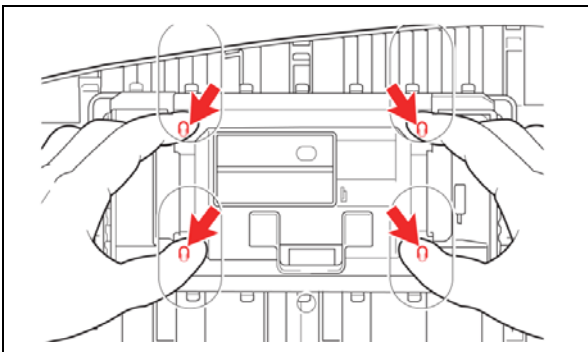
- a) Gently push in the 4 studs to loosen the inflator for removal.

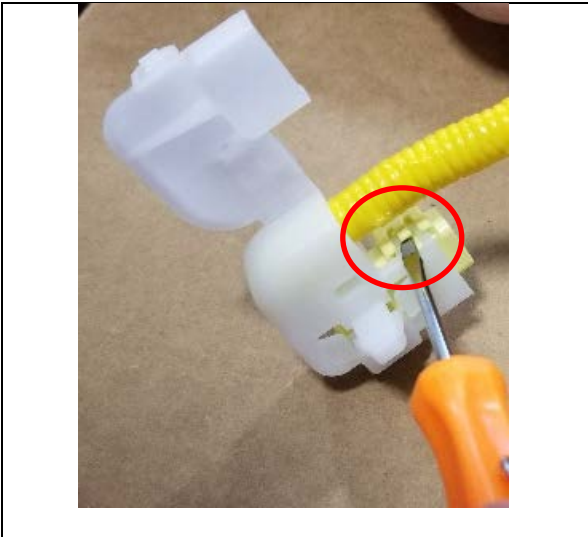
- a) Carefully use a pocket screwdriver to disengage the first release tab as shown in the image
- b) Carefully use a pocket screwdriver to disengage the second release tab as shown in the image

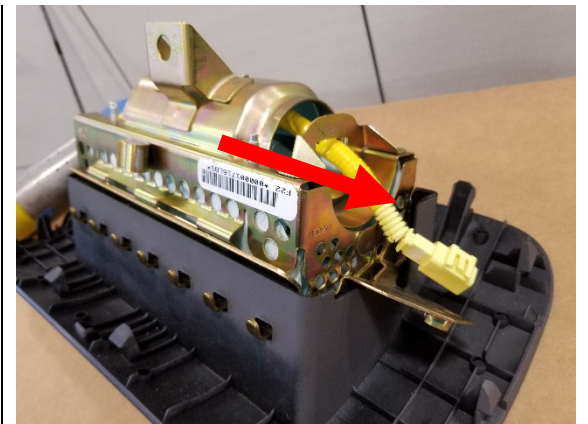
- c) Open the connector cover. Once open carefully use a pocket screwdriver to disengage the release tab and remove the connector cover from the connector

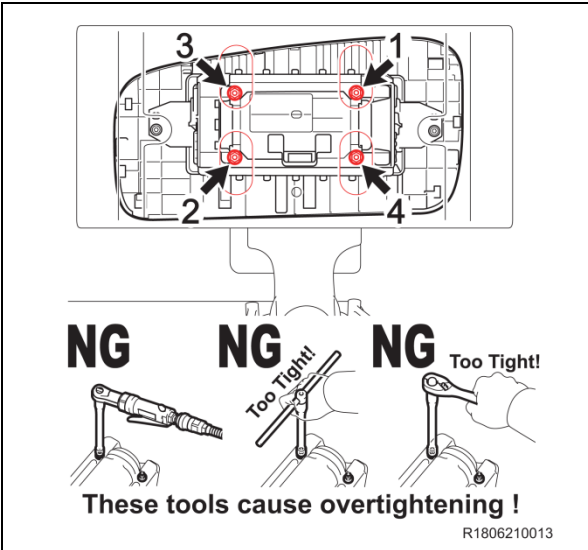
a) Tighten the nuts evenly in two increments following the sequence shown in the illustration. Use a socket driver or torque wrench to tighten the nuts.

- There will be some resistance when tightening the nuts because they are self-locking, confirm the nuts are tightened correctly.
- **DO NOT** use a power tool, T-handle, or ratchet when tightening the nuts to avoid over torquing.
