**TECHNICAL INSTRUCTIONS
FOR
SAFETY RECALL JLI/JLJ/JLK
FRONT PASSENGER AIRBAG INFLATOR REPLACEMENT
CERTAIN 2006 – 2012 MY IS 250/350 and 2008 – 2009 MY IS F**

Update 01/14/2021

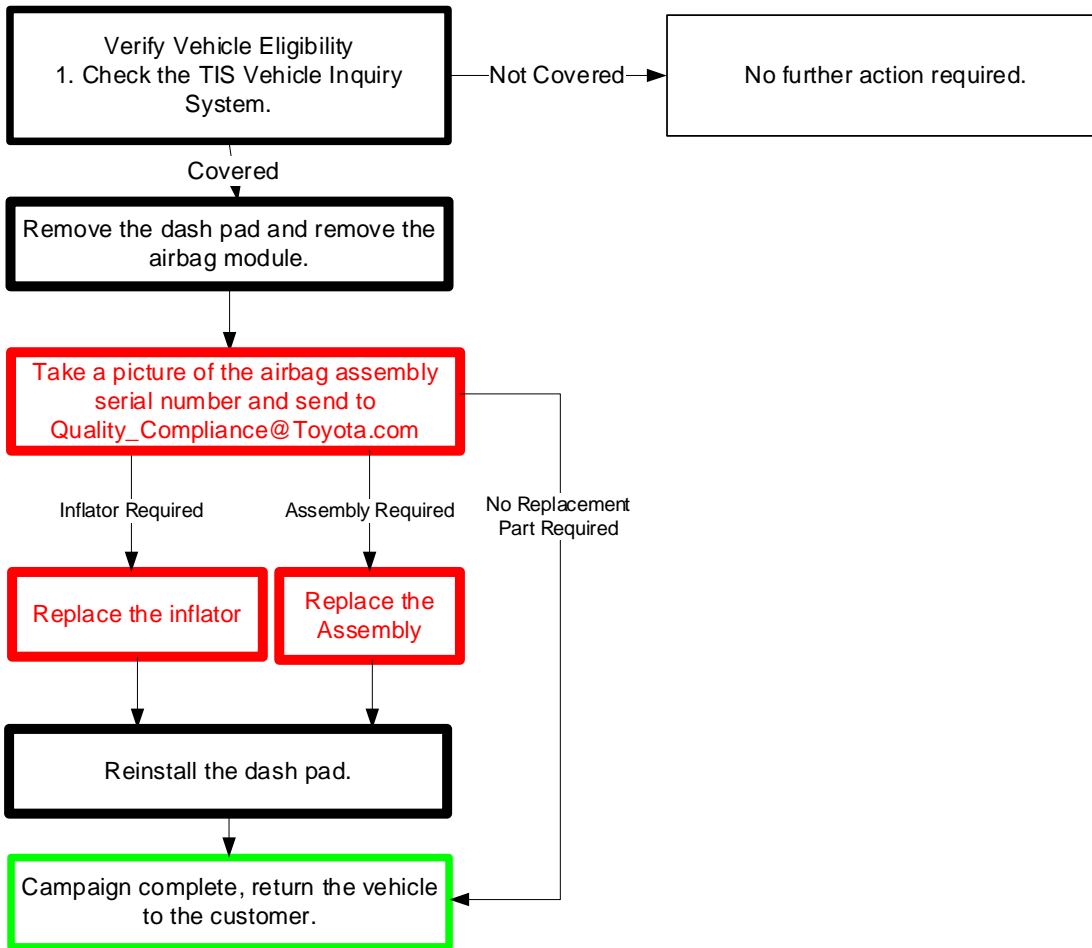
I. OPERATION FLOW CHART

The flow chart is for reference only. **DO NOT** use it in place of the full technical instructions. Follow **ALL** steps as outlined in the full technical instructions to confirm the campaign is completed correctly.

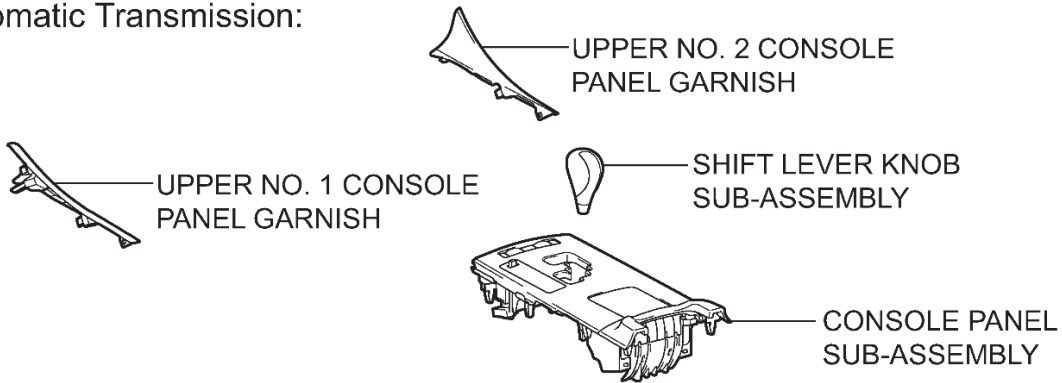
for Automatic Transmission:

VII. FRONT PASSENGER AIRBAG REMOVAL COMPONENTS

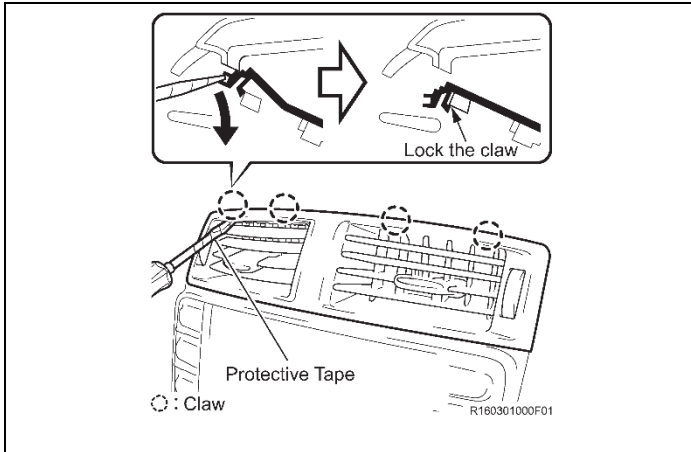
Removing the No. 3 air register

Remove any peripheral parts on left and right side of the register to allow access to the back of the register.

Wrap the tip of a screwdriver with tape.

Lock the 4 claws inside the register as shown.

NOTE: Do not use a molding removal tool to remove the register it could be damaged.

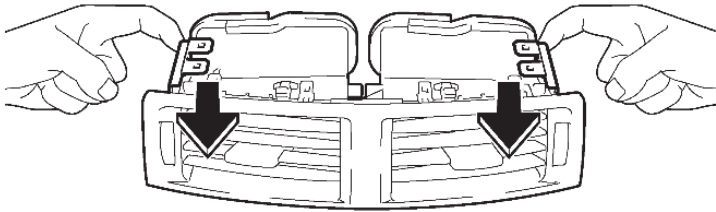
OK Push from the back side

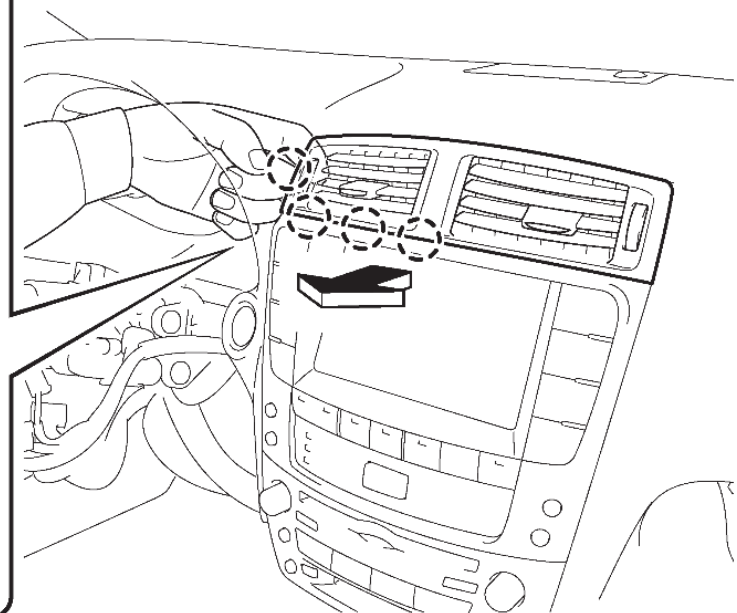
Back side of the part manufactured after August 2008:

○ : Claw

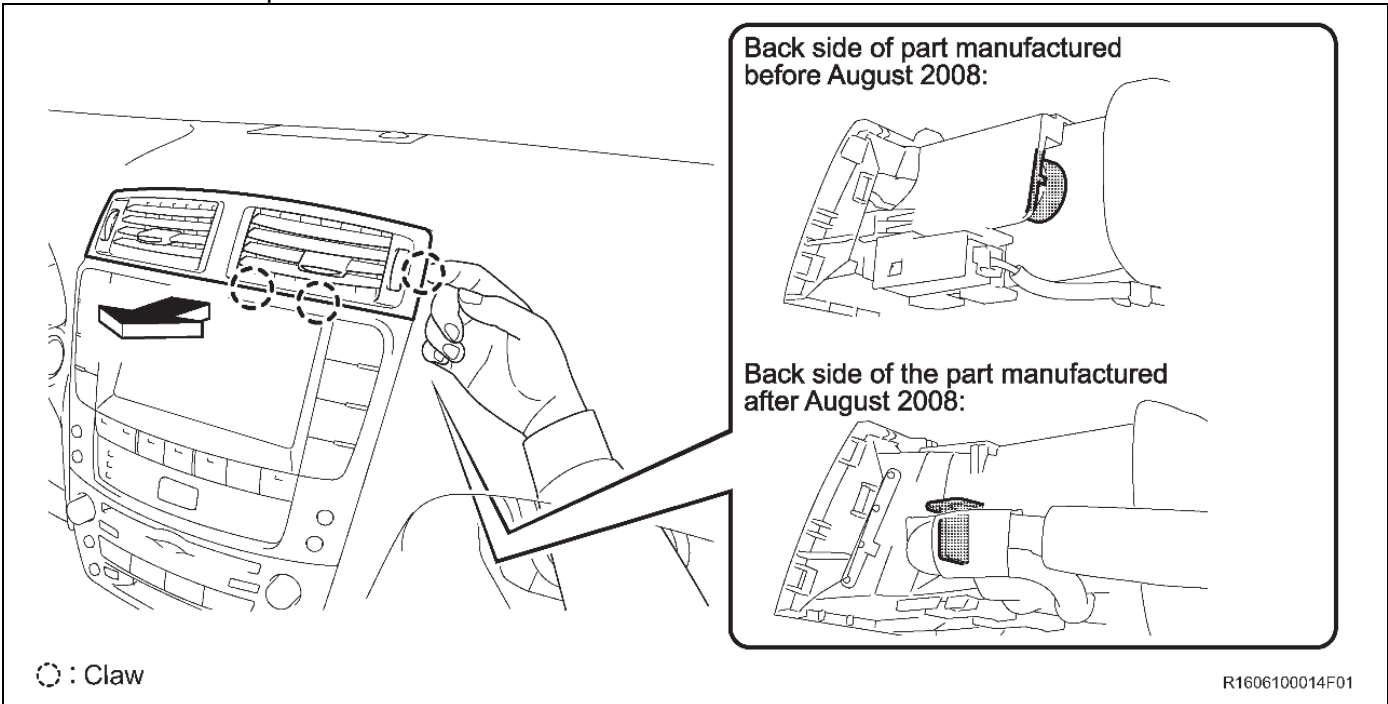
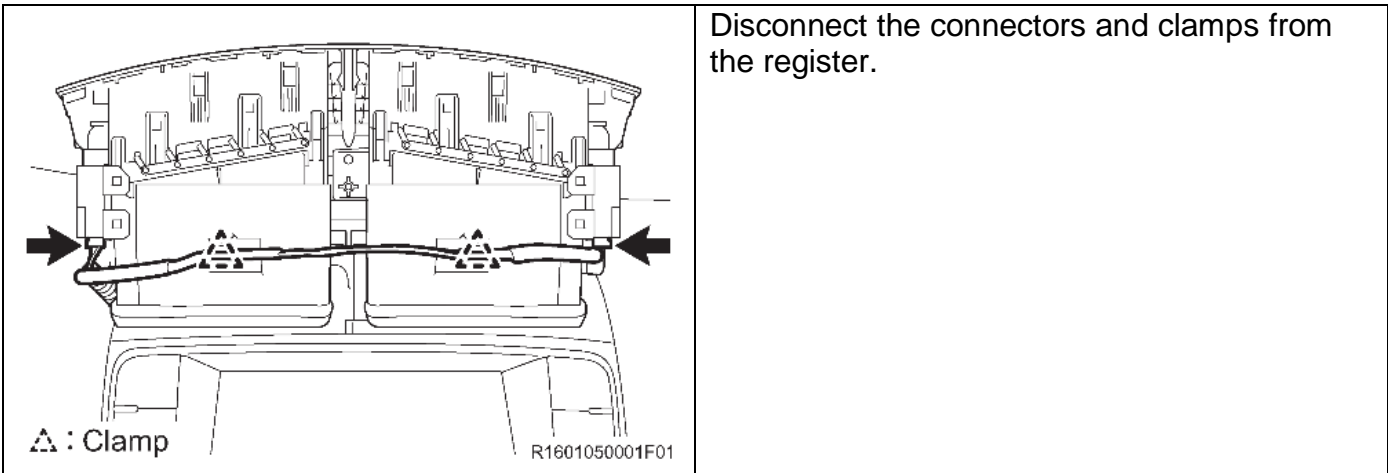
Using your finger on the right side push out at the point shown to disengage the 3 claws and remove the register from the instrument panel.

NOTE: DO NOT contact the positioning tabs while removing the instrument panel as the panel could be damaged.

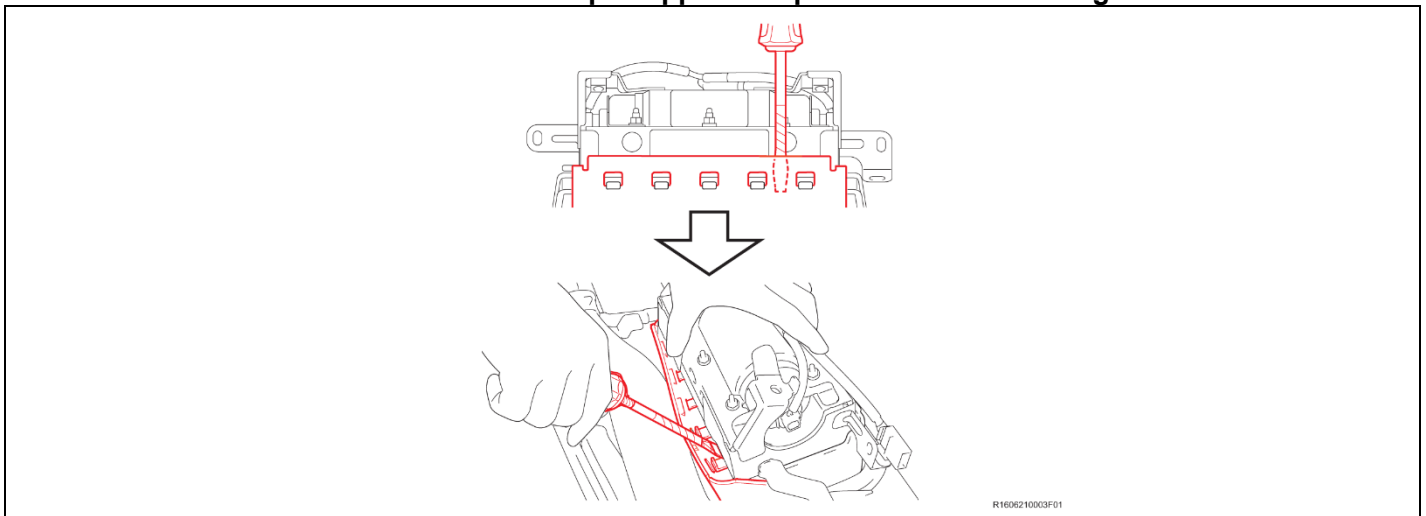
- c) Remove the 4 bolts, disengage the straps, and then remove the airbag assembly.

NOTE: Use a screwdriver with the tip wrapped in tape to remove the airbag from the dash.

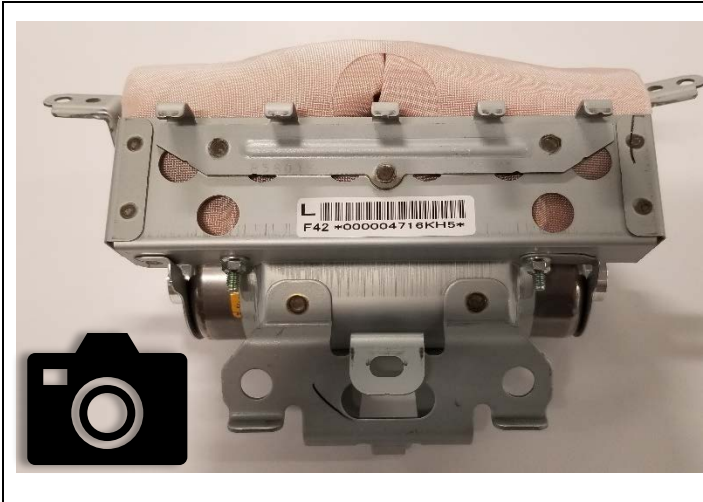
1. TAKE A PICTURE OF THE AIRBAG ASSEMBLY SERIAL NUMBER

- a) Take a picture of the airbag assembly serial number exactly like the image to the left.
- b) Email the picture to Quality_Compliance@toyota.com for review.

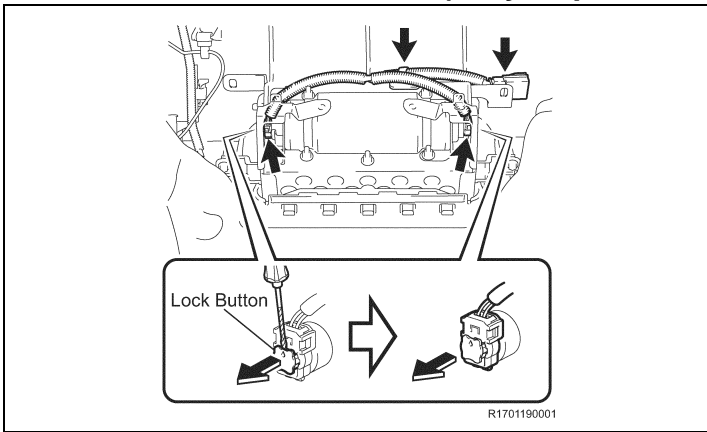
- a) Using a screwdriver to release the lock button of the connector.
- b) Disconnect the 2 connectors.
- c) Disengage the 2 clamps.

NOTE: The removed instrument panel wire will not be reused.

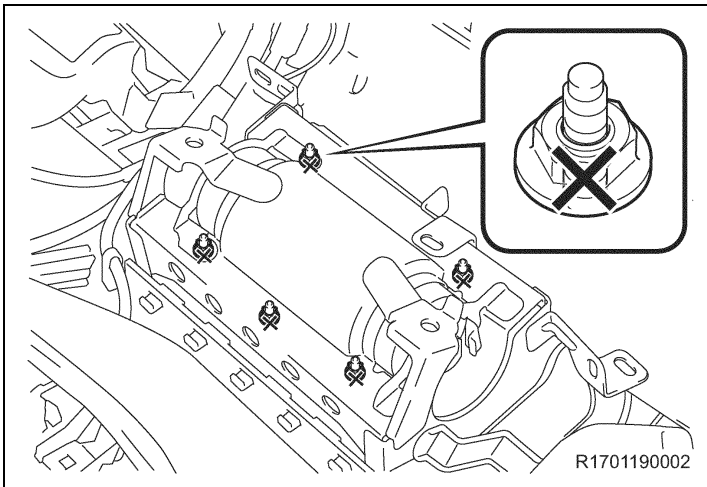
- d) Mark the 5 self locking nuts to prevent reuse.

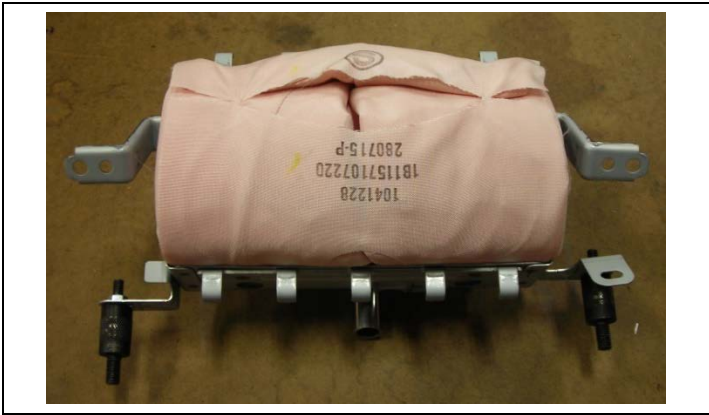
e) Mount the adaptors (579943-3R3) to the airbag as shown.

NOTE: The 6mm stud mounts to the airbag.

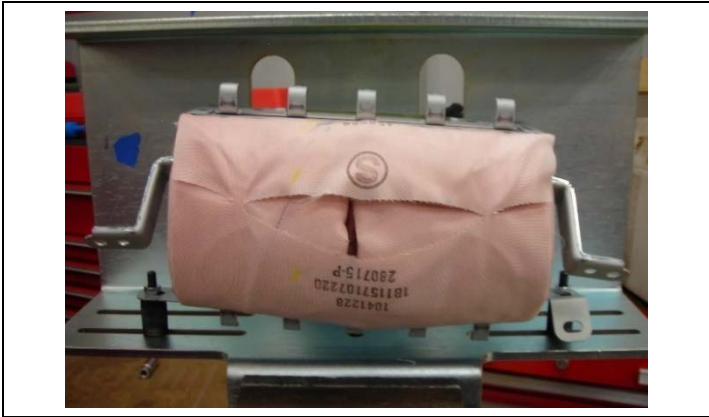
f) Mount the airbag to the mounting bracket as shown.

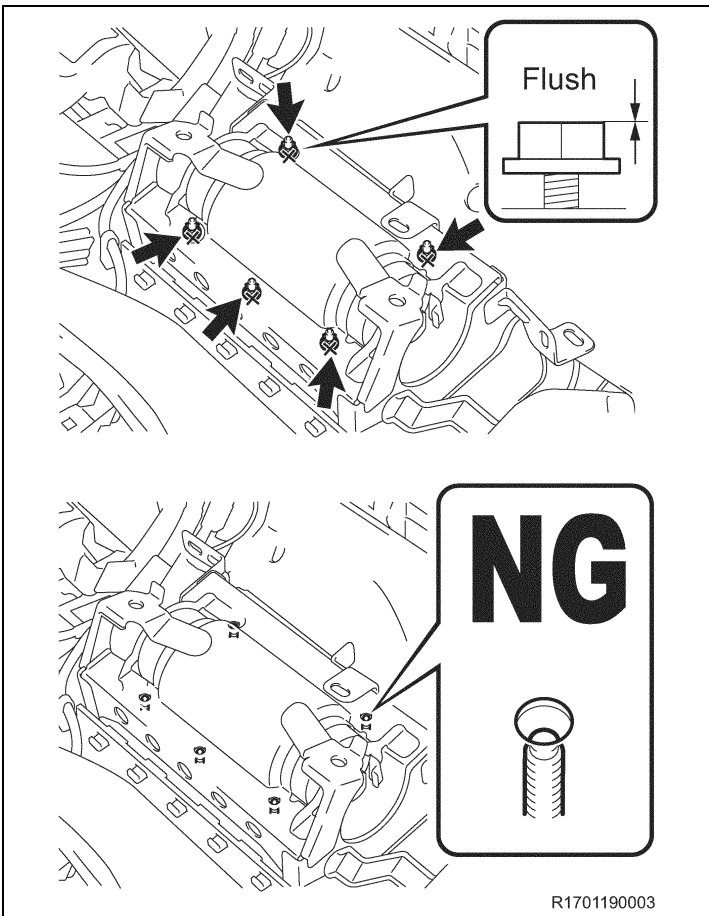
g) Loosen the 5 nuts until each nut is flush with the top of the stud as shown.

NOTE: You may need to slide the airbag to the left or right to access the middle nut. DO NOT use power tools to remove the nuts.

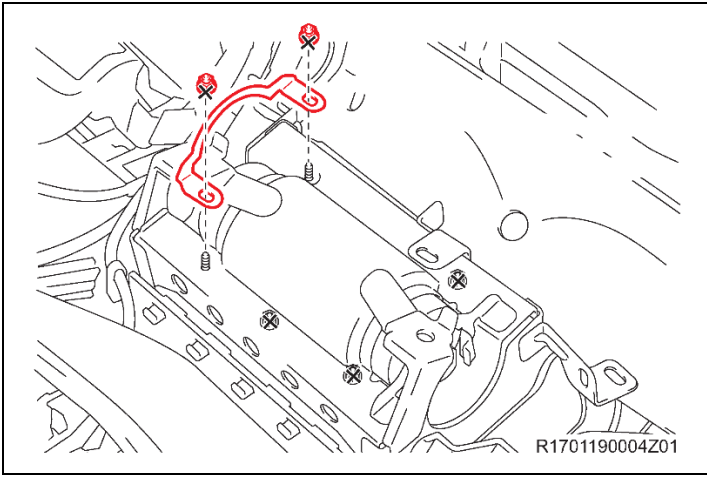
- h) Loosen and discard the 2 nuts on the end where the positioning plate is removeable.
- i) Remove and discard the plate.

NOTE:
DO NOT use power tools.

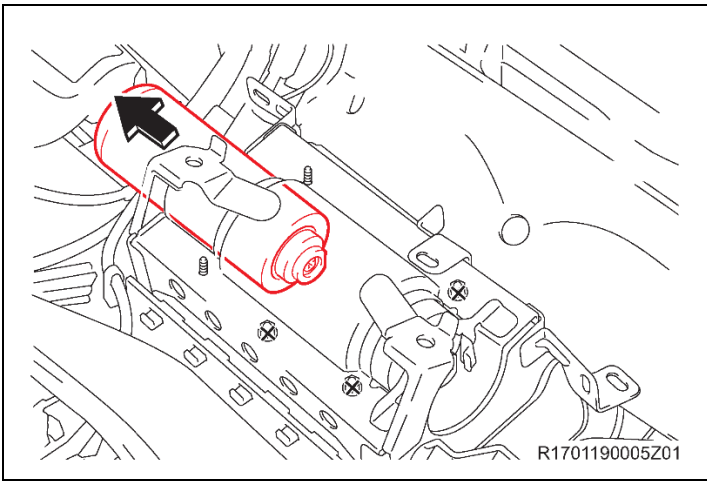
- j) Remove the inflator.

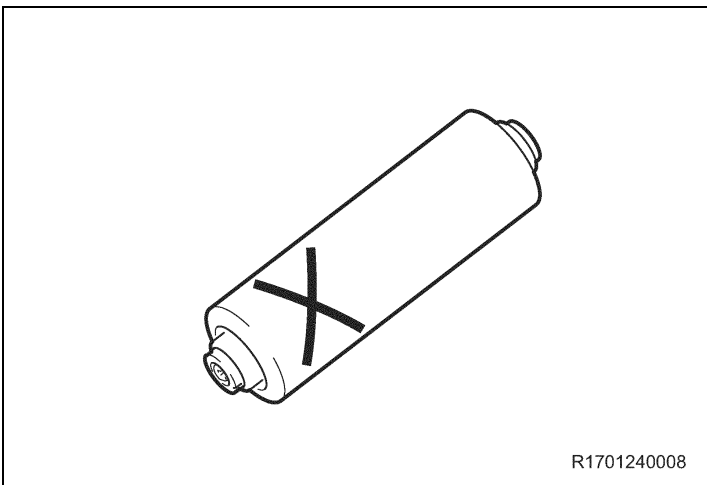
- k) Mark the old inflator so it is not reused.
- NOTE: Return the old inflator to the parts department for recovery.**

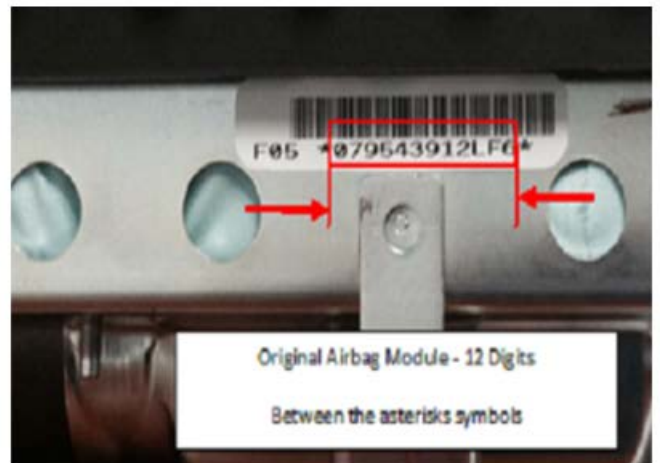
Airbag Serial Number Label Example

- The airbag serial number is **ALWAYS** the **12 DIGITS** located between the asterisks.
- The 3 digits before the asterisk **ARE NOT** part of the serial number, and **SHOULD NOT** be entered or an inaccurate response may be returned.

Original Airbag Module - 12 Digits
Between the asterisks symbols

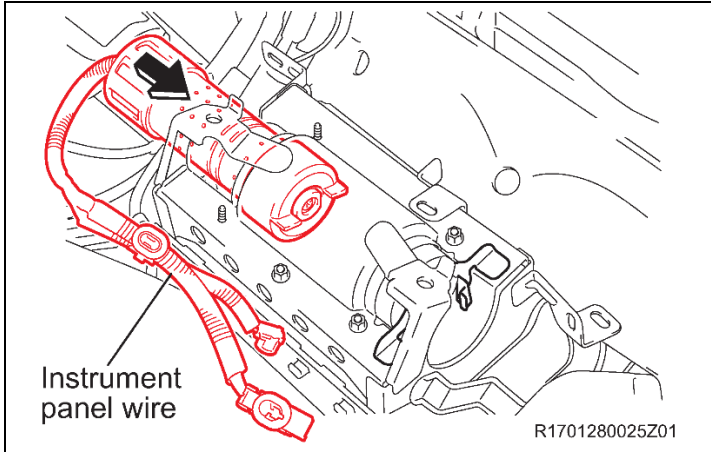
1. **INSTALL THE NEW INFLATOR**
 - a) Install the new inflator as shown.

b) Ensure that the inflator is oriented in the correct position as shown.

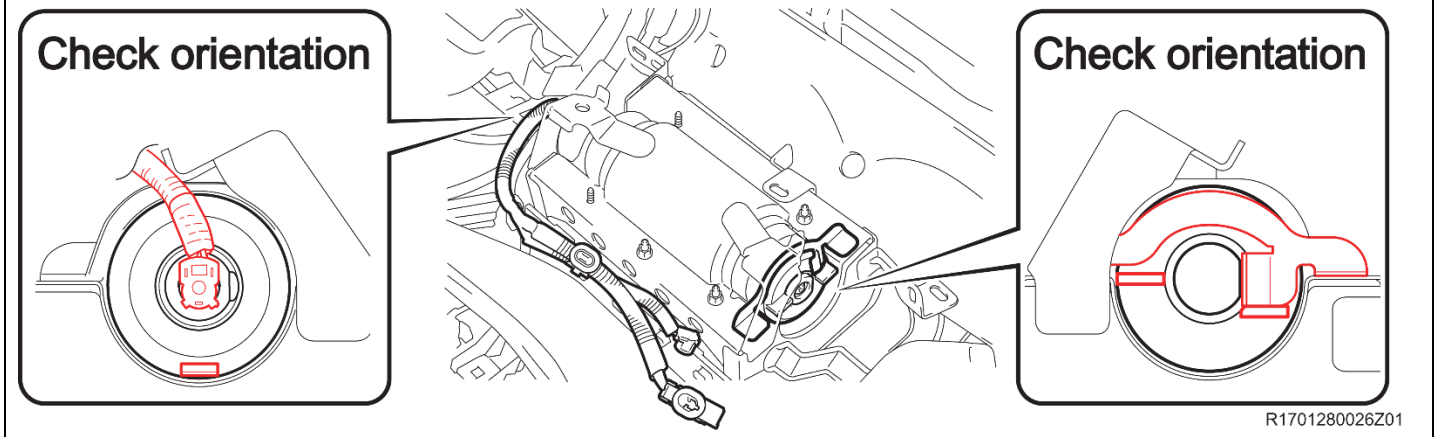
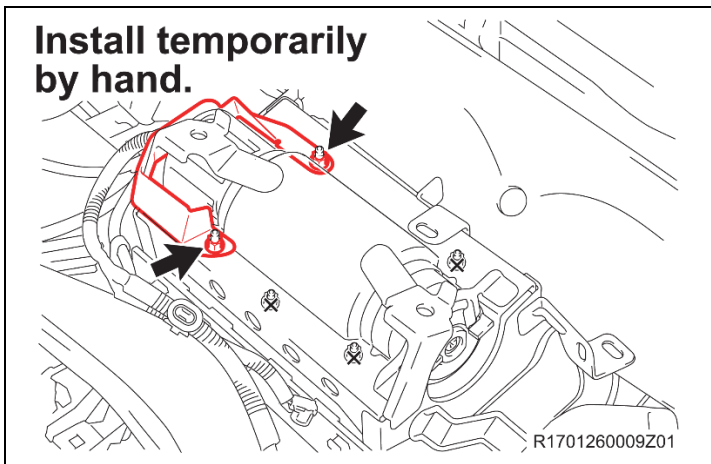
- **Make sure the inflator is correctly positioned.**
- **The inflator cannot be fully inserted if it is upside down.**

- a) Install the **NEW** positioner plate.
- b) Temporarily install 2 **NEW** nuts.

**Install temporarily
by hand.**

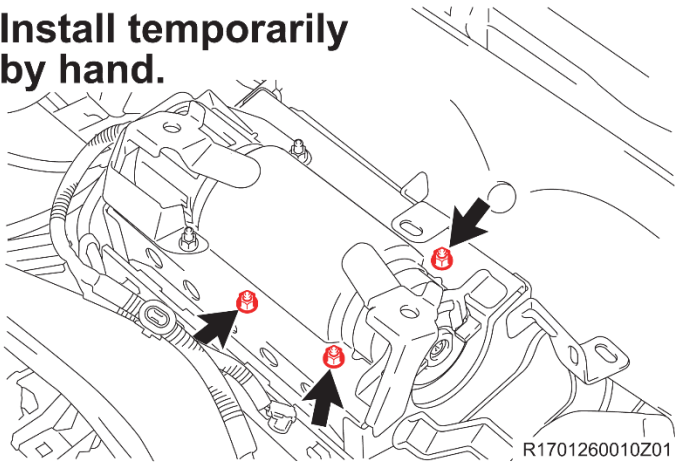
- c) Remove and discard the 3 remaining nuts.
- d) Temporarily install 3 **NEW** nuts.

e) Push the inflator towards the position determining plate and eliminate any gaps.

- If any gaps exist, the flats may move apart and could result in abnormal operation during airbag deployment.

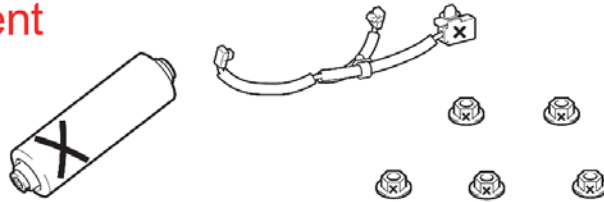
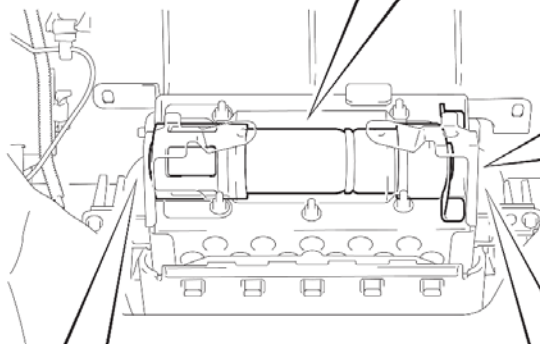
(a) Replacement
of parts.

(b) No gap.

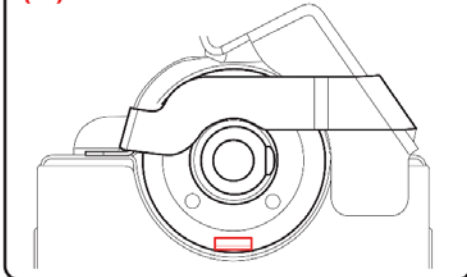
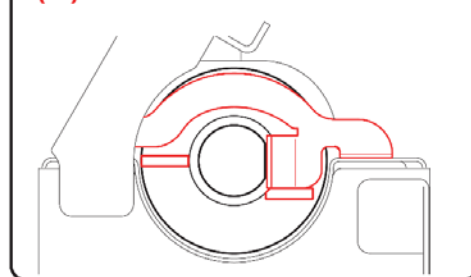
(b) Check orientation.

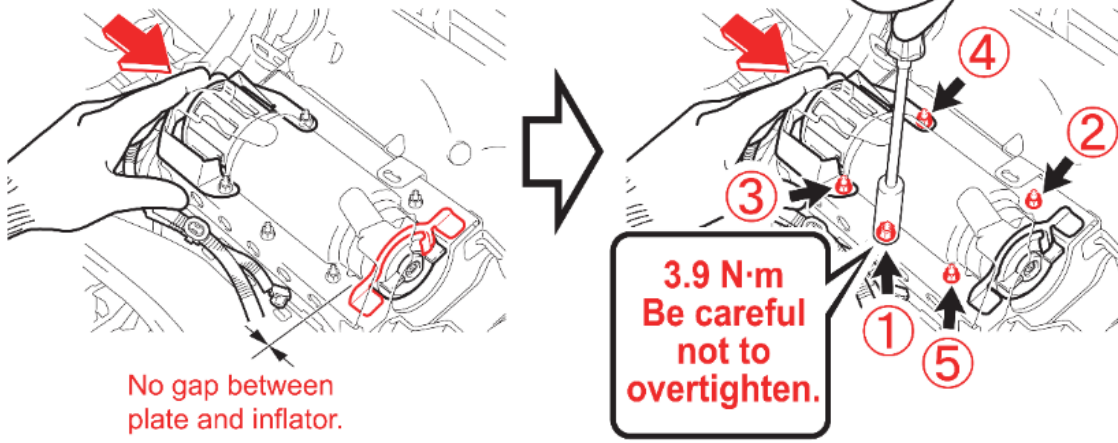
f) Tighten the 5 nuts evenly in several increments in the sequence shown. Use a socket driver or torque wrench to tighten the nuts.

Torque: 35 in. lbf (3.9N·m)

- There will be some resistance when tightening the nuts because they are self-locking, confirm the nuts are tightened correctly.
- **DO NOT** use a power tool, T-handle, or ratchet when tightening the nuts to avoid over torquing and deforming the studs.
- You may need to slide the airbag to the left or right with in the mounting bracket to access the center nut.

OK

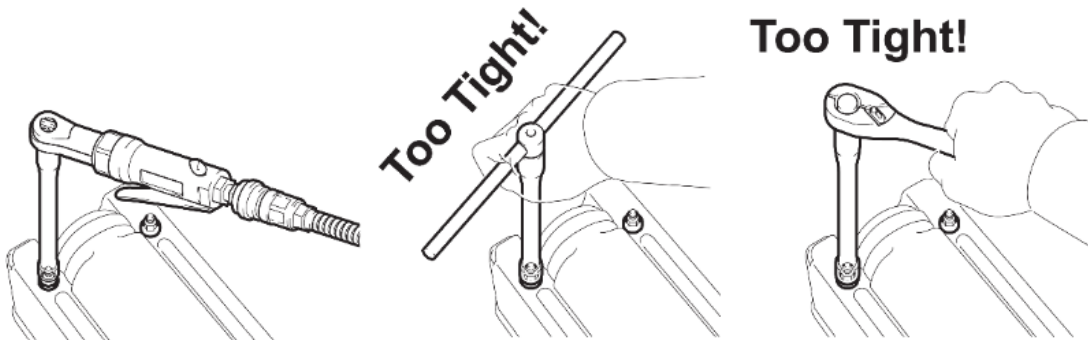
NG

These tools cause overtightening !

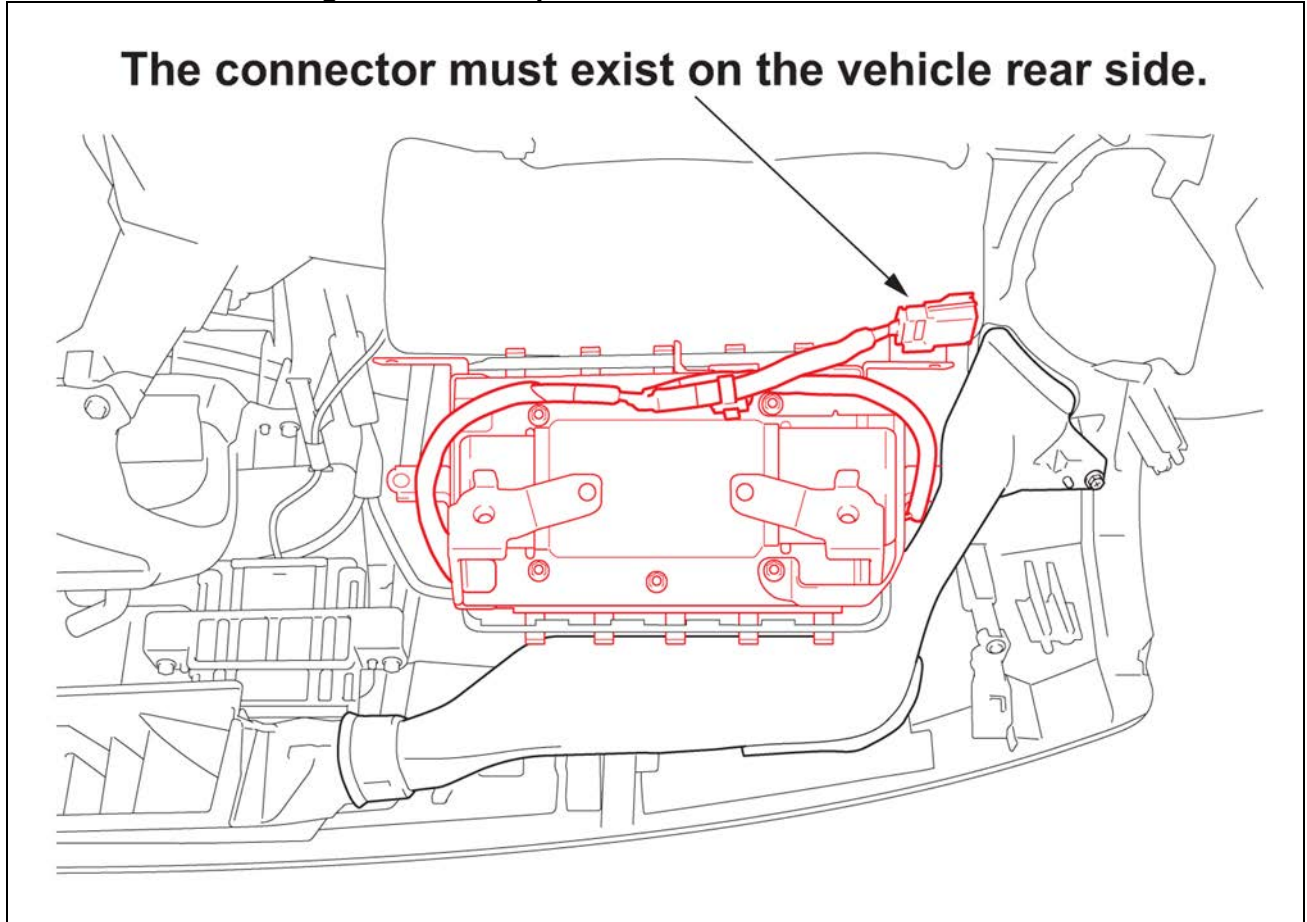
- a) Position the airbag assembly in the instrument panel, engage the straps, and then install the 4 bolts.

- The bolts do NOT need to be replaced. Reinstall the original bolts

NOTE: Ensure the airbag connectors is positioned as shown
