**TECHNICAL INSTRUCTIONS**  
**FOR**  
**SAFETY RECALL JLI/JLJ/JLK**  
**FRONT PASSENGER AIRBAG INFLATOR REPLACEMENT**  
**CERTAIN 2010-2015 MY IS 250 CONVERTIBLE**  
**CERTAIN 2010-2011 MY IS 350 CONVERTIBLE**

**Updated 01-14-2021**

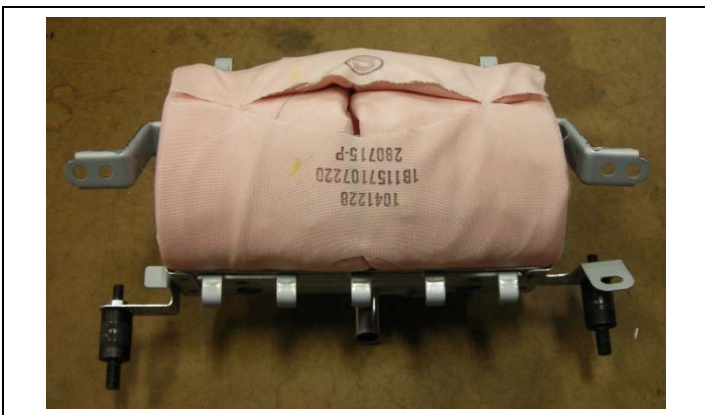
- Mount the adapters (579943-3R3) to the airbag as shown.

**NOTE: The 6mm stud mounts to the airbag.**

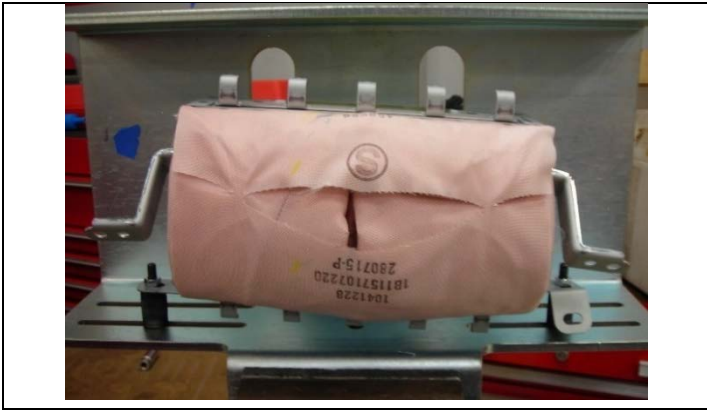
- f) Mount the airbag to the mounting bracket as shown.

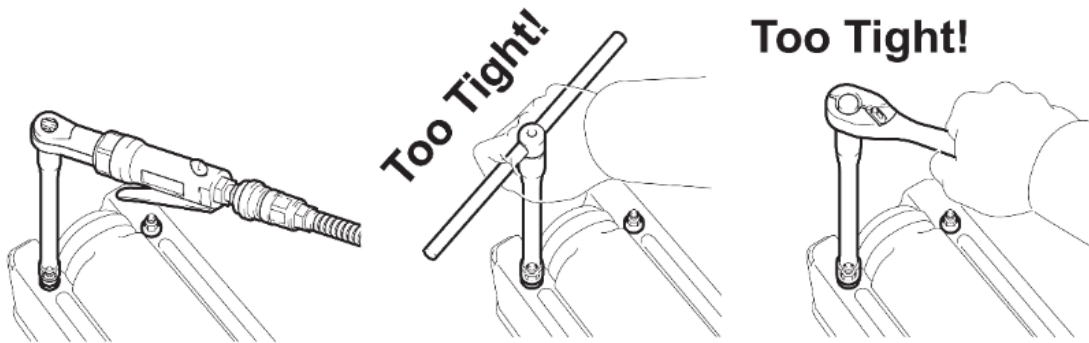
f) Tighten the 5 nuts evenly in several increments in the sequence shown. Use a socket driver or torque wrench to tighten the nuts.

- There will be some resistance when tightening the nuts because they are self-locking, confirm the nuts are tightened correctly.
- **DO NOT** use a power tool, T-handle, or ratchet when tightening the nuts to avoid over torqueing and deforming the studs.
- You may need to slide the airbag to the left or right with in the mounting bracket to access the center nut.

# OK

## These tools cause overtightening !
