TECHNICAL INSTRUCTIONS

SAFETY RECALL JLL

PASSENGER AIRBAGS COULD DEACTIVATE

CERTAIN 2008 – 2019 LX 570

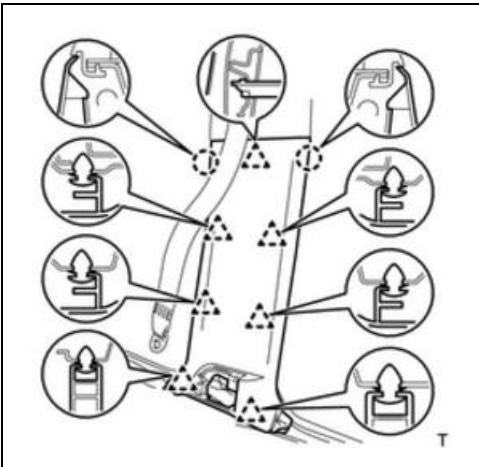
- d. Detach the 2 claws and 7 clips.
