# IMPORTANT UPDATE

## TECHNICAL INSTRUCTIONS

SAFETY RECALL J05

**PASSENGER AIRBAGS COULD DEACTIVATE**

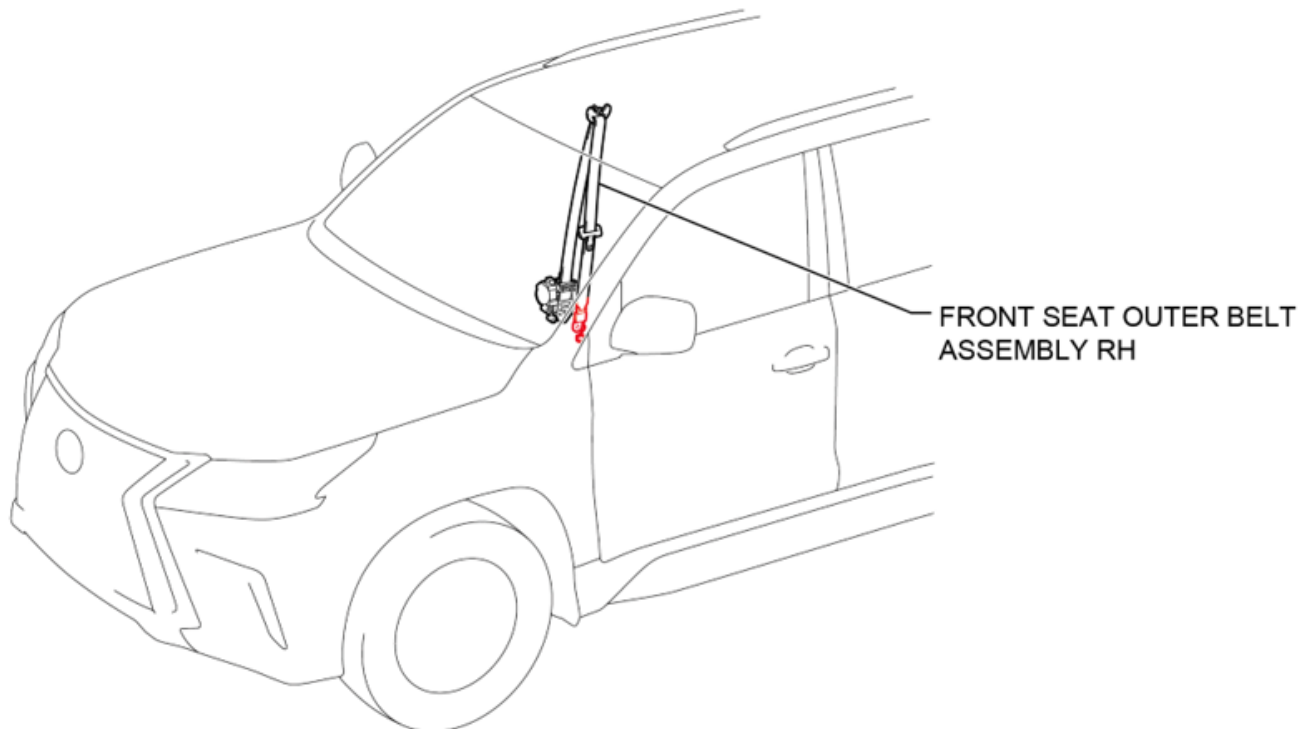
The front passenger occupant classification system has a seatbelt tension sensor that could malfunction over time and could cause the airbag warning light and the passenger airbag “OFF” indicator to illuminate. In addition, the front passenger airbag, passenger knee airbag, and the passenger seat-mounted side airbag may be deactivated. If these airbags are deactivated, there is an increased risk of injury to the occupant in the event of a crash.

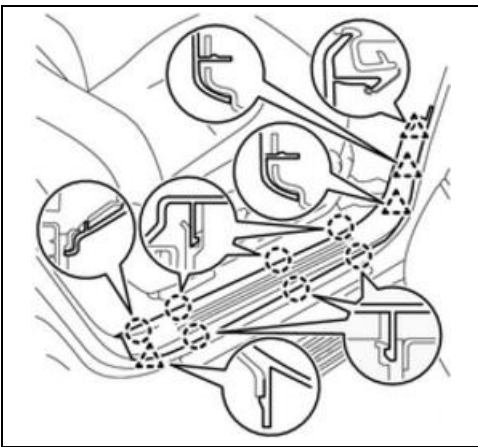
### 3. REMOVE FRONT SCUFF PLATE RH

- Detach the 7 claws and 4 clips.
- Disconnect the electrical connector for the illumination circuit, if equipped.

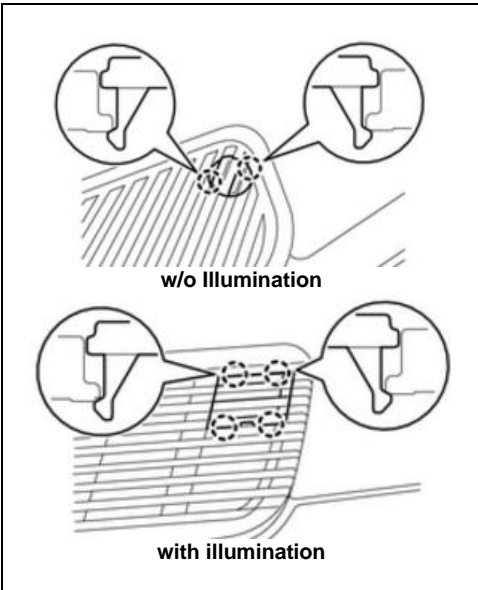
### 4. REMOVE REAR SCUFF PLATE RH

- Remove the access cover on the step by disengaging the claws.

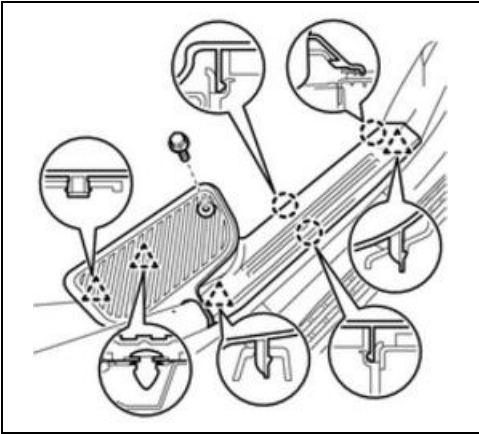
- b. Remove the screw.
- c. Detach the 3 claws and 4 clips.
- d. Disconnect the electrical connector for the illumination circuit, if equipped.

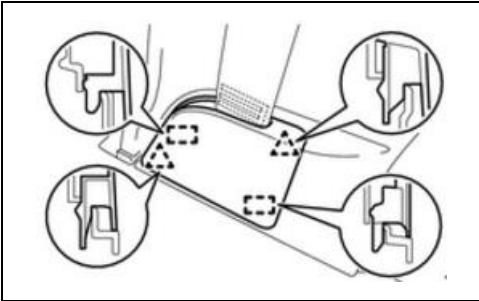
**5. REMOVE LOWER CENTER PILLAR GARNISH RH**

- a. Detach the 2 clips and 2 guides to remove the cover at the base of the Center Pillar Garnish.

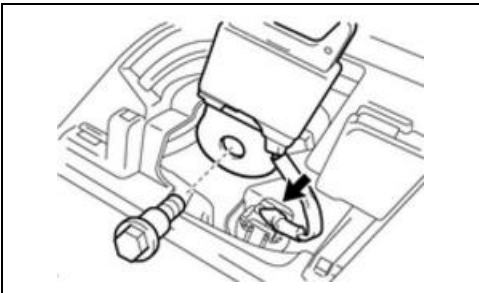
- b. Remove the bolt from the seat belt anchor.
- c. Disconnect the connector.

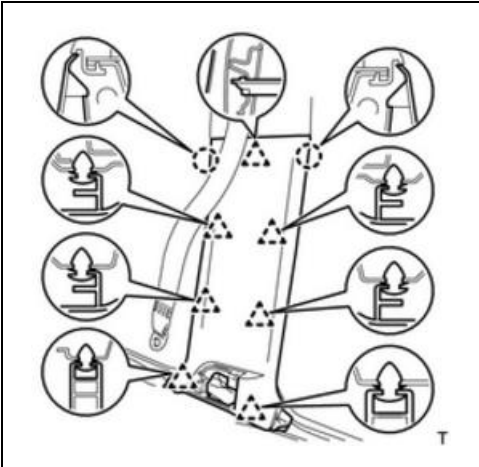
- d. Detach the 2 claws and 7 clips.

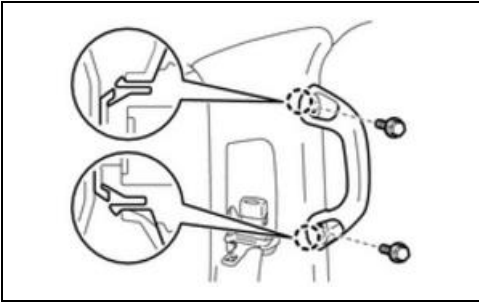
**6. REMOVE REAR ASSIST GRIP RH**

- a. Detach the 4 claws to remove the 2 assist grip plugs.
- b. Remove the 2 bolts.
- c. Detach the 2 claws and remove the rear assist grip.

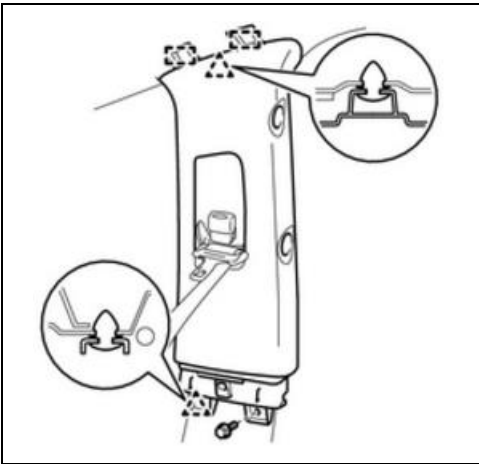
**7. REMOVE UPPER CENTER PILLAR GARNISH RH**

- a. Remove the bolt
- b. Detach the 2 clips and 2 guides.
- c. Pass the seat belt anchor through the Center Pillar Garnish.

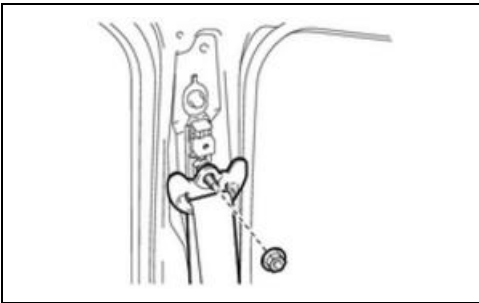
**8. REMOVE FRONT SEAT OUTER BELT RH**

- a. Remove the nut and shoulder anchor.

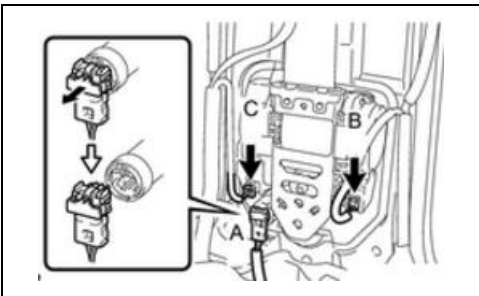
- b. Disconnect the pretensioner connector (A)
- c. Disconnect the tension reducer connector (B)
- d. Disconnect the pre-collision connector (C) if equipped.

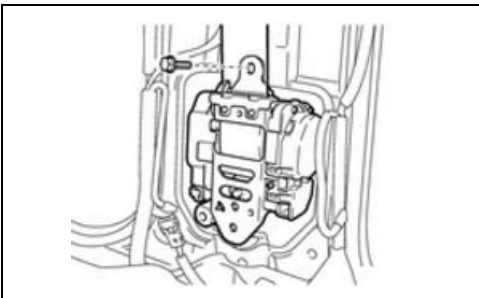
- e. Remove the bolt.

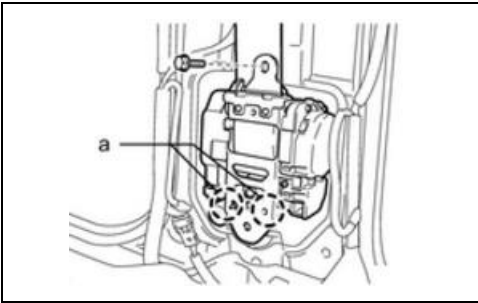
### 1. INSTALL **NEW** FRONT SEAT OUTER BELT RH

- Align the claws (a) of the vehicle with the **NEW** Front Seat Outer Belt positioning holes.
- Install the bolt.

**Torque: 8.5N·m {87 kgf·cm, 75 in.lbs}**

**Note: When installing the retractor, make sure the claws of the vehicle (a) only contact the installation areas of the retractor.**

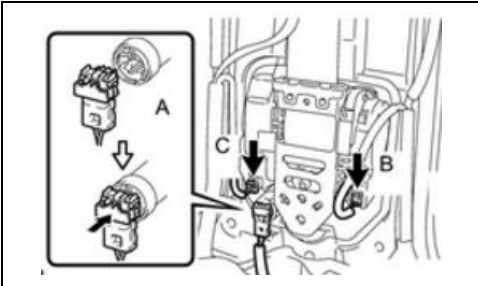
- Connect the pretensioner (A) connector.
- Connect the tension reducer (B) connector.
- Connect the pre-collision connector (C) if equipped.

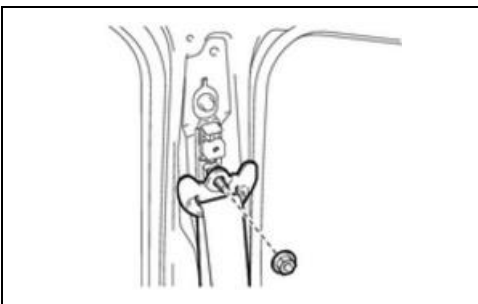
- Install the shoulder anchor to the shoulder belt with the nut.

**Torque: 42 N·m {428 kgf·cm, 31 ft.lbs}**

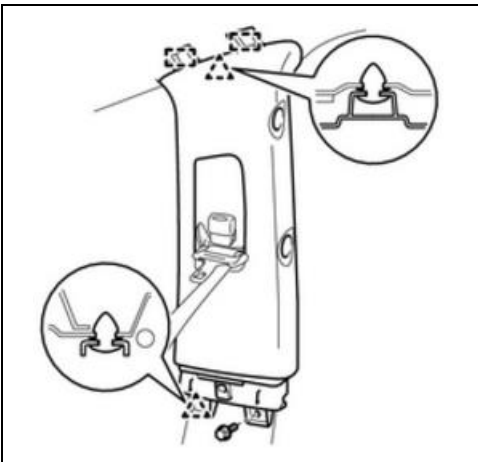
### 2. INSTALL UPPER CENTER PILLAR GARNISH RH

- Pass the seat belt anchor through the Center Pillar Garnish.
- Attach the 2 clips and 2 guides.
- Install the bolt.

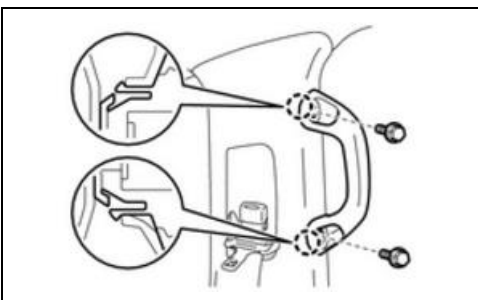
### 3. INSTALL REAR ASSIST GRIP RH

- Attach the 4 claws to attach the 2 assist grip plugs.
- Install the 2 bolts.
- Attach the 4 claws to install the 2 assist grip plugs.

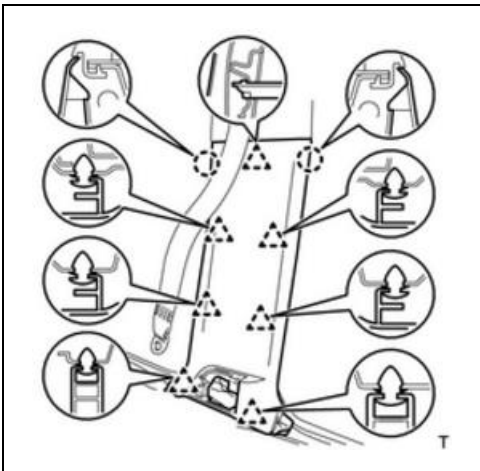
**4. INSTALL LOWER CENTER PILLAR GARNISH RH**

a. Attach the 2 claws and 7 clips.

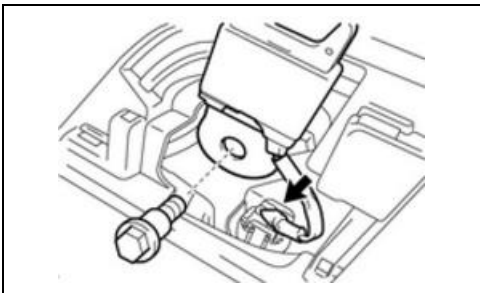
b. Connect the electrical connector.

c. Install the bolt for the seat belt anchor.

**Torque: 42 N·m {428kgf·cm, 31 ft.lbs}**

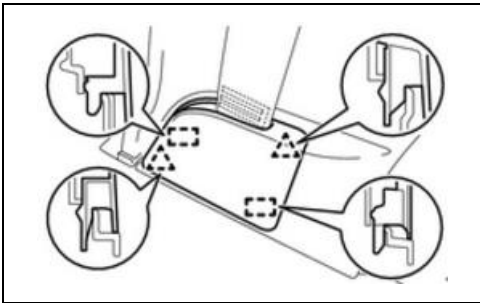
d. Install the 2 clips and 2 guides for the cover at the base of the Center Pillar Garnish.

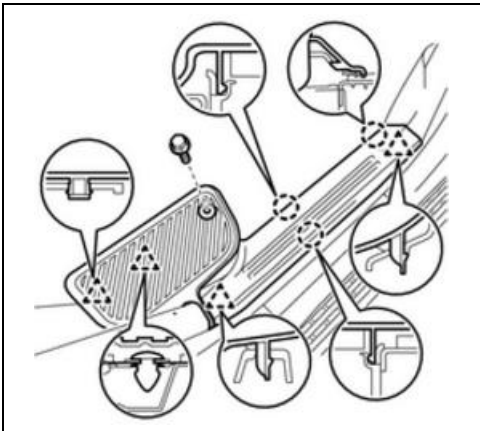
**5. INSTALL REAR SCUFF PLATE RH**

a. Connect the electrical connector for the illumination circuit, if equipped.

b. Attach the 3 claws and 4 clips.

c. Install the screw.

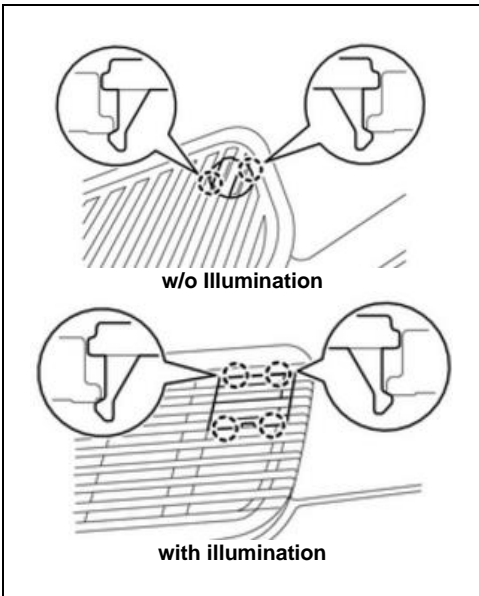
- d. Attach the access cover on the step by engaging the claws.

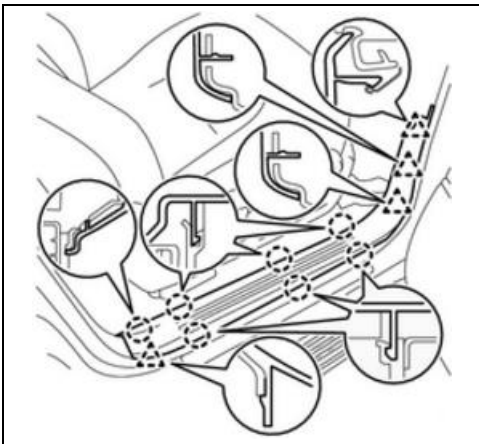
**6. INSTALL FRONT SCUFF PLATE RH**

- a. Connect the electrical connector for the illumination circuit, if equipped.
- b. Engage the 7 claws and 4 clips.
