TECHNICAL INSTRUCTIONS

SAFETY RECALL JS5

PASSENGER AIRBAGS COULD DEACTIVATE

CERTAIN 2008 – 2019 LANDCRUISER

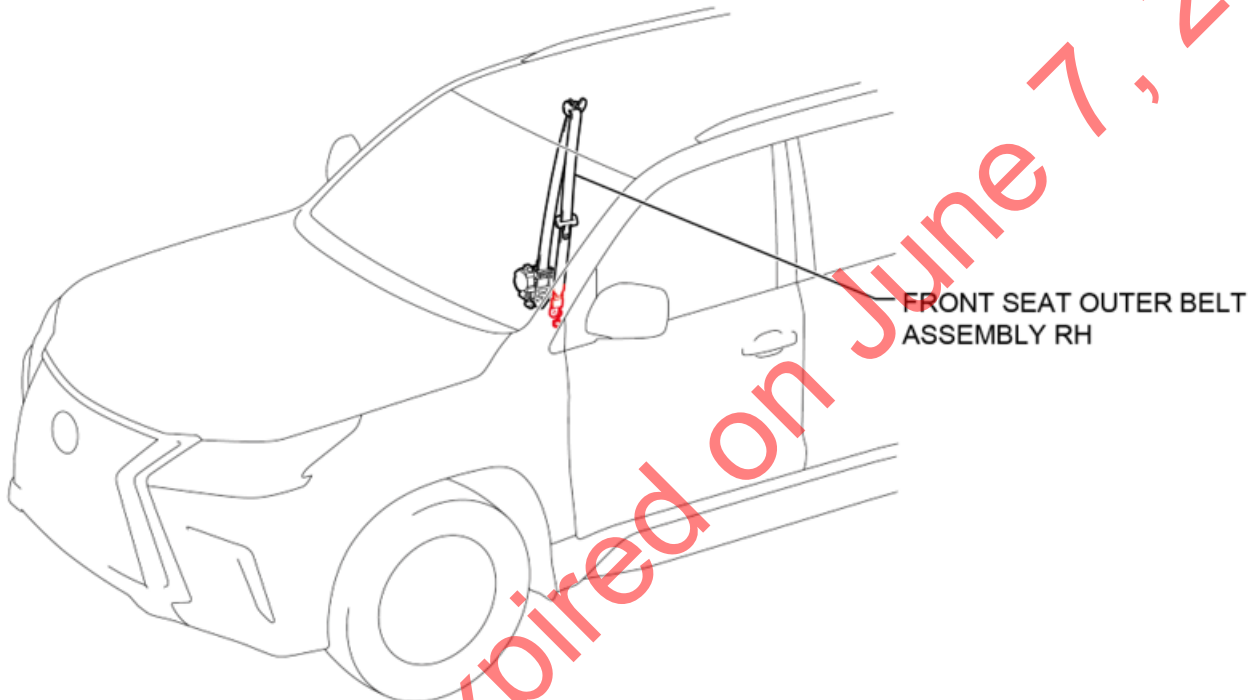
The front passenger occupant classification system has a seatbelt tension sensor that could malfunction over time and could cause the airbag warning light and the passenger airbag "OFF" indicator to illuminate. In addition, the front passenger airbag, passenger knee airbag, and the passenger seat-mounted side airbag may be deactivated. If these airbags are deactivated, there is an increased risk of injury to the occupant in the event of a crash.

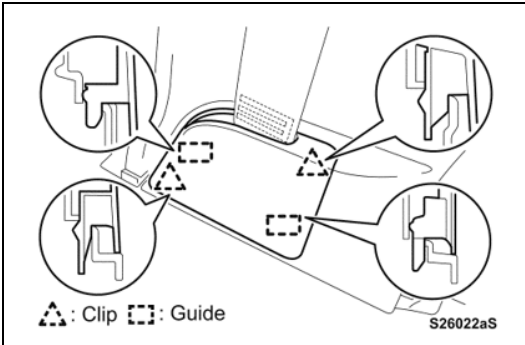
1. VERIFY THAT THE VEHICLE IGNITION IS IN THE OFF POSITION.
2. ADJUST FRONT RH SEAT POSITION
 - a. Slide the RH front seat fully forward.
 - b. Position RH front seatback to the vertical position.

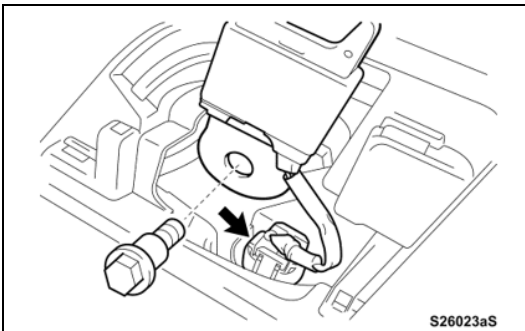
3. REMOVE CENTER PILLAR GARNISH COVER RH
 - a. Pull vertical (straight up) on the RH garnish cover at the base of the B-pillar to detach the 2 clips and 2 guides.

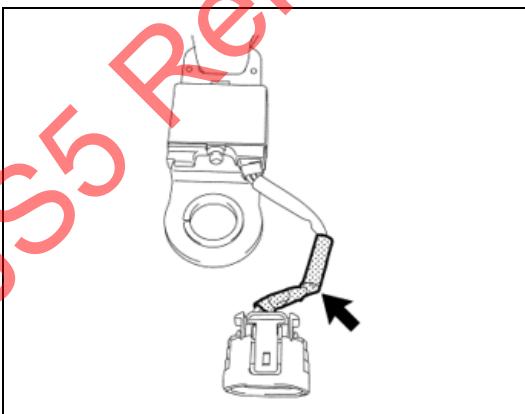
5. MODIFY SEAT BELT TENSION SENSOR
 - a. Extend the seat belt about 24".
 - b. Apply some protective painters tape to hold the belt in position.

- c. Unravel the vinyl tape from the outer end of the tube.

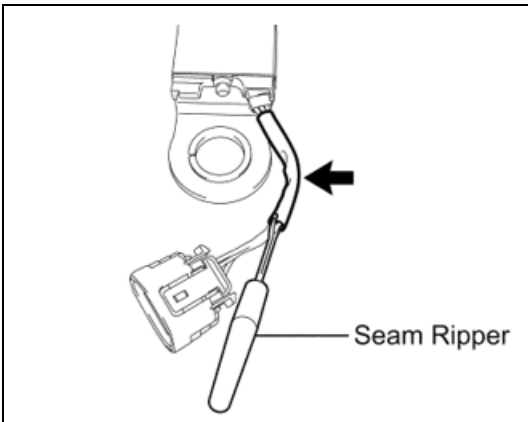
BE CAREFUL. DO NOT DAMAGE THE WIRES.

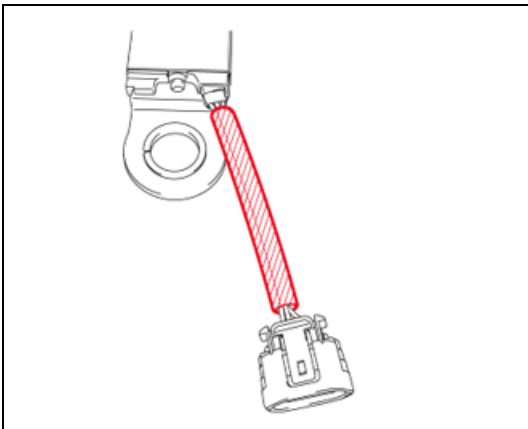
d. Using a seam ripper, carefully slice the black vinyl tube to remove it from the harness.

STOP BE CAREFUL. DO NOT DAMAGE THE WIRES.

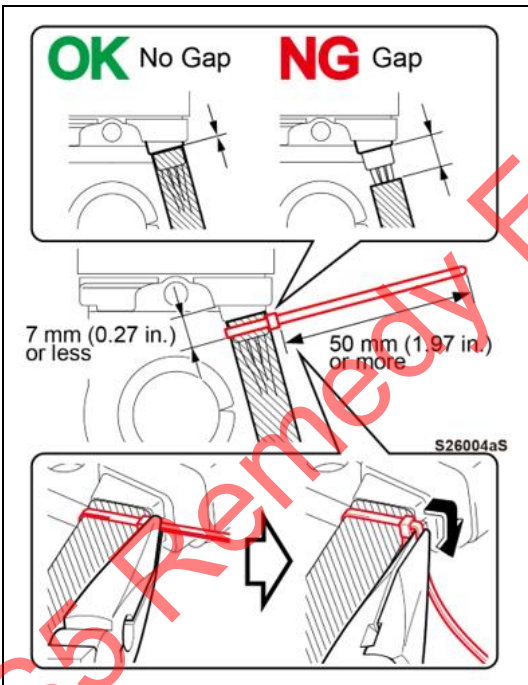
e. Install the **NEW** braided wire harness tube.

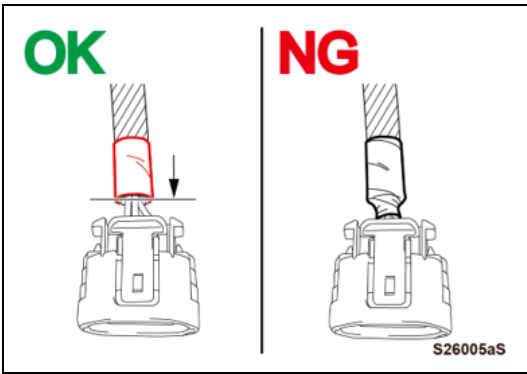
f. Slide the **NEW** braided harness tube over the base of the seat belt tension sensor as shown in the illustration.
 g. Wrap the **NEW** zip-tie around the harness and tighten in the position as shown.
 h. Using pliers, continue to tighten the zip-tie until the excess tail length is 50mm (1.97") or longer.
 i. Cut off the excess tail of the zip-tie.

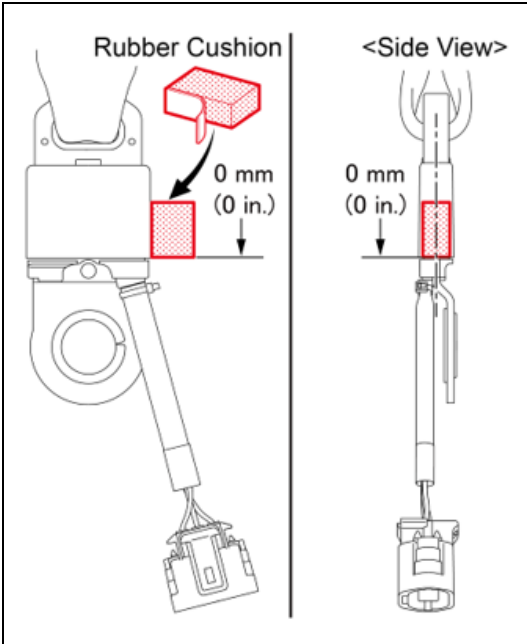
j. Cut a piece of vinyl (electrical) tape and wrap it around the end of the braided harness tube, as shown.

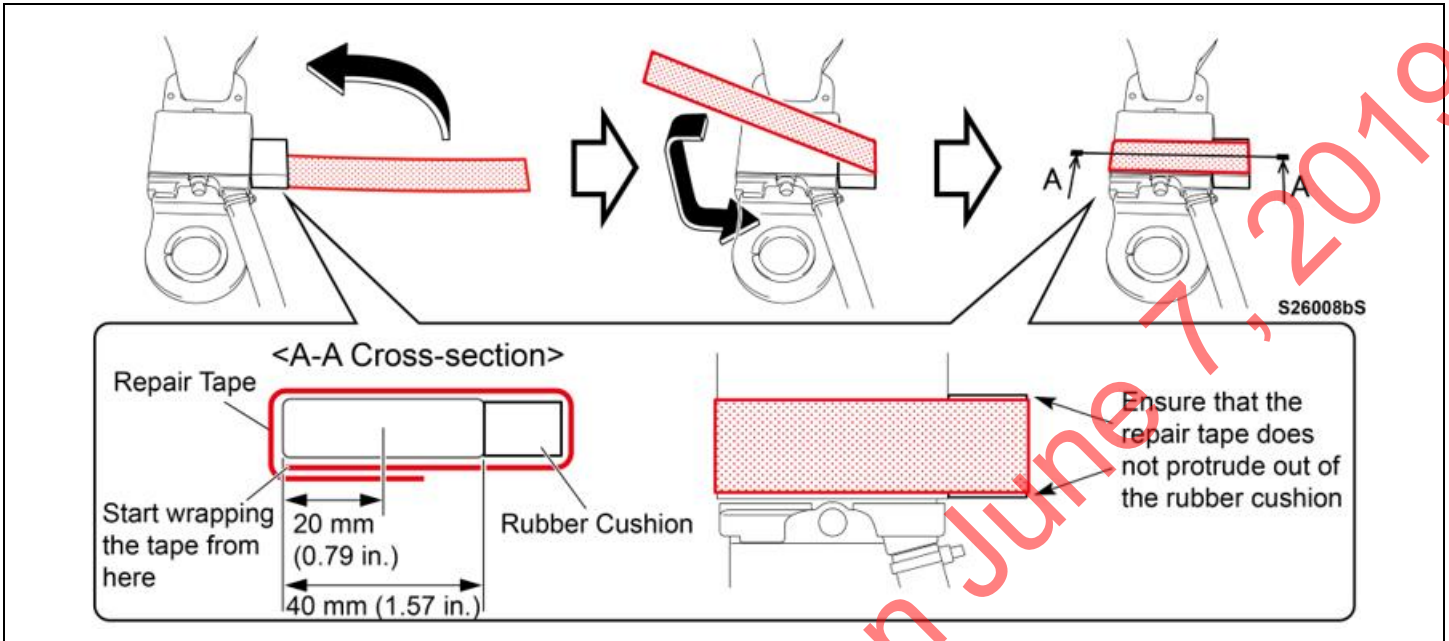
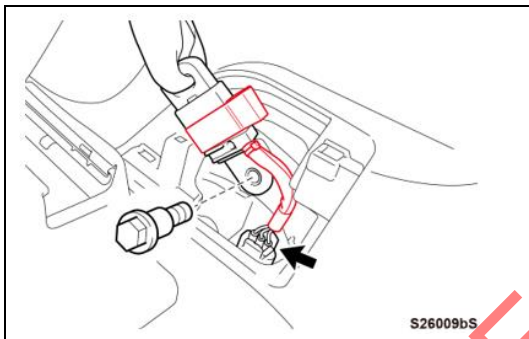
- n. Wrap the Tessa Abrasion Resistant tape around the seat belt tension sensor and the rubber cushion, starting from the rear edge, as shown in the following illustration.
