# **TECHNICAL INSTRUCTIONS**

**SAFETY RECALL JLL**

**PASSENGER AIRBAGS COULD DEACTIVATE**

**CERTAIN 2008 – 2019 LX 570**

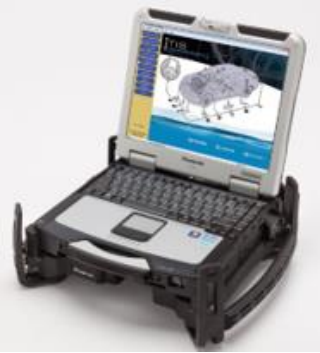
### 1. CHECK FOR DTC'S

- Using a Techstream, check for Diagnostic Trouble Codes.

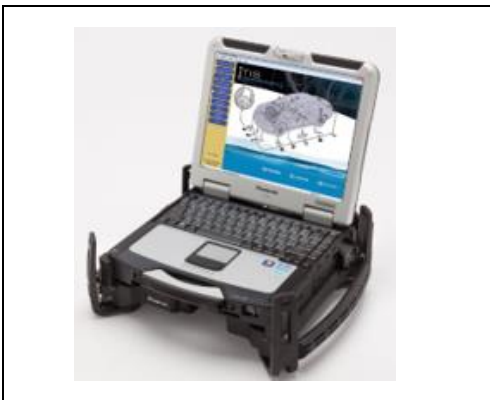
**8. PERFORM VERIFICATION HEALTH CHECK**

- a. Using a Techstream, perform a Health Check.
- b. Clear DTC's that may be present.
- c. **Re-run the Health Check to confirm that no DTC's reappear.**
