RECALL CAMPAIGN BULLETIN

VOLUNTARY SAFETY RECALL CAMPAIGN 2019 ALTIMA; FUEL FEED HOSE RETAINER INSPECTION

CAMPAIGN ID #: PC669
APPLIED VEHICLES: 2019 Altima (L34)
APPLIED ENGINE: PR25DD

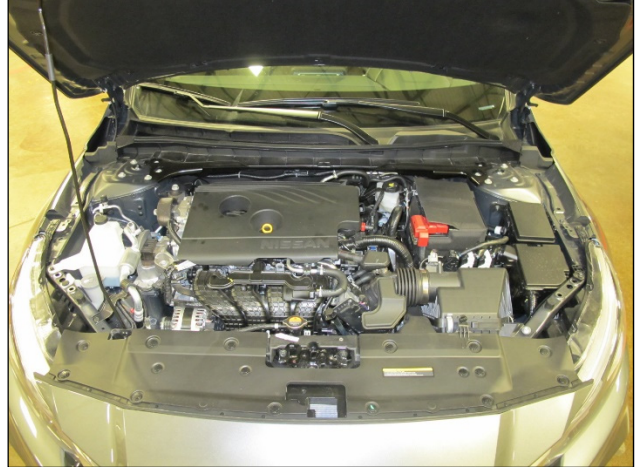
Figure 1

1. Open the hood and secure the hood with the hood prop rod.

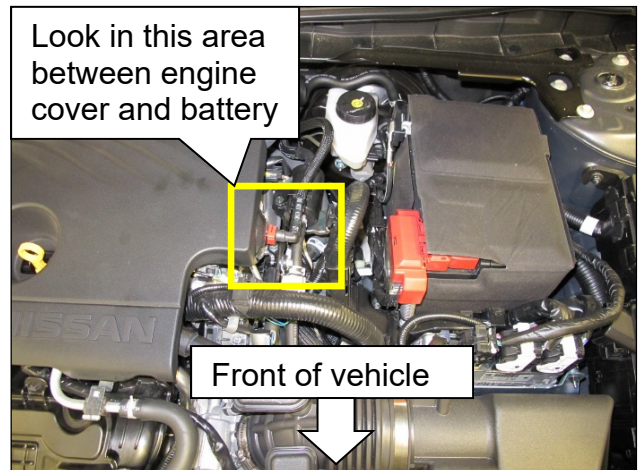
Figure 2

2. Locate the fuel feed hose retainer area outlined in Figure 2.
 - The fuel feed hose retainer is red in color.

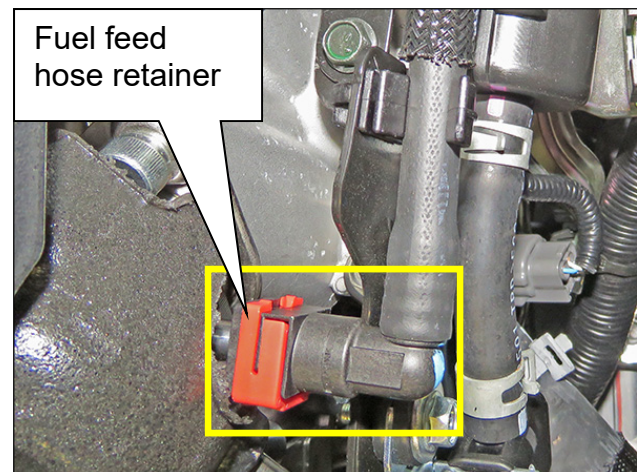
Figure 3

3. Locate the fuel feed hose retainer shown in Figure 3.

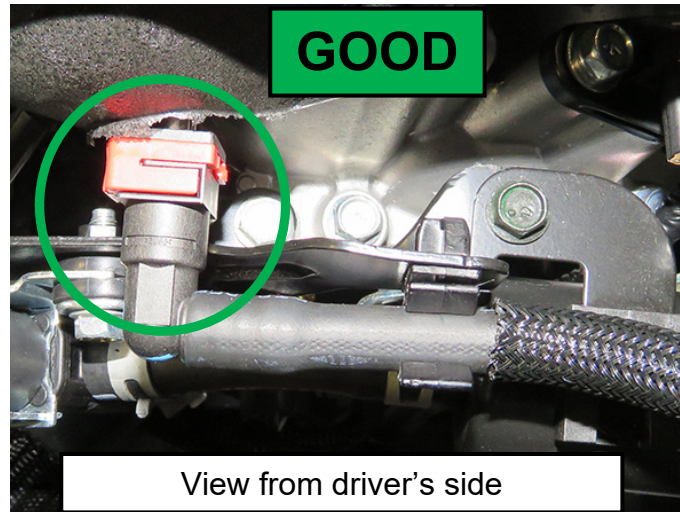
Figure 4

- If the fuel feed hose retainer is secured as shown in Figure 4, skip to step 7.

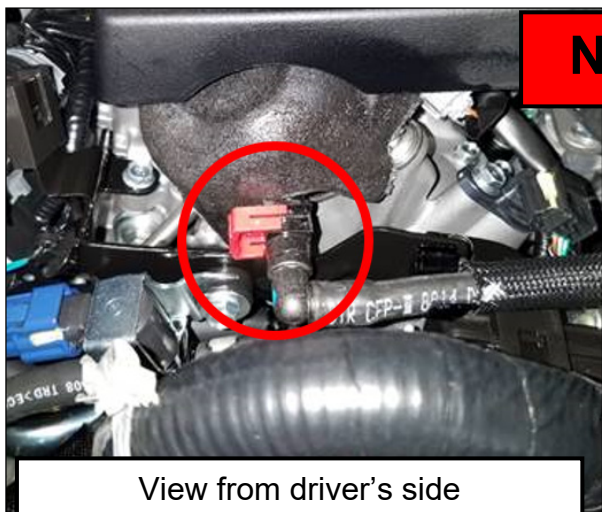
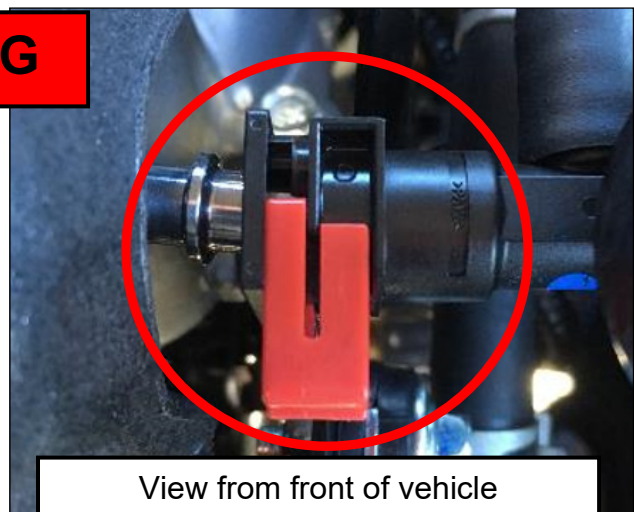
- If the fuel feed hose retainer condition is out (not fully locked, similar to Figure 5 and Figure 6), follow the instructions in step 5 on the next page.

5. Insert the fuel hose until fully seated.

6. Push the fuel feed hose retainer until a “click” sound is heard and check that the retainer is securely installed.

- Pull the quick connector by hand and check that is locked.

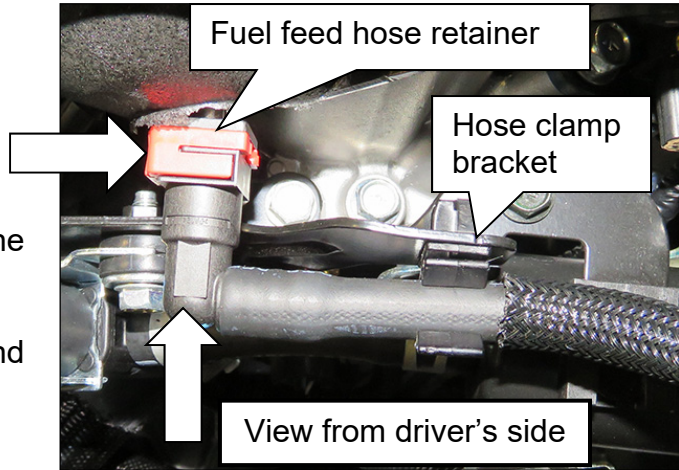
Figure 7

7. Verify the fuel feed hose is secured in the hose clamp bracket shown in Figure 7.
