DATE: July 30, 2019
TO: Blue Bird Owners
Subject: **RECALL R18ZN, HSM NextGen (School Bus) Seat with Integrated Child Restraint Belt System Warning Label**

IMPORTANT SAFETY RECALL NOTICE

SUBJECT: RECALL R18ZN, HSM NextGen (School Bus) Seat with Integrated Child Restraint Belt System Warning Label

RECALL #18E083 SERVICE REPAIR PROCEDURE #1801-0012

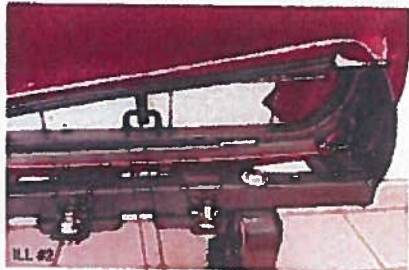
#500-094, ICS LOWER BELT CLIP
CUSHION FRAME ICS ROD

- 5 LOCATE ICS BELT CLIP AND UNHOOK. WHEN (2) ICS POSITIONS, INSTALL ONE AT A TIME. SEE ILL #2.
 - 6 ROTATE CUSHION INTO DOWNWARD POSITION
 - 7 PULL BUCKLE END OF BELT, THE PULLING MOTION MAY LOOSEN GROMMET FILLER PART AND ALLOW ENTIRE BELT TO BE REMOVED.

- 9 GUIDE ICS BELT CLIP FIRST THROUGH GROMMET, ASSURE BELT ORIENTATION IS CORRECT.
 - 10 ROTATE CUSHION IN UPWARD POSITION.
 - 11 ATTACH ICS BELT CLIP INTO CUSHION FRAME ICS ROD, ASSURE BELT AND BELT CLIP ARE ON BOTTOM SIDE OF CUSHION FOAM AND FLEXMAT.

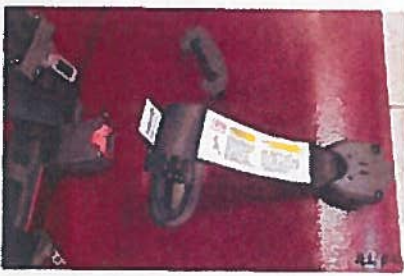
#500-094, ICS LOWER BELT BUCKLE
GROMMET

- 14 PLACE GROMMET FILLER PART BACK INTO GROMMET, ASSURE FILLER PART IS FLUSH WITH REMAINING GROMMET ASSY.
 - 15 ASSURE CUSHION IS LOCKED IN THE DOWNWARD POSITION.

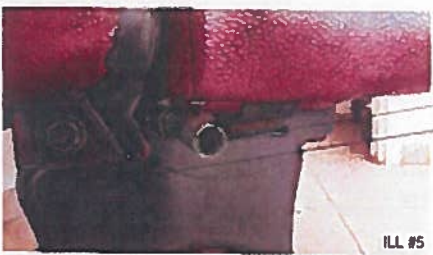
#600-640, CUSHION KEY
PLUNGER

- 2 ASSURE ALL NEEDED PARTS/ITEMS ARE AVAILABLE.
 - 3 UNLOCK CUSHION AND PLACE IN UPWARD POSITION. TO UNLOCK PLACE KEY IN PLUNGER, TWIST TO SET AND PULL OUT TO D SENGAGE. SEE ILL #5

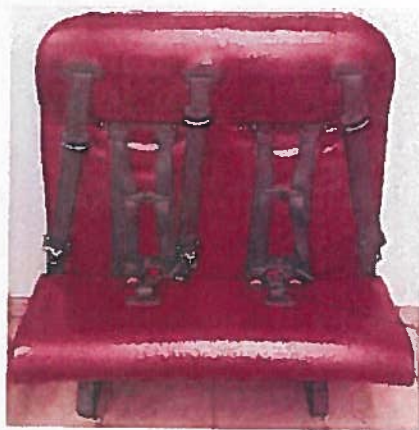
ILL #1

500-094 ICS LOWER BELT BUCKLE

1. FIRST CHECK WHETHER ICS LOWER BELT BUCKLE NEEDS REPLACED. IF CURRENT ICS BELT DOES NOT HAVE LABEL, PROCEED WITH THE ADDITION OF LABEL 800-651-HT.
2. LOCATE LABEL AS SHOWN ON BELT 500-094 BOTTOM VIEW. ASSURE LABEL IS LOCATED ON BOTTOM OF BELT.
3. USE HEATED HAIR STRAIGHTENER OVER BELT AND LABEL. GLIDE HAIR STRAIGHTENER BACK AND FORTH SLOWLY AS NEEDED TO ACTIVATE LABEL HEAT TRANSFER.
NOTE! SEE ILL #2 TO SEE VISUAL DIFFERENCE OF ACTIVATED HEAT TRANSFER ON LABEL.
NOTE! USE CAUTION TO NOT KEEP HAIR STRAIGHTENER IN ONE AREA TOO LONG. THIS WILL AVOID OVERHEATING THE LABEL THAT COULD CAUSE DAMAGE/LEGIBILITY
4. ASSURE LABEL DOES NOT MOVE WHILE ACTIVATING HEAT TRANSFER.
5. CHECK THAT LABEL HEAT TRANSFER IS FULLY ACTIVATED ON WEBBING. ANY QUESTIONABLE AREAS REPEAT STEPS 2 - 5.

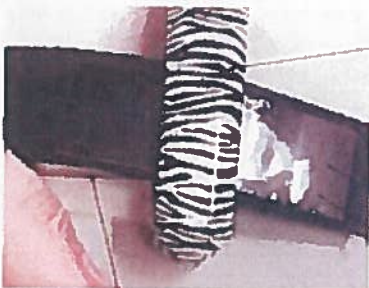
ILL #2

HAIR STRAIGHTENER

LABEL
(HEAT TRANSFER NOT ACTIVATED)
EXAMPLE OF HEAT TRANSFER CLEAR LABEL
(NOT 800-651-HT)

LABEL
(HEAT TRANSFER ACTIVATED)

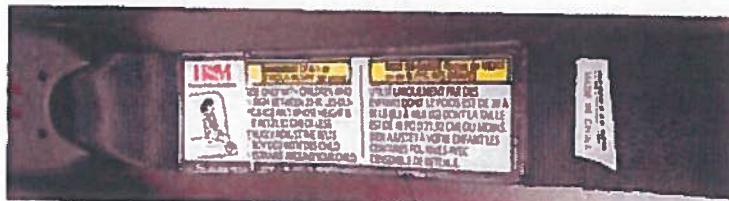
ILL #3

LABEL #800-651-HT

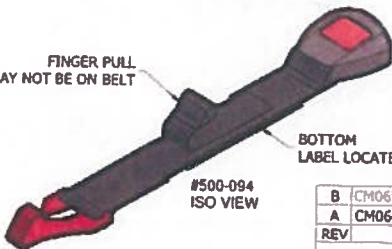
#500-094
ISO VIEW

#500-094, ICS LOWER BELT BUCKLE
(w/ REQUIRED LABEL)

FINGER PULL
MAY OR MAY NOT BE ON BELT

BOTTOM
LABEL LOCATED
