**DATE:** May 29, 2019  
**TO:** Blue Bird Owners  
**Subject:** RECALL R19ZU, Hydraulic Parking Brake Cable Retention

# RECALL

## R19ZU Hydraulic Parking Brake Cable Retention

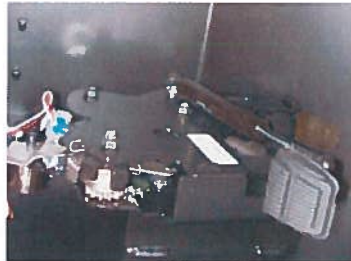
Figure 1 - Foot Brake Pedal

1. Locate the foot operated parking brake pedal at the Drivers Control Module (DCM).
2. Release the foot park brake to the fully released position (See Figure 1).
