IMPORTANT SAFETY RECALL NOTICE

NHTSA Recall Number: 18V-884 School Bus
NHTSA Recall Number: 18V-885 Non-School Bus

SUBJECT: RECALL R19ZV – Vision Transmission Shifter Cable and Brake Line Routing with Ford 6.8L V10 Engines

R19ZV Revision A Vision Trans Shifter Cable & Brake Line

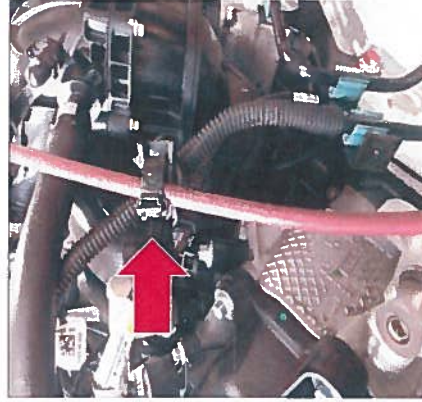
Photo 1

Check the transmission shifter cable and insure it is NOT mounted to the top rear of the engine (Photo 1). Also inspect the fuel line to insure the PCV hose is not attached to the fuel line (Photo 2). If so, cut the mounting cable ties and remove ties and mounting saddle. Inspect the fuel line for any chaffing at shifter cable mounting point and replace fuel line if necessary.

3. Check the transmission shifter cable and insure it is NOT mounted to the top rear of engine (Photo 1). If so, cut the mounting cable tie and remove mounting saddle. Inspect fuel line for any chaffing at shifter cable mounting point and replace fuel line if necessary (Photo 1).

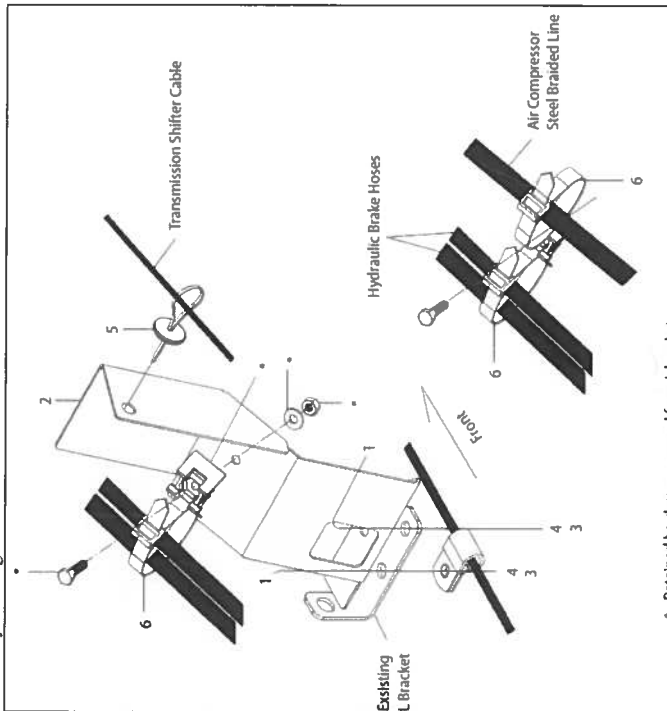
Figure 1

4. Locate the existing steel brake line L bracket mounted to the inside of the LH frame rail. Remove and retain the hydraulic brake line clamp, two-way saddle and fasteners from the top of the L bracket (Figure 1).

5. Install heat shield bracket (Item 2) to the top of the L bracket with fasteners (Items 1, 3, 4) and remount the metal brake line clamp under the existing L bracket (Figure 1).

- Please insure steel brake line is clamped in a parallel line to the frame rail.
6. Install the previously removed two-way saddle containing the rubber hydraulic brake line to the heat shield using the existing fasteners as shown (Figure 1).

7. On units with an air compressor, secure the air compressor steel braided line to the heat shield saddle with an additional tie cable (Item 6) separate of hydraulic brake lines as shown (Figure 1).

- Verify the routing of the braided line to insure no dips in the line with a continuous downward slope to the air dryer.
8. Secure the transmission shifter cable to the side of the heat shield with button head zip tie (Item 5) as shown (Figure 1).

* - Retained hardware removed from L bracket.

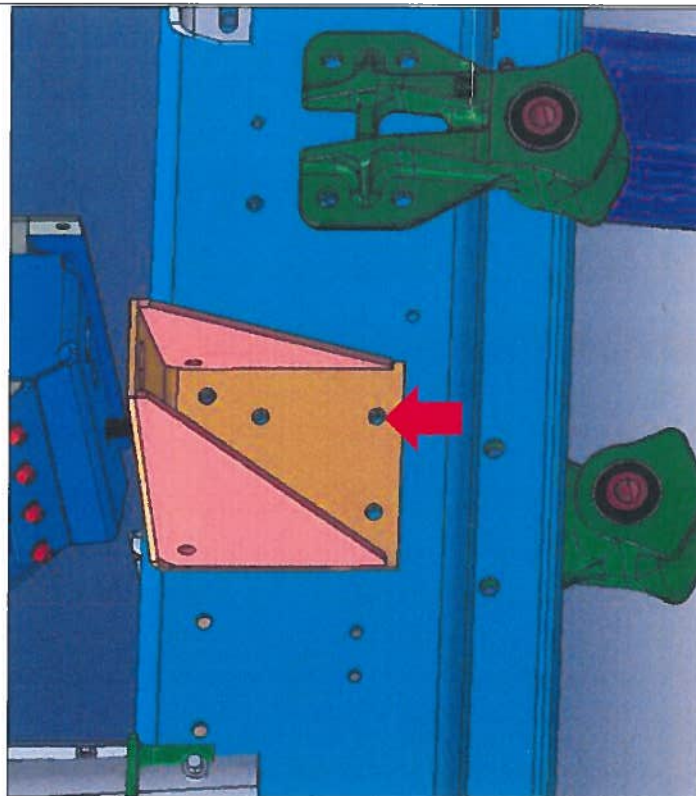
Figure 2

1. Locate and remove lower rearward Huck fastener from driver's side outrigger bracket. Indicated with small red arrow (Figure 2).
2. Install L bracket (Item 7) with fasteners (Items 8, 9, 10) on the inside of frame rail in the location of the removed Huck fastener. Torque to 56-58ft lbs.

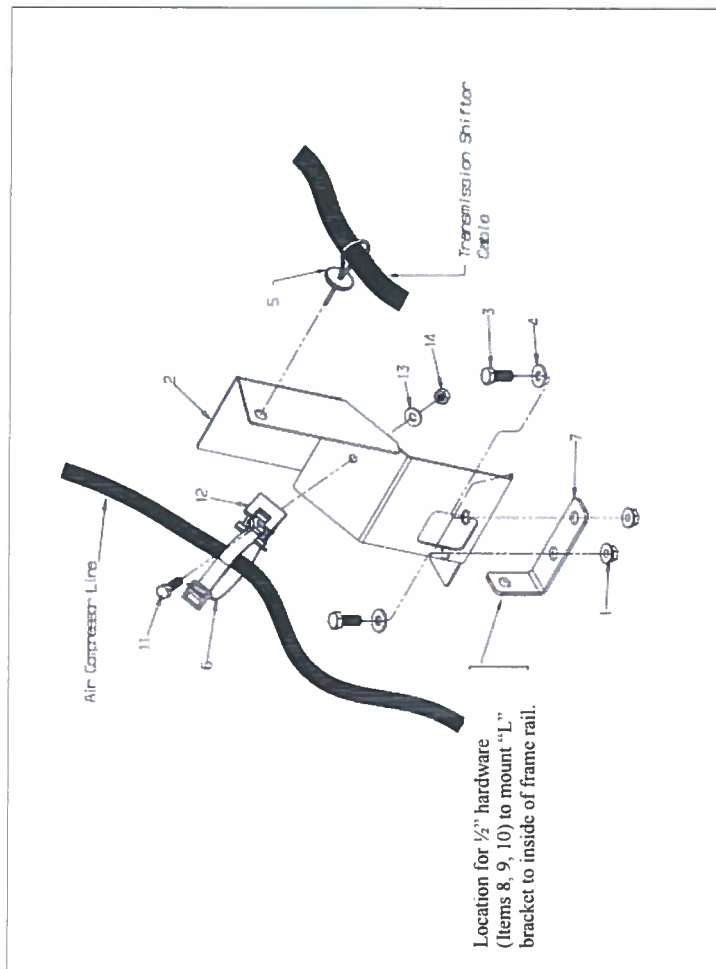
Figure 3

3. Install heat shield bracket (Item 2) to the top of the L bracket with fasteners (Items 1, 3, 4) as shown (Figure 3).
4. Install Saddle (Item 12) to the heat shield with fasteners (Items 11, 13, 14) as shown. Secure the air compressor steel braided line to the heat shield saddle using Zip Tie (Item 6) as shown (Figure 3).

- Verify the routing of the braided line to insure no dips in the line with a continuous downward slope to the air dryer.
5. Secure the transmission shifter cable to the side of the heat shield with button head zip tie (Item 5) as shown in (Figure 3).
