***** IMPORTANT SAFETY RECALL *****
NHTSA Recall No. 18E-112
Cummins Campaign #C2101
Supplemental Notice: Updated Remedy

C2101 – Attachment B – ISV Secondary FEAD Upfit Instructions

ISV Secondary Belt Drive – Upfit Installation Instructions

Campaign Number: c2101	Revision: A	Released Date: 17-Jan-2020
ISV 5.0L Belt Slip Safety Campaign for Blue Bird Bus		Expiration Date (U.S. and Canada): 15-Jan-2045
		Expiration Date (International): 15-Jan-2045

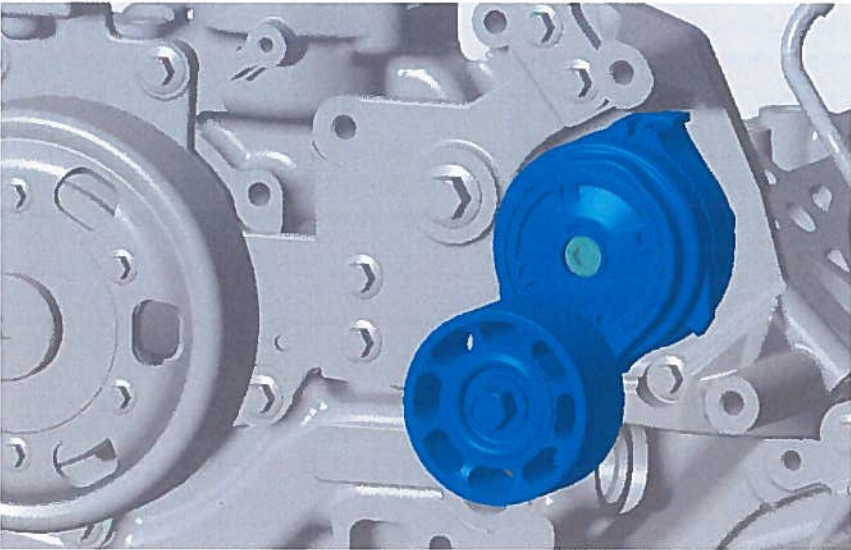
Install belt tensioner 4316721 using capcrew 4324939. Torque: 65 N-m [50 ft-lb]

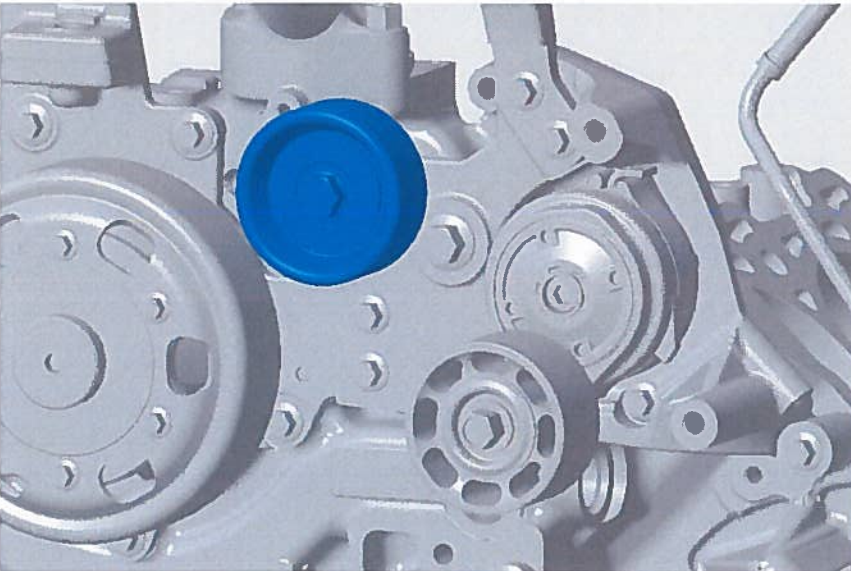
Install idler pulley assembly 4390737 (integrated capscrew). Torque: 34 N-m [25 ft-lb]

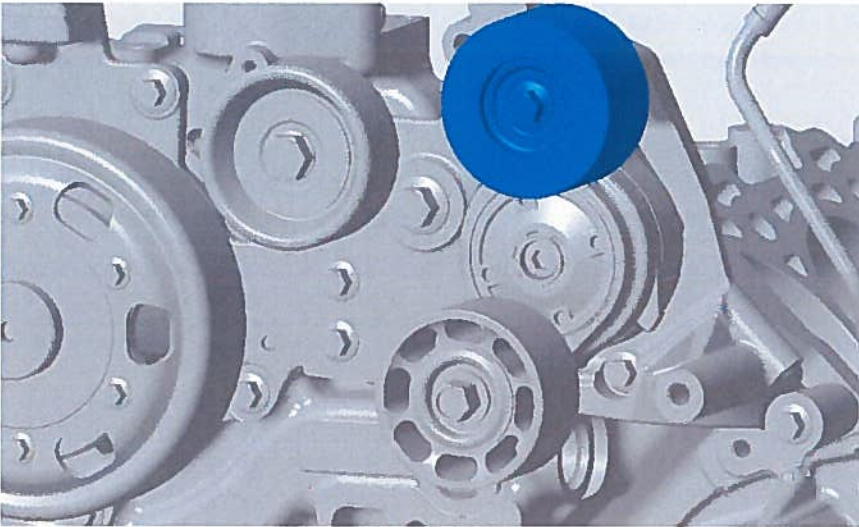
Install idler pulley assembly 5598353 (integrated capscrew). Torque: 65 N-m [50 ft-lb]

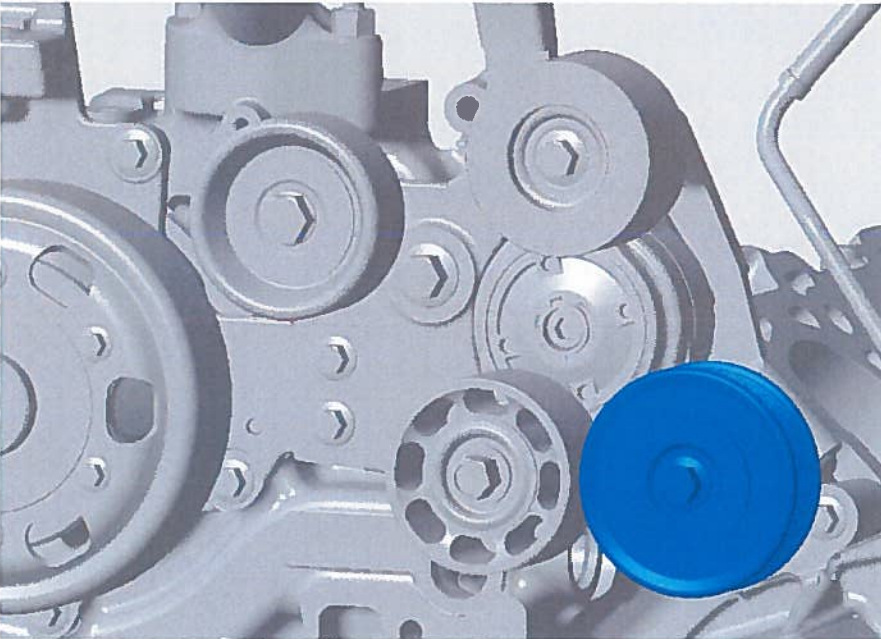
Install idler pulley assembly 5598324 (integrated capscrew). Torque: 65 N-m [50 ft-lb]

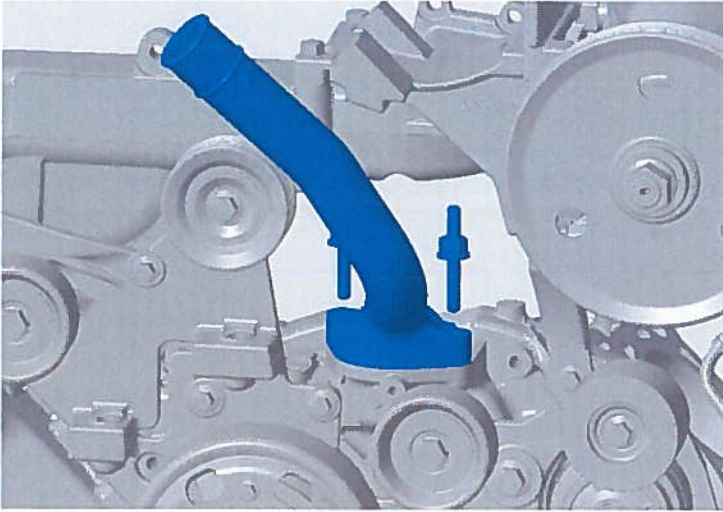
Intall thermostat into new thermostat housing 5414320. Install thermostat housing 5414320 as shown in the figure below. Use same capscrews 4325276. Refer to procedure 008-157-tr. Torque: 18 N-m [159 in-lb]

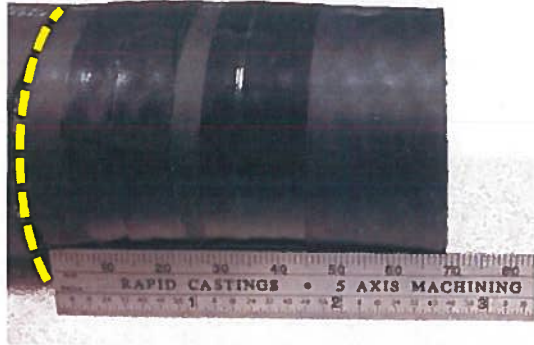
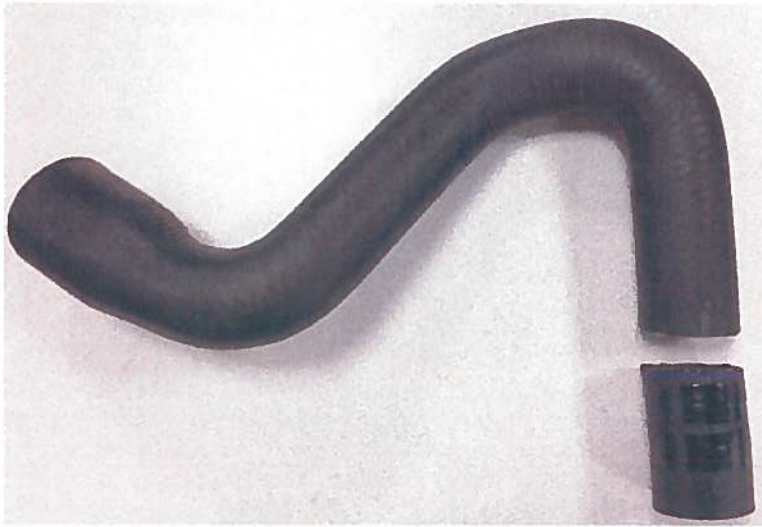
1. Remove the coolant hose from the vehicle.
2. Identify the end that connects to the thermostat housing (engine side). This will be the narrower end.
3. Mark 70 mm (2.75 in) from the end using a pen or marker.
4. Use a sharp utility knife to cut the hose. Try to cut the hose perpendicular to the edge. Make sure not to remove too much. More length can be removed if it does not fit properly.

Remove 70 mm (2.75 in.) from engine side of hose

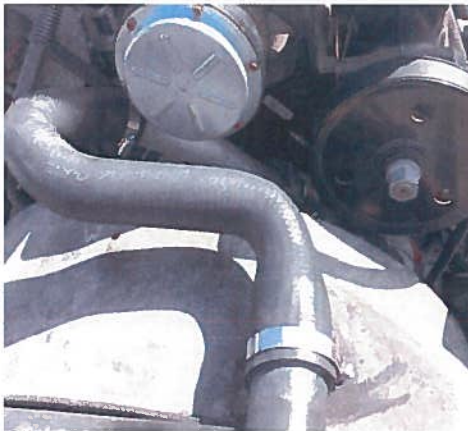
5. Check the fit of the coolant hose on the vehicle to ensure there is no kinking.
