GROUP	NUMBER	
RECALL	18-01-023	
DATE	MODEL(S)	
JUNE, 2018	IONIQ (AE)

2017MY IONIQ (AE) HEV HYDRAULIC CLUTCH ACTUATOR SUBJECT: (HCA) PHASE CAP: INSPECTION, REPAIR, OR REPLACEMENT (RECALL CAMPAIGN 176)

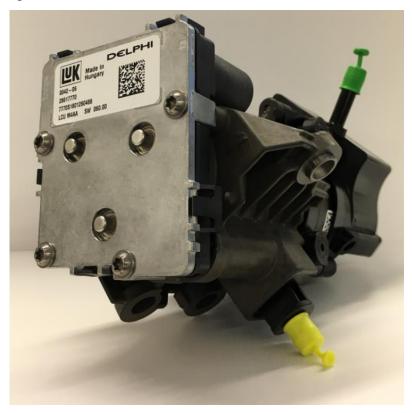
**Description:** This bulletin describes the procedure to inspect, repair, or replace the Hydraulic Clutch Actuator (HCA) on 2017MY Ioniq (AE HEV) Hybrid Electric Vehicles. A burr on the HCA housing can lead to oil seal damage that can lead to an internal oil leak. A short can then occur between the motor and phase cap, increasing the risk of a fire.

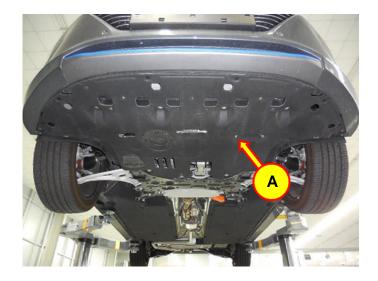
Lift up the vehicle. Remove the engine undercover (A). Locate the Hydraulic Clutch Actuator.

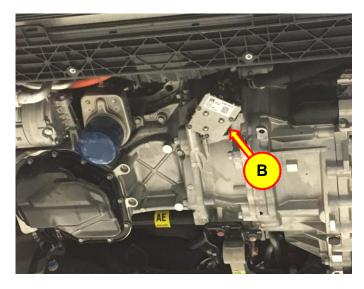
2. Locate the Hydraulic Clutch Actuator (B).

3. If the metal bracket (C) is present on the HCA, reinstall the engine undercover. The inspection is complete.

If the metal bracket is not present on the HCA proceed to the HCA Phase Cap Repair procedure below.

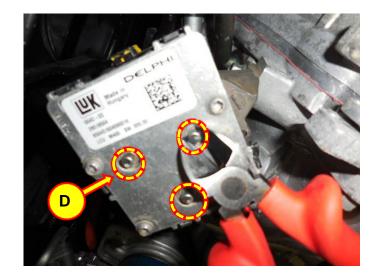
1. Remove the 3 phase caps (D).

NOTE: Remove the phase caps by lightly squeezing and pulling with a set of Diagonal Cutting Pliers.

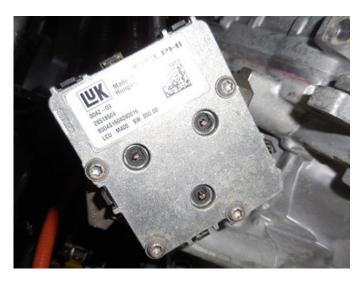
2. With the phase caps removed, inspect for electrode contamination or any signs of oil. If the electrodes are contaminated or there are signs of oil, replace the HCA according to the applicable shop manual.

NOTE: How to check for electrode contamination.

NOTE: If the HCA is replaced, be sure to carry out all steps of the GDS recalibration procedure.

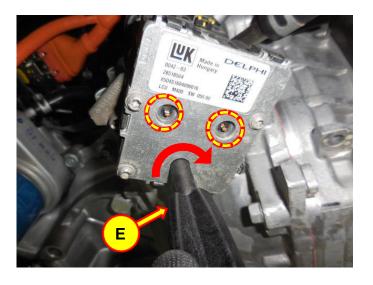
3. If the electrodes are not contaminated, insert the cleaning side of the cleaning and installation tool (E) into the cap hole, turn the tool and remove any debris that may be in the cap holes.

Take care not to damage the electrodes. Do not use compressed air to clean out the phase cap holes.

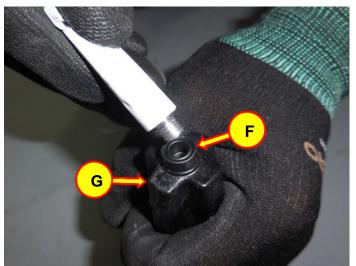
4. Place a new phase cap (F) into the install side of the cleaning and installation tool (G).

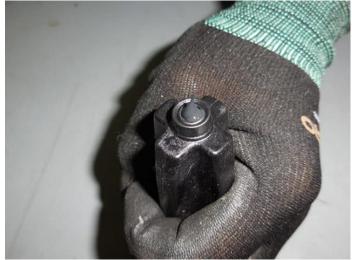
5. Using the supplied glue, apply it to the phase cap as shown.

6. After applying glue, install phase cap into the cap hole on the HCA.

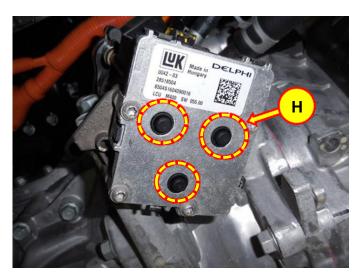
7. Repeat for both the remaining phase caps (H).

NOTE: Discard the tool after cleaning and installing the three phase caps.

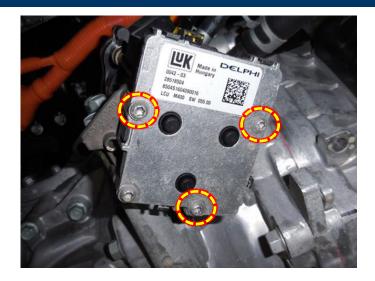
8. Remove the three Torx bolts indicated on the photo using the supplied Torx wrench.

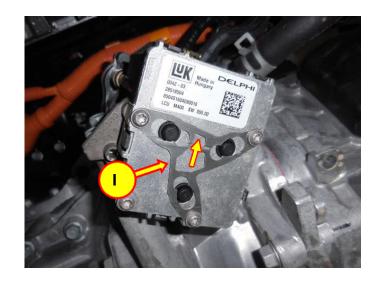
9. Install the supplied metal bracket (I). Position the bracket so the notch cut out in the center stamping points towards the label.

Screw tightening torque: 2.95lb-ft (35.4 lb-in, 0.41kgf.m, 4.0N.m)
