Service Bulletin

Subject: **Recall 2817-18RC02 Fork axle carrier**

Product: **Brutale 800 – Brutale 800 RC – Brutale 800 RR – Brutale 800 RR AMERICA – Brutale 800 RR PIRELLI – DRAGSTER RC – DRAGSTER RR – F3 675 – F3 800 – RVS#1**

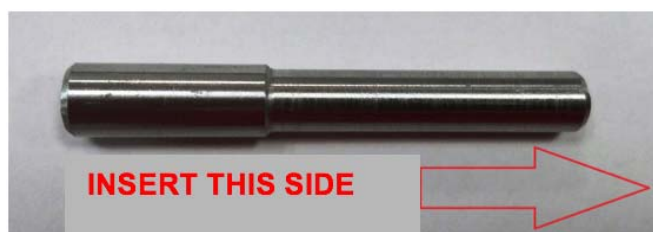
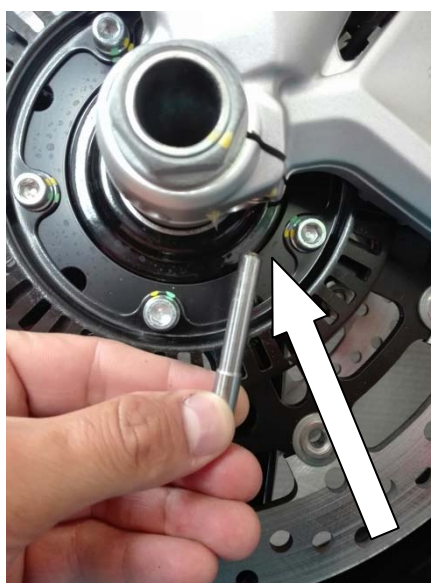
In order to carry out the inspection on the affected motorcycles, it is necessary to use the gauge pad, depicted in the picture below, which you will receive if you have purchased motorcycles whose vehicle identification number is included on the list of motorcycles that may potentially be subject to this recall.

The gauge pad should be inserted in lieu of the lower fork leg screws:

1. Take the gauge pad
2. Remove the lower fork leg screw (code 8C00B2690) on both sides
3. The status of the lower fork leg will be shown by whether or not it is possible to insert the side with the smaller diameter of the gauge pad inside the threaded hole of the screw.
The pad must be inserted without any force, by applying minimal pressure with two fingers.

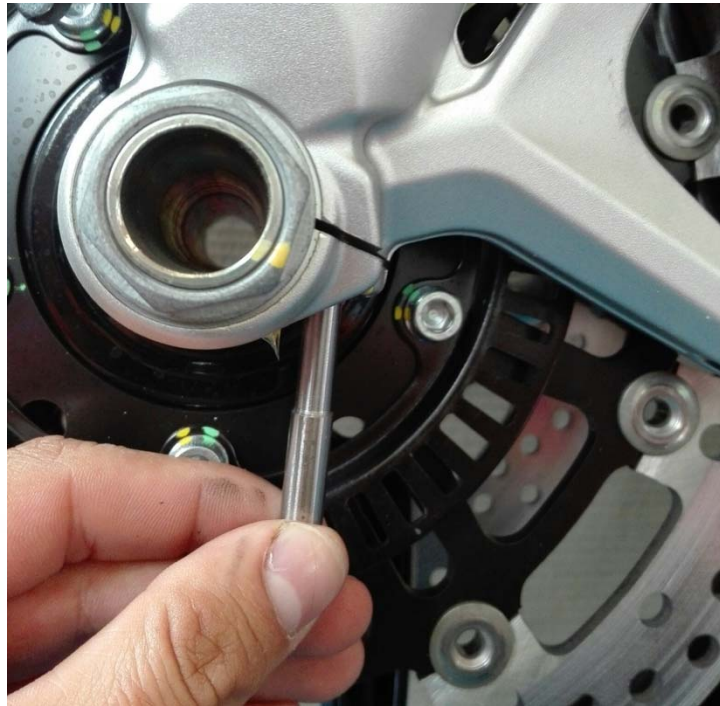
- The pad DOES NOT FIT: the lower fork leg is conforming;
insert the screws back and tighten them again at a torque of 18 Nm; go to point 'A' in the following section, 'warranty claim', in order to obtain reimbursement for the work performed and to certify the conformity of the vehicle.

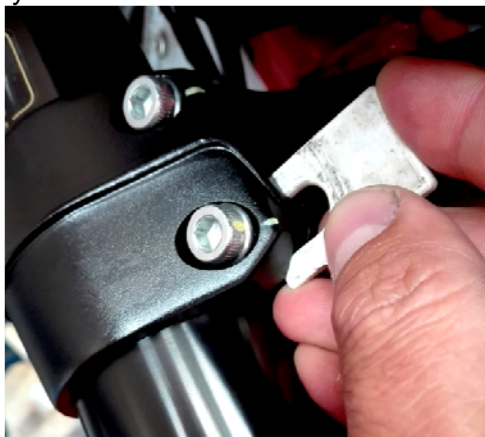
- Loosen the screws of the upper triple clamp and of the lower triple clamp and remove the fork leg; to prevent damage to the components, we recommend using a plastic wedge to separate the parts slightly:

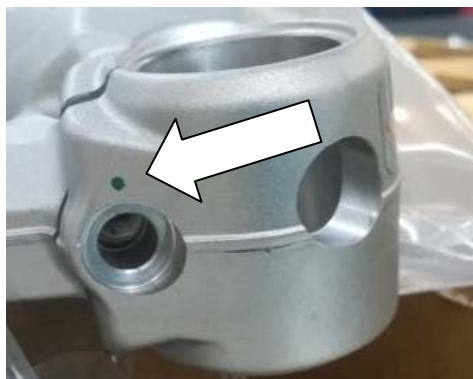
- Take the new fork leg making sure that it is marked with the green marking near the screw hole of the lower fork leg:

- Reposition the leg making sure that the previously measured 'X' installation distance is maintained.
- Remove the separating wedges and tighten the triple clamp screws at the following torques:
right/left upper triple clamp screw (code 8C00B2690): 18 Nm
lower triple clamp screws (code 8C00B2690): 18 Nm
- Reinstall the front wheel and tighten the pin and the screws of the lower fork leg at the following torques:
front wheel pin nut (code 8A00B9883): 60 Nm
lower fork leg screws (code 8C00B2690): 18 Nm
- Reinstall the front brake calipers and tighten the screws at a torque of 45 Nm
- Reinstall the front fender and tighten the screws at a torque of 10 Nm
- For F3 675\800: reinstall the windscreen and the fairing
