# Product Safety Recall

## 17478 Front Passenger Air Bag Inflator

Reference Number: N161644422

Release Date: January 2019  
Revision: 02

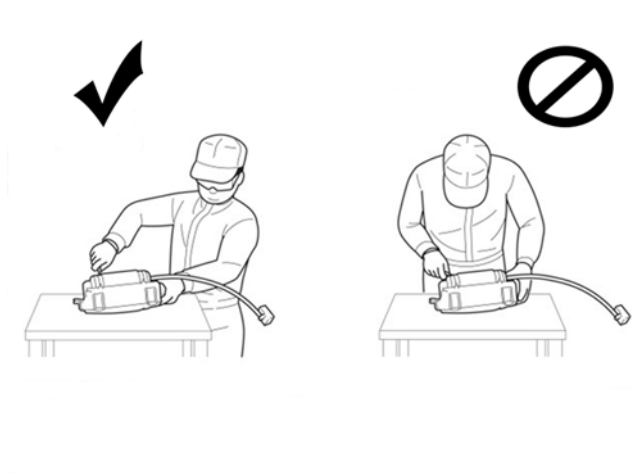
4486635

**Caution:** Avoid standing directly over the inflator.

**Note:** Place clean sheets of paper on the bench inflator side up.

1. Carefully place the airbag on the bench inflator side up.
2. Wrap a flat-blade screwdriver with tape.

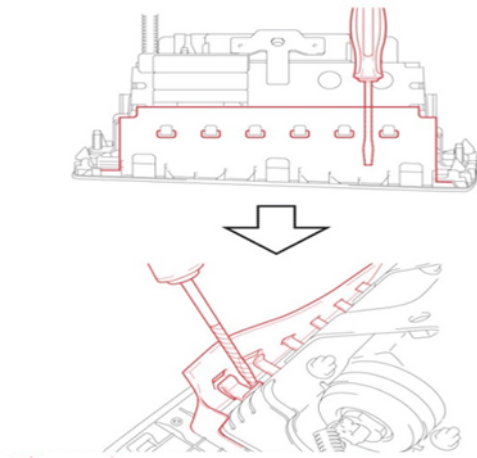
4486638

3. Remove the cover.
  - 3.1. Gently insert the screwdriver between the airbag door and module and disengage the claws holding the door to the module.
  - 3.2. After all the claws have been disengaged, separate the module from the door.
  - 3.3. Mark the old module so it is not reused.
  - 3.4. Inspect the door for damage to the mounting slots.

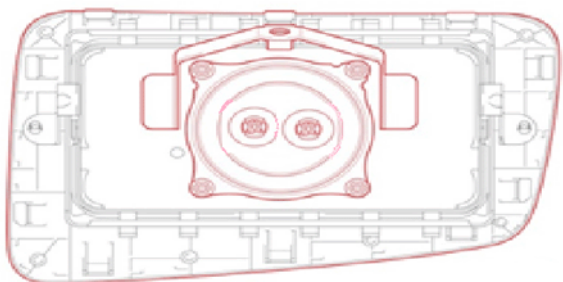
4486640

### 4. Install the new module.

4.1. Carefully slide the new module into the airbag door. Note the mounting direction.

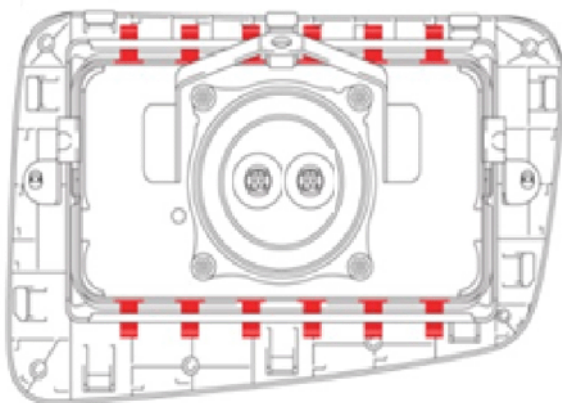
4486641

4.2. Reengage the tangs of the module into the door using the screwdriver with the shaft wrapped in tape.

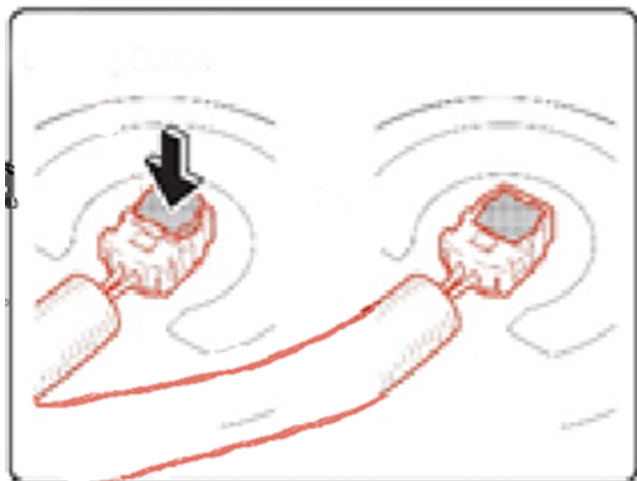
4486647

4.3. Connect the new harness to the new module.

4.4. Press the lock tab down.
