# Recall Campaign

INT FL769-01/02

## Interim Recall

## Subject: TBB SynTec S3B Seat Frames (Restraint Seats)

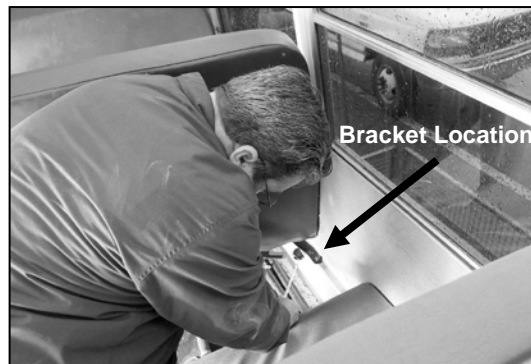
Figure 2

1. Look at the seat mounting bracket. It is behind the seat, at the seat rail along the wall. See **Figure 2**. (A flashlight may be helpful.)

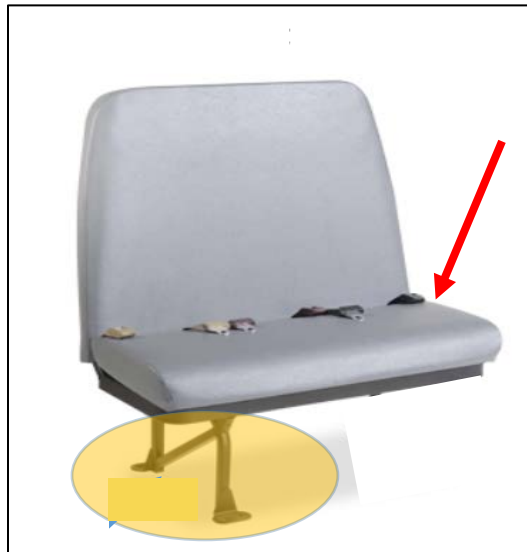
Figure 1: Remove Seat Cushion

1. Park the vehicle, shut down the engine, make sure the shifter is in Park or Neutral, set the parking brake, chock the tires.
2. Remove the seat cushion. See **Figure 1**.
