Subject: Recall campaigns 16V916 and 16V917

**RECALL
CAMPAIGN**

TITLE:	Seat support reinforcement
TO:	Dealer/Owner
PRODUIT:	Model Ford Transit with QS11 seat 39" with lap belts
KIT #:	KS-1801, KS-1803, KS-1804, KS-1805
FROM:	Standards and Regulations

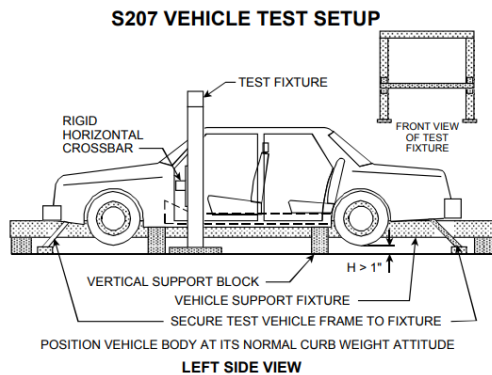
FIGURE 13

the test vehicle so that load application angles will be correct”, while Figures 6B and 13 of the Test Procedure document of FMVSS 207 illustrates such attachments.

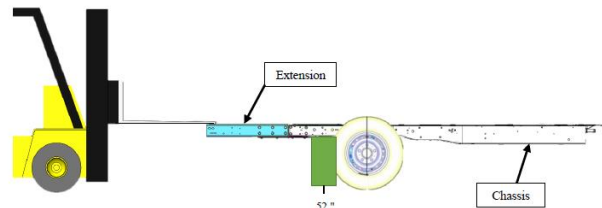
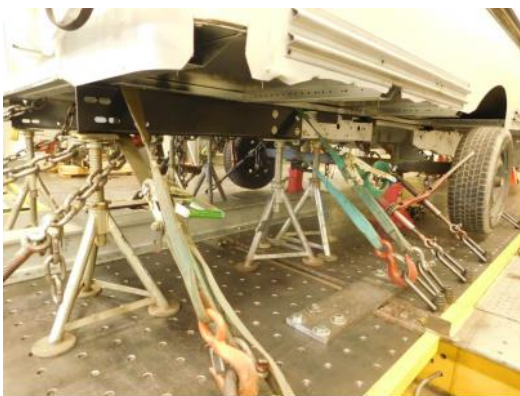
It then became clear that the initial test procedure was responsible for the failing of the frame extension adaptor. As illustrated herein, because of the manner the vehicle was attached in the initial test, any movement was impossible from the front of the vehicle back to the attachment at 52 inches, just behind the rear axle (green rectangle), but small lateral and longitudinal movements were possible from the fixed attachment back to the rear extremity of the frame extension, which included the frame extension adaptor. We believe that during the pull, small movements of the frame extension dislodged the lift, which allowed the frame extension to become free to “follow” the pull force, resulting in the breakage of the frame extension adaptor.

During the new tests, the frame and frame extension were solidly attached - as herein pictured - in compliant with the requirements of FMVSS 207 and 210. These attachments insured to stop any lateral or longitudinal movements of the vehicle, including the frame extension. We believe the new tests demonstrated that the initial test procedure was responsible for the breakage, when none of the tests, even the failed test of the 3-place seats equipped with Type 1 seat belts, resulted in a breakage of the frame extension.

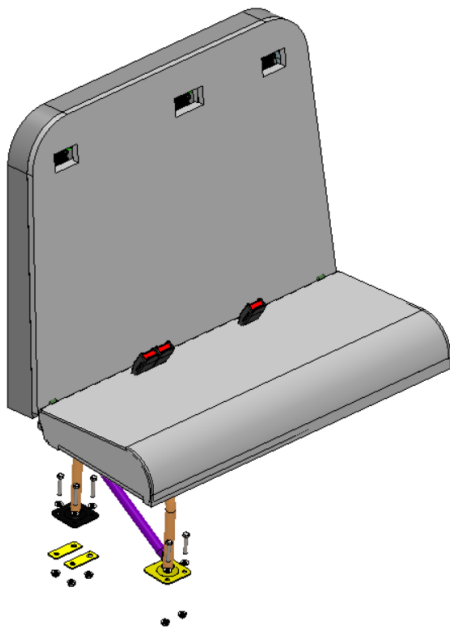
Figure 1: Actual seat setup

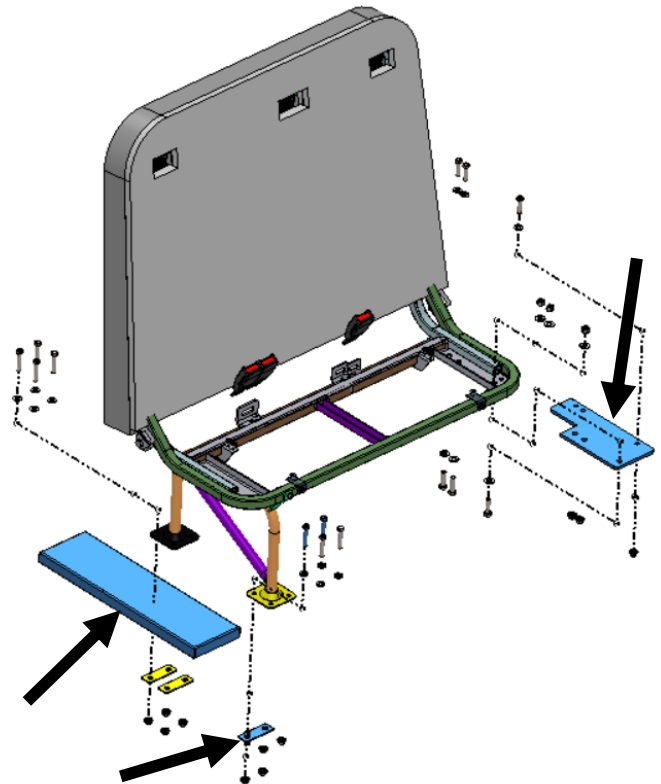
Figure 2: Reinforced seat setup (pointed components are added or changed)

Addition of reinforcement is required to meet the C/FMVSS 207/210 requirements on 39" seats with lap belts.

As for the remedy for the recalled vehicles, as detailed in the attached repair instructions, the chosen solution consists in adding a reinforcement plate under the floor and replacing the plate fixing the seat to the wall. Also, two attachment points (bolts) are added to fix the front leg to the floor.

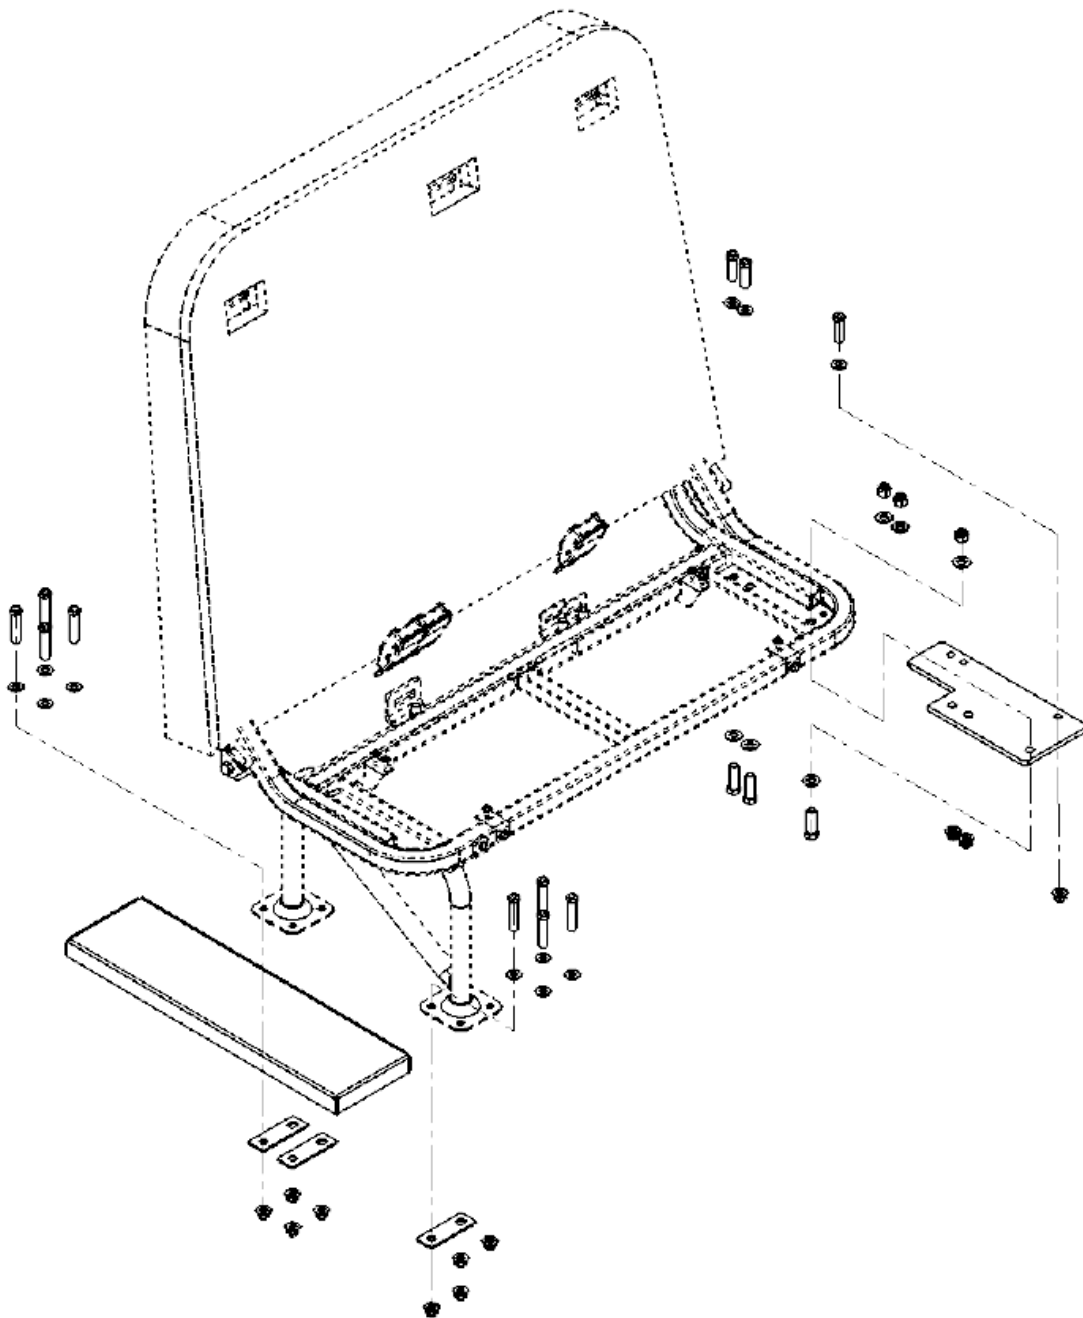
Figure 3 - Exploded view

This procedure is to modify all the 39" seats equipped with lap belts, hereafter called the *concerned seats*. Other seats should not be modified. For details of the assembly (components and position), please refer to the image in the Parts and Material section.

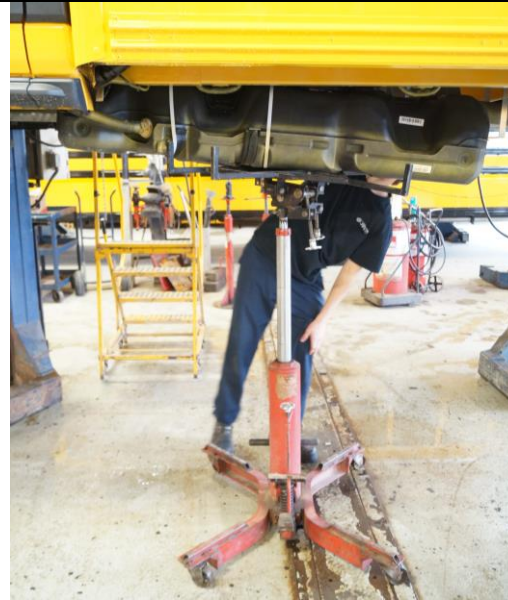
First, use a jack to lower the gas tank. To do so, remove the 3 metal straps holding it with the 13mm drive socket. Carefully lower the tank, being careful that the hoses are not damaged or disconnected.

Figure 4 - Fuel tank descent

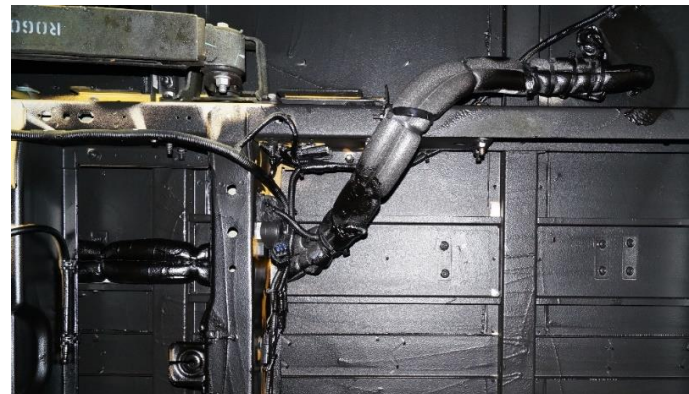
Carefully move aside any items, such as AC unit hoses, that may be in the way. If required, use a cutting plier to remove clips or partially cut insulating sleeves.

Figure 5 - Exemple of items to move under the vehicle

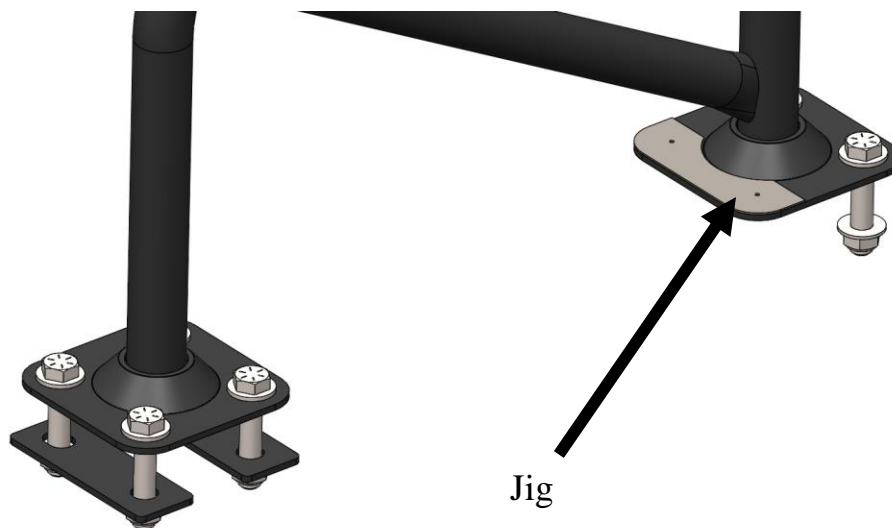
For each concerned seat, use the jig (item #11D04970-REP) to mark the position of the holes to drill. To do so, align the three straight edge of the jig with the side of the leg plate, as shown on Figure 6.

Figure 6 – Drilling jig positioning

With the jig in position, use the punch to mark the position of the holes on the leg.

Remove the jig and drill two 3/8" holes in the leg plate and in the floor using the 3 1/2" long drill bit. Use a 6" long drill bit only if the hole is align with a floor cross member. If using a 6" long drill bit, be extremely careful to avoid damage to any item under the vehicle (especially the gas tank).

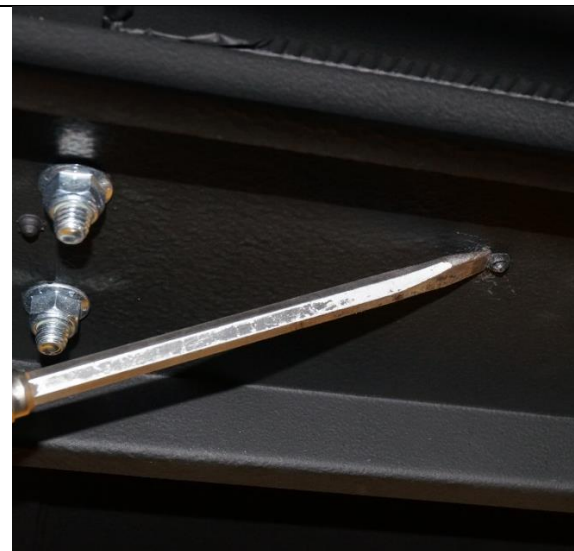
Then remove the rivets ends present into the seat supports with a hammer and a chisel or a cutting wheel.

Figure 7 - Cutting rivet with chisel

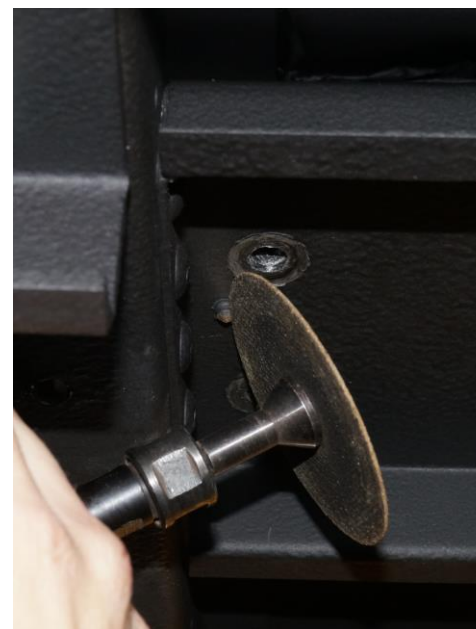
Figure 8 - Cutting rivet with cutting wheel

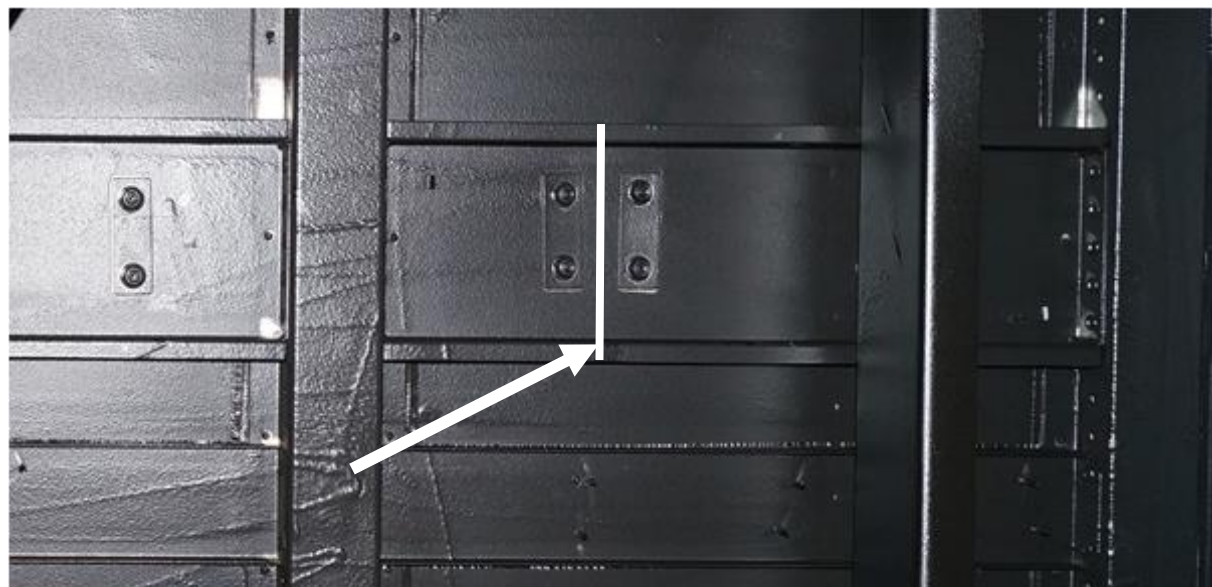
For each concerned seat, mark the center of the bolt pattern of the rear seat leg as indicated on Figure 9.

Figure 9 - Marking the center of the seat rear bolt pattern

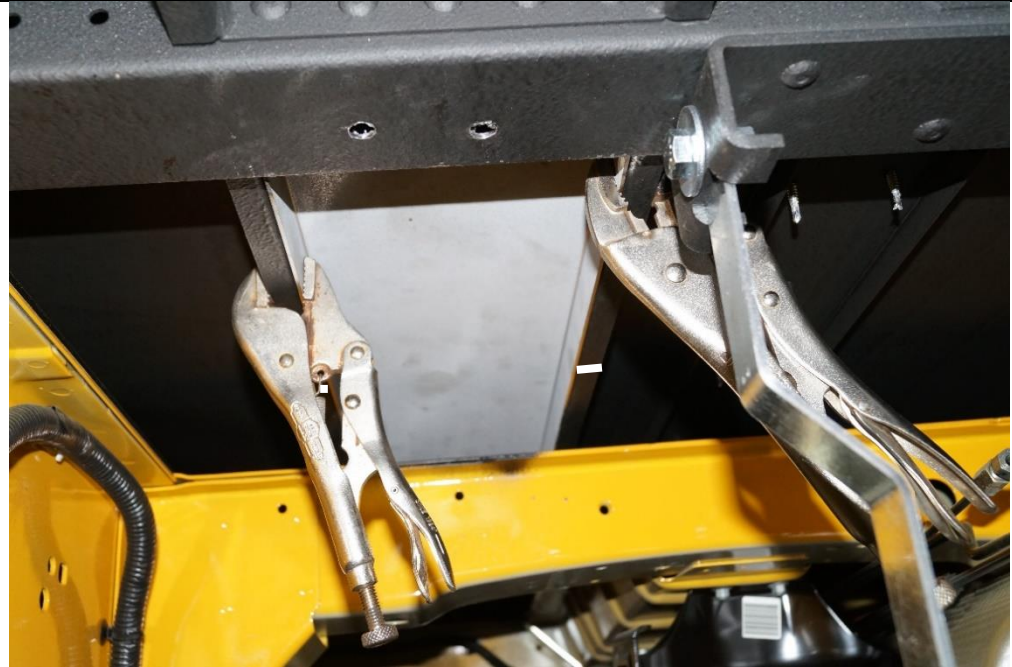
Insert the appropriate seat reinforcement (#11D0487-REP or #11D0488-REP) in each seat support having a rear leg attachment. Make sure the marked rear leg bolt pattern is as near from the center of the seat reinforcement as possible. Once positioned, fix it with locking pliers.

Figure 10 - Fixing the seat reinforcement

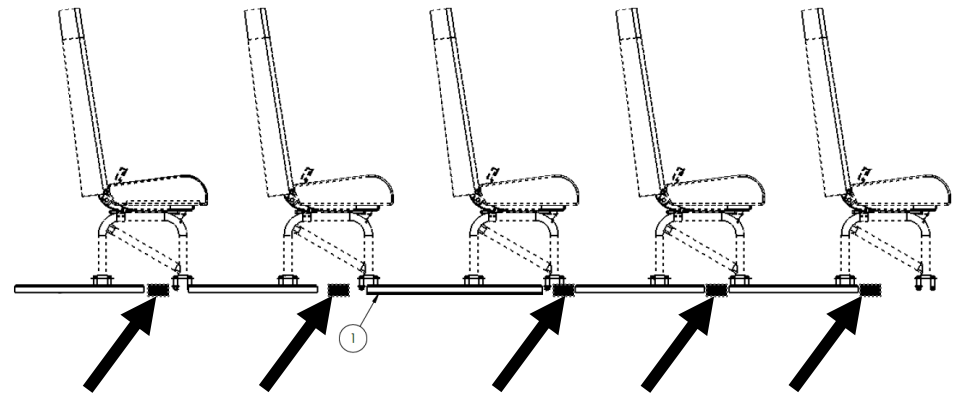
See figure 11 for the position of 11D0487-REP, identified as ① on the Figure. The floor cross members are shown as black boxes and pointed with black arrows. Reinforcements should be inserted to fit in-between the floor cross members.

Figure 11 - Seat reinforcement position (long vs short)

IMPORTANT: Make sure that the longer seat reinforcement #11D0487-REP is inserted in the long seat support under the third seat. It can only fit in that position

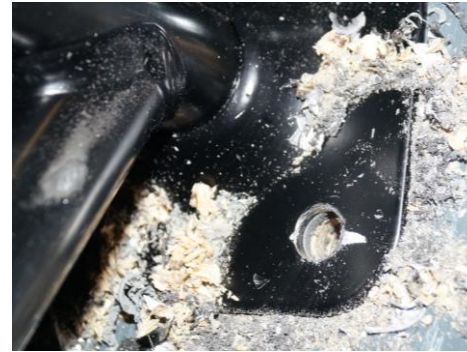
From inside the vehicle, drill through the reinforcement using the holes in the seat leg as a template with a hand drill and a 3½" long 3/8" drill bit.

Figure 12 - Drilling from inside de vehicle

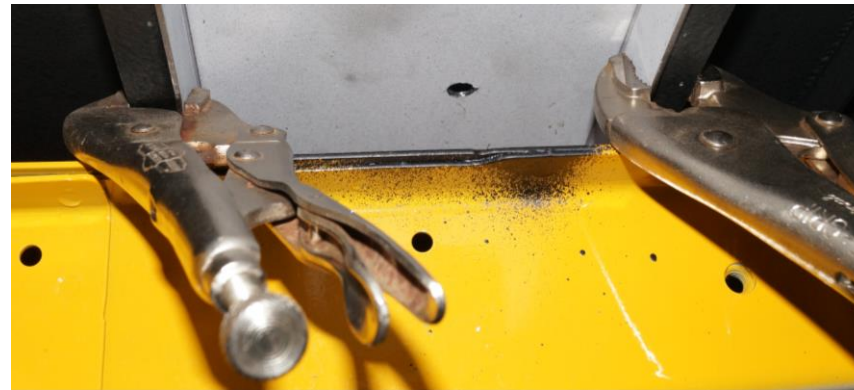
Figure 13 - Hole from under the vehicle

It is recommended to insert a bolt (#81C06C200) and tighten it with the appropriate washer (#83J06), plate (#31D0018) and nut (#82R06C) after each drilled hole.

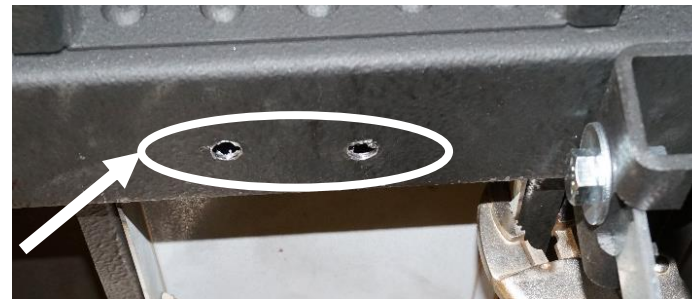
In case a front leg need to be bolted through a cross member as illustrated in Figure 14, use longer bolts #81C06C308.

Figure 14 - Holes in floor cross-member

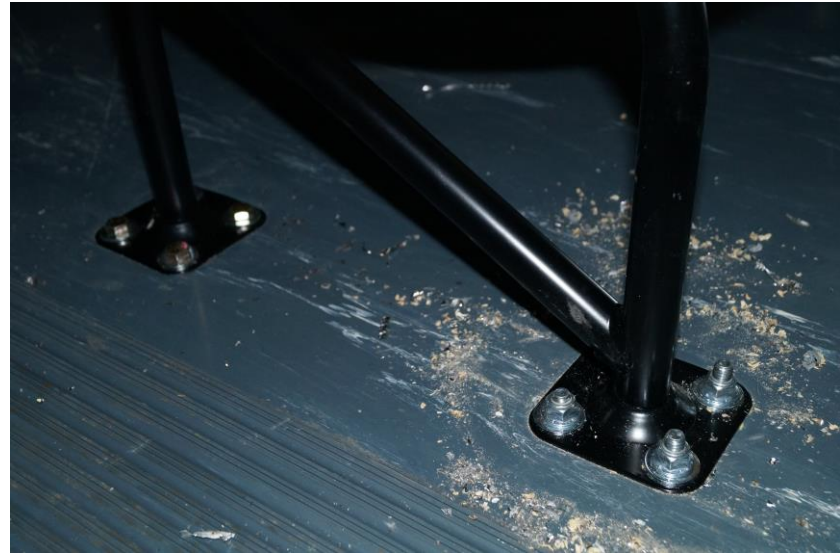
Bolt the seat to the floor with the new supplied fastener (#81C06C200, #83J06, #31D0018 and #82R06C).

Figure 15 - Fixing the seat leg (in the vehicle)

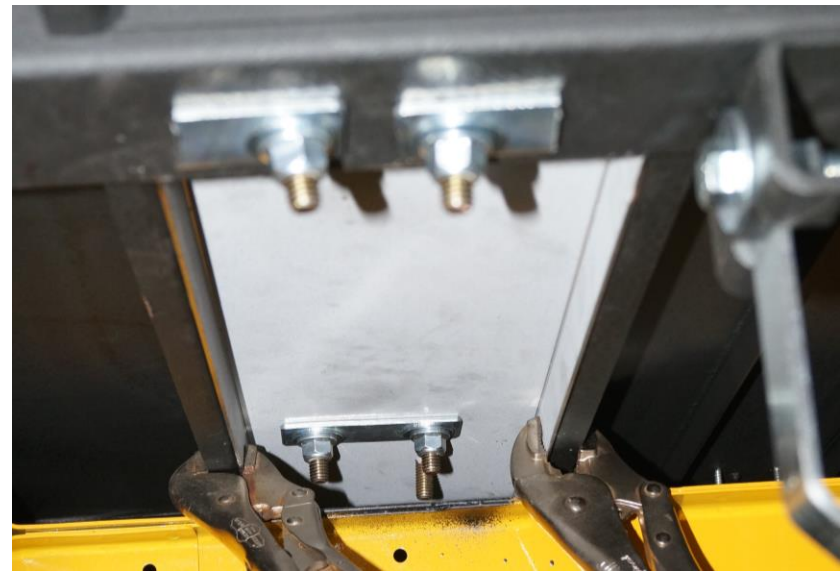
If the bolt pattern in plate #31D0018 does not allow the correct assembly, it is acceptable to cut it in two halves and install them as shown on Figure 16 (top assembly).

Figure 16 - Fixing the seat leg (under the vehicle)

Only the bolts attaching the rear leg and the 2 rearmost bolts of the front leg should be bolted through the plate #31D0018.

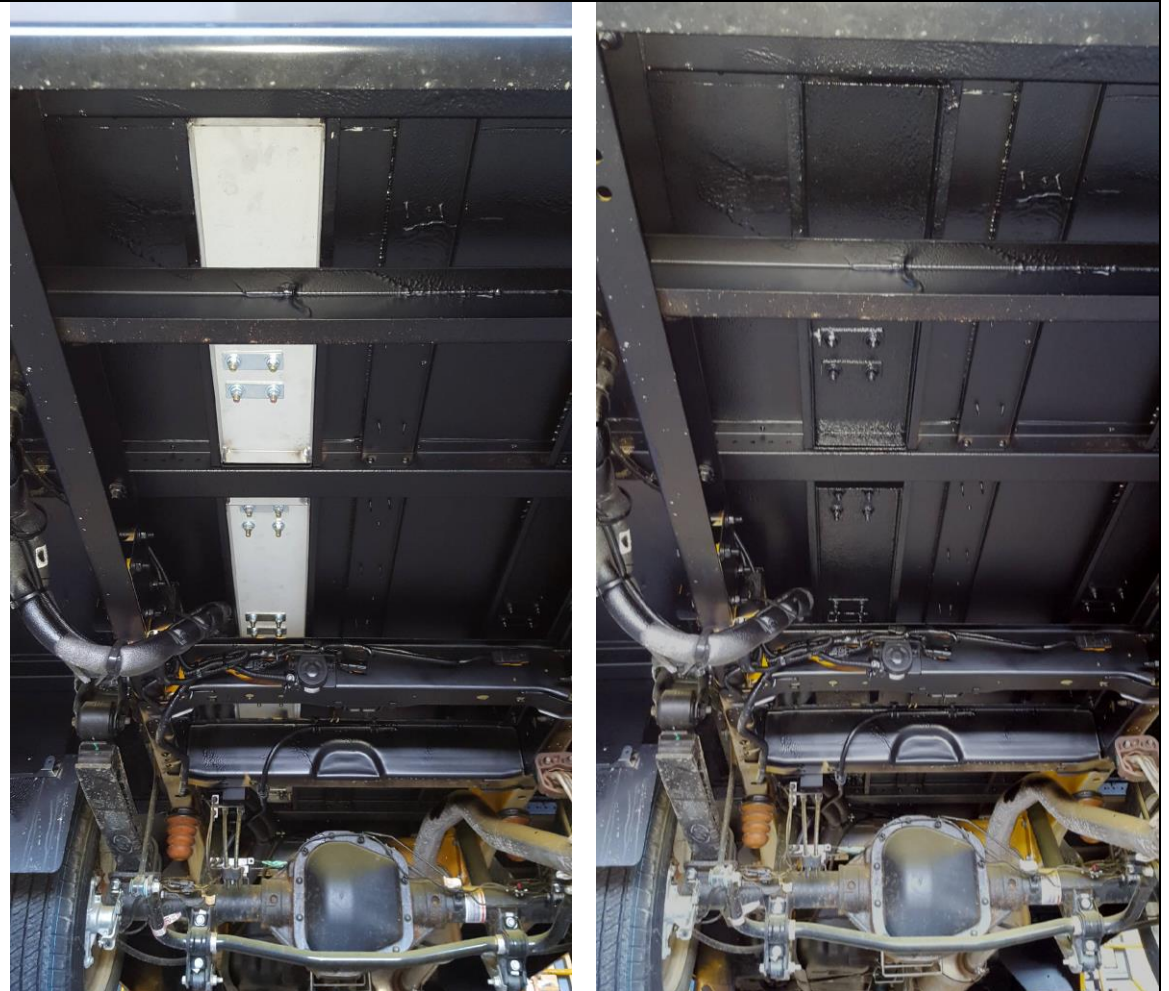
Apply Rubberized Gravlguard Paintable to completely cover the new components under the vehicle.

Figure 17 – Gravlguard application (before and after)

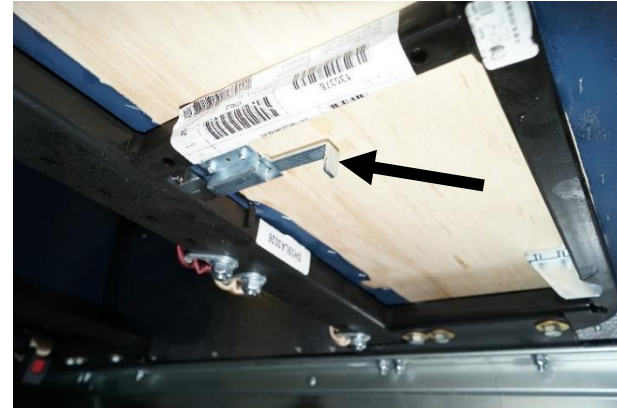
For each concerned seat, remove the seat cushion using the latch under it, as pointed on Figure 18.

Figure 18 - Seat cushion latch position

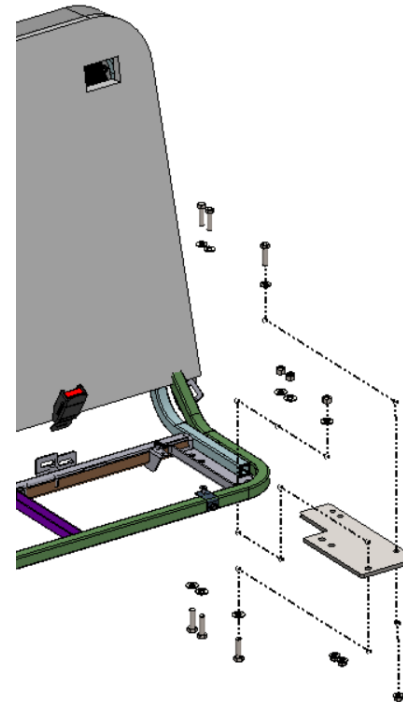
Replace the original plate with the Side wall plate #11D0489-REP and attach it to the seat with:

- 3X 7/16 bolts #81B07F108
- 6X 7/16 washers #83A07
- 3X 7/16 flange locknuts #82E07F

- 3X 3/8 bolts #81C06C108
- 3X 3/8 washers #83J06
- 3X 3/8 flange locknuts #82R06C.

Figure 19 - Fixing plate installation

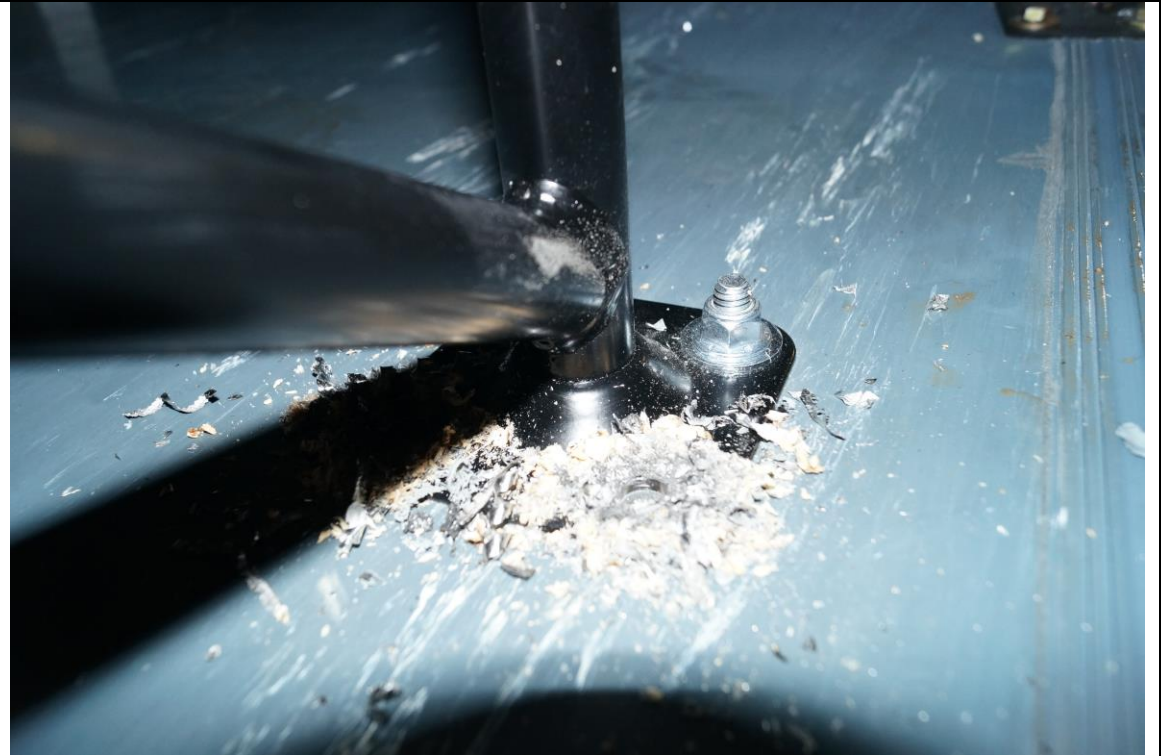
Use a vacuum cleaner or a broom to clean up the inside of the vehicle, making sure there is no cutting chips left (See Figure 20).

Figure 20 - Drilling chip to clean
